Your Inspection Report

123 Address
Atlanta, GA 33333

INSPECTION DATE:
Tuesday, July 28, 2020

Report No. 34930, v.2

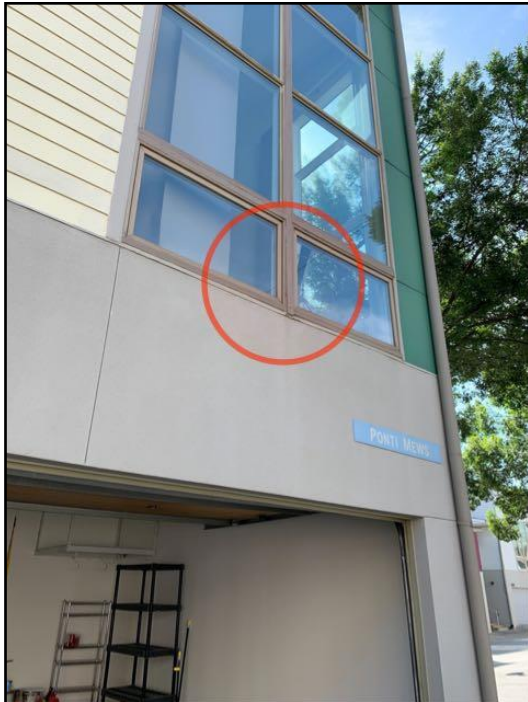
2. Condition: • Rot/Insect damage

Location: Rear patio. Front

7. Rot/repair and seal

Task: Repair or replace

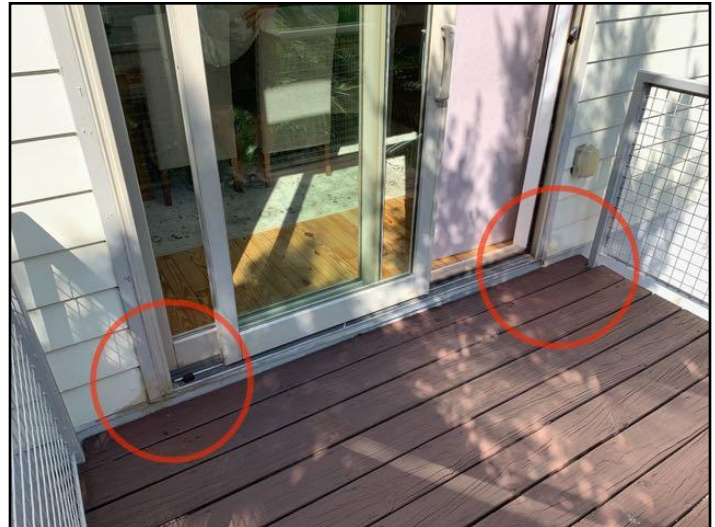
8. Rot/Insect damage

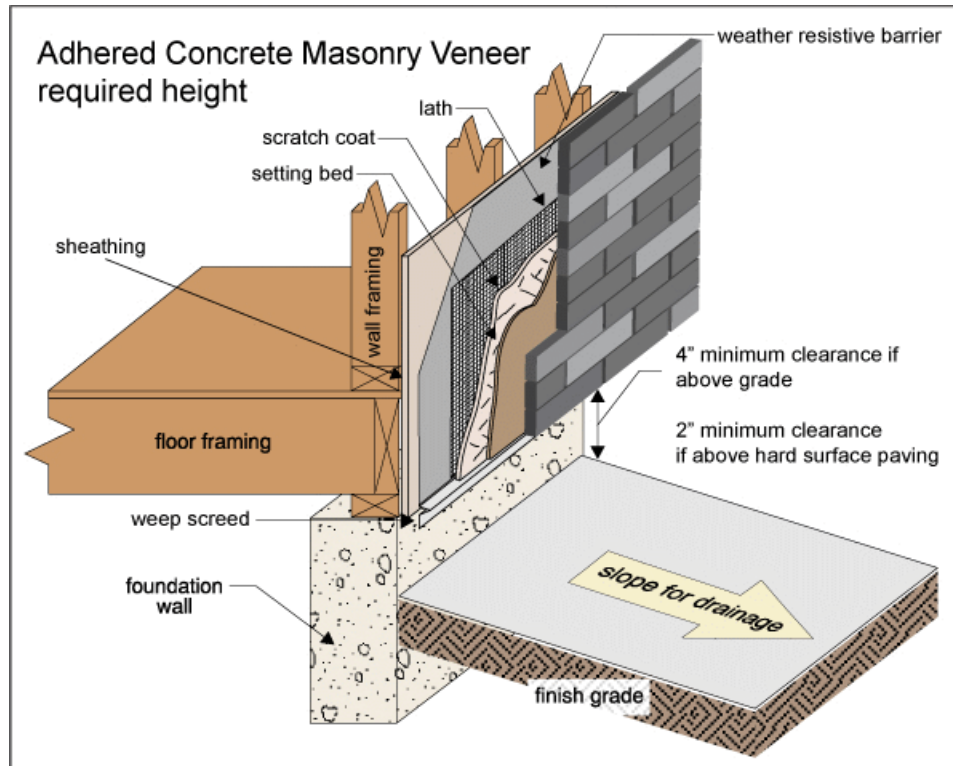
3. Condition: • Artificial Stone Siding

Adhered masonry stone/manufactured stone veneer cladding has been installed on this home. This material can suffer from installation issues allowing water intrusion that may cause hidden damage to the structure. Installation procedure consists of multiple layers which are completely concealed behind the adhered masonry stone veneer cladding and cannot be evaluated by a visual inspection. We recommend a detailed inspection by a qualified specialist where, in most cases, invasive testing is part of this protocol.

Task: Consult with a qualified contractor

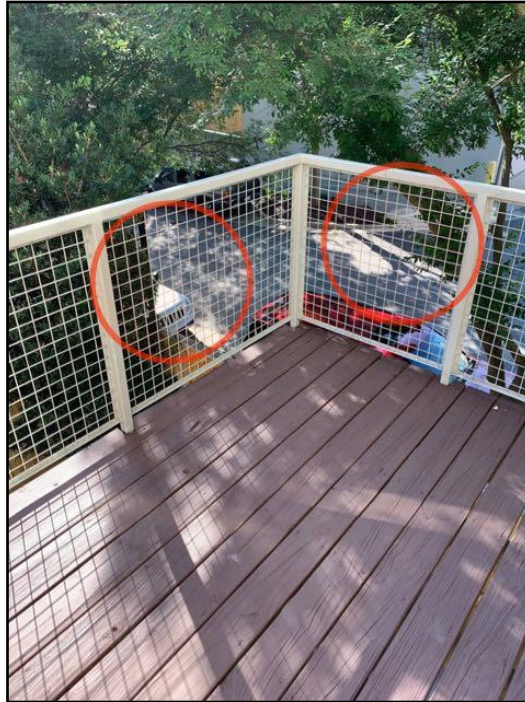
4. Condition: • Balusters/spindles climbable

Location: Patio

9. Balusters/spindles climbable

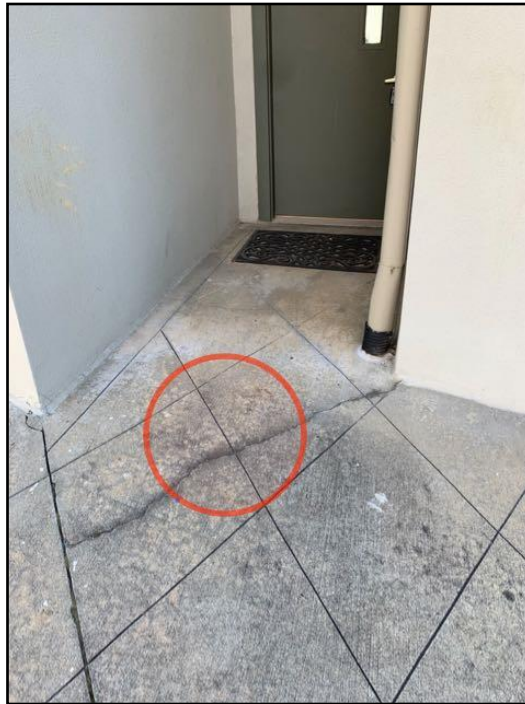
5. Condition: • Cracked or Damaged Surfaces

Location: Front walkway

10. Cracked or Damaged Surfaces

Task: Repair As Needed

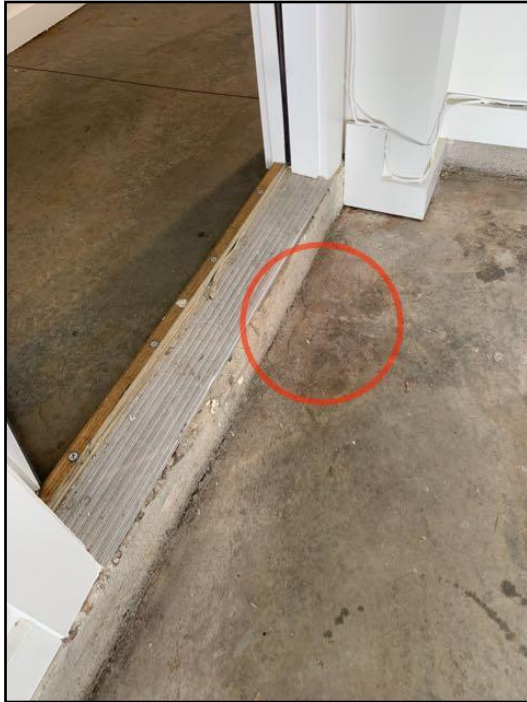
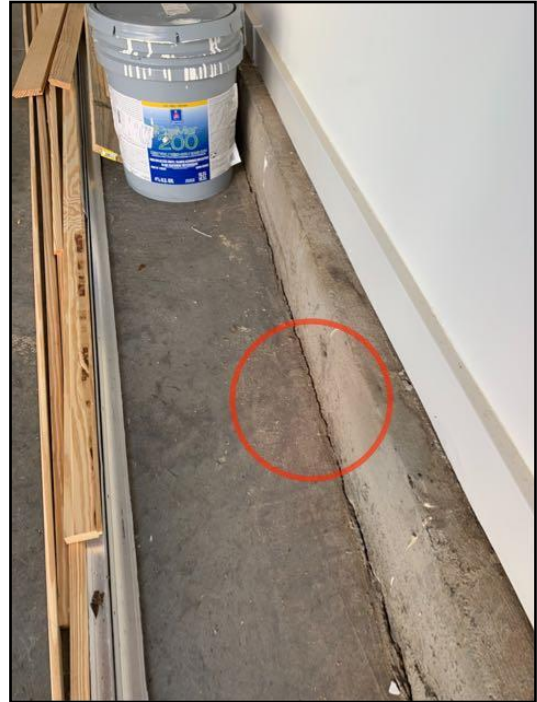
6. Condition: • Cracks in Floor

Location: Garage

11. Cracks in Floor

12. Cracks in Floor

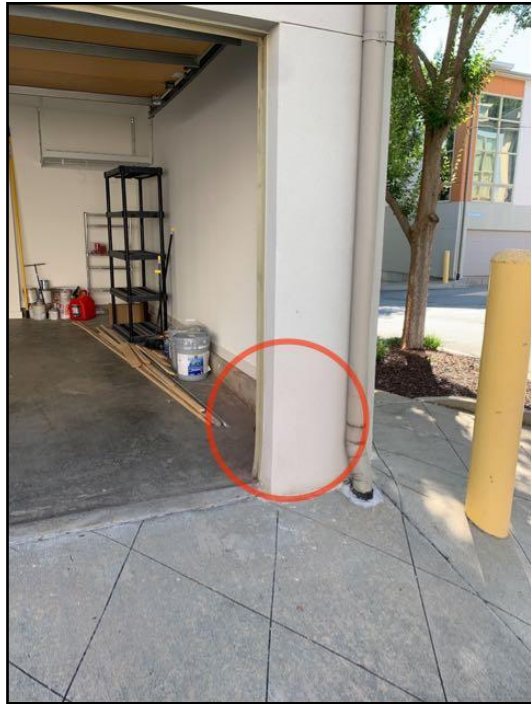
7. Condition: • Prior repairs

Location: Front

13. Prior repairs

Task: Request disclosure

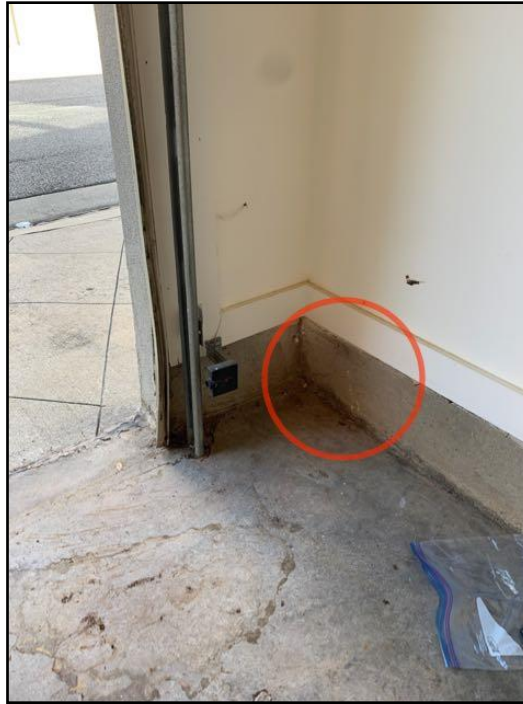
8. Condition: • Typical minor cracks/settling
This is consistent with a home this age and pointed out as a courtesy and no issues noted.

Location: Garage

14. Typical minor cracks/settling

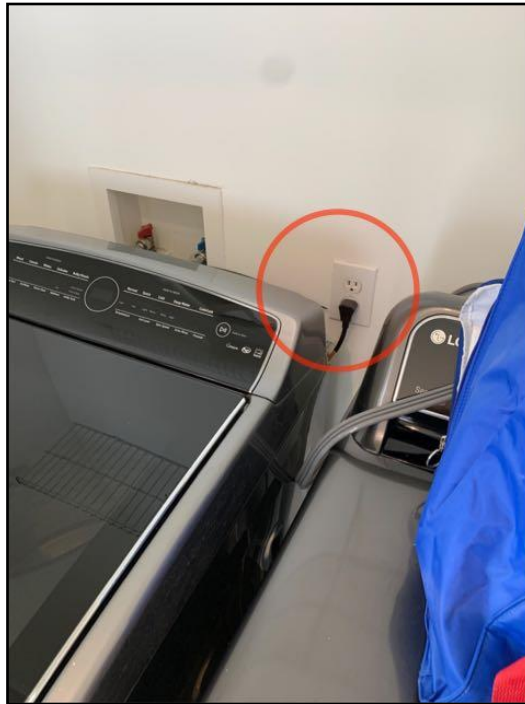
9. Condition: • No GFCI/GFI (Ground Fault Circuit Interrupter)

Implication(s): Electric shock

Location: Laundry closet

15. No GFCI/GFI (Ground Fault Circuit...

Task: Upgrade

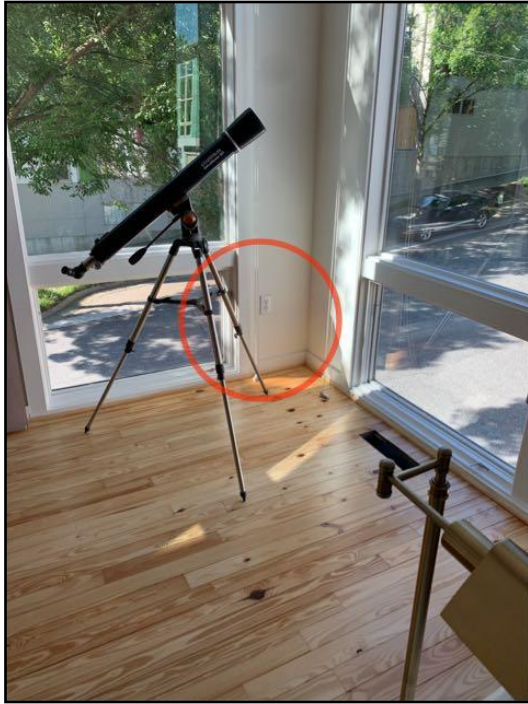
10. Condition: • Loose Receptacles (Outlets) noted

16. Loose Receptacles-Living room

Task: Secure

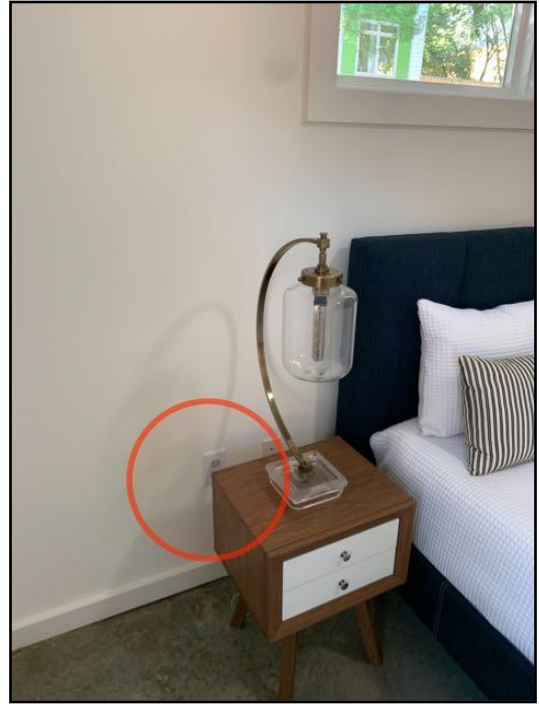
17. Loose Receptacles-Basement bedroom

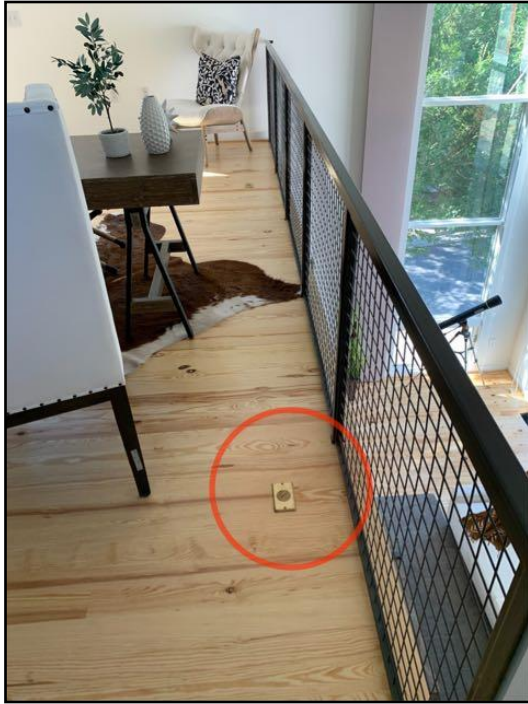
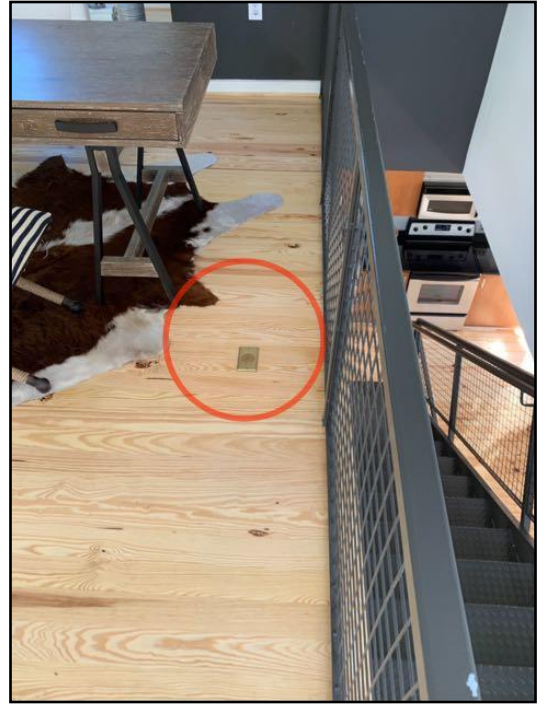
11. Condition: • Inoperative

Location: Second-floor hallway

18. Inoperative-2nd floor hallway

19. Inoperative-2nd floor hallway

Task: Replace

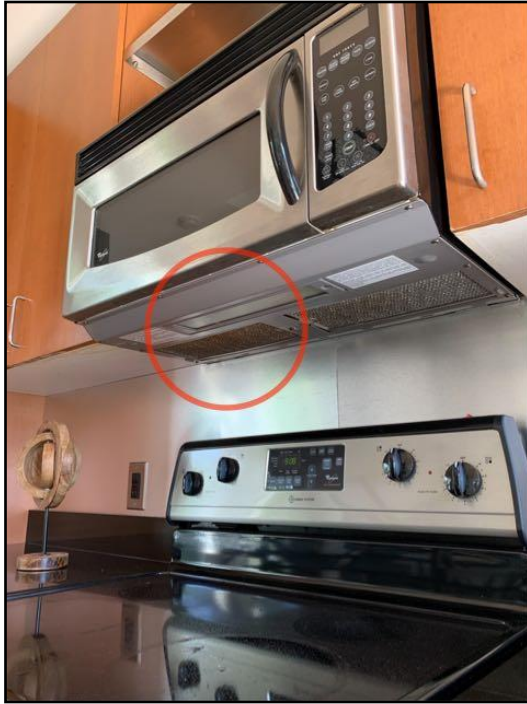
12. Condition: • Inoperative

This is most likely blown bulbs and recommend confirming operation from the seller.

20. Inoperative-Kitchen

Task: Correct

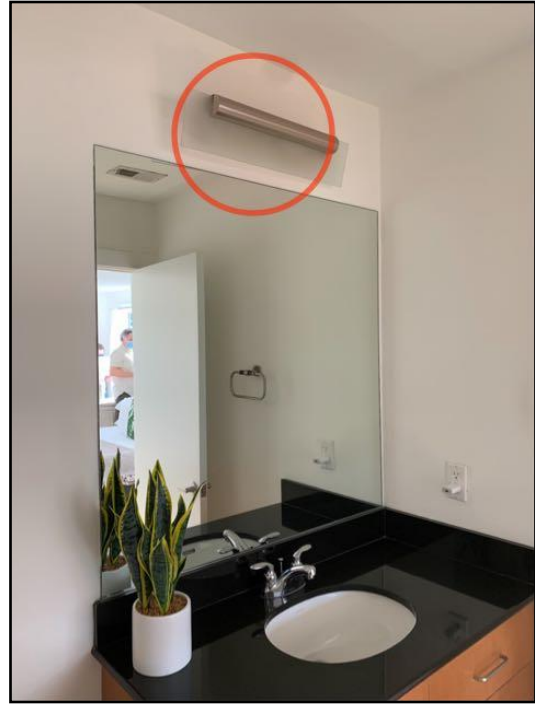
21. Inoperative-master bathroom

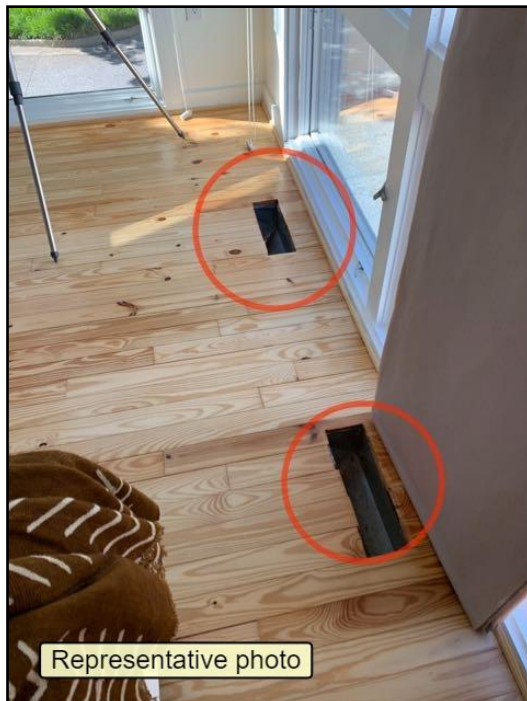
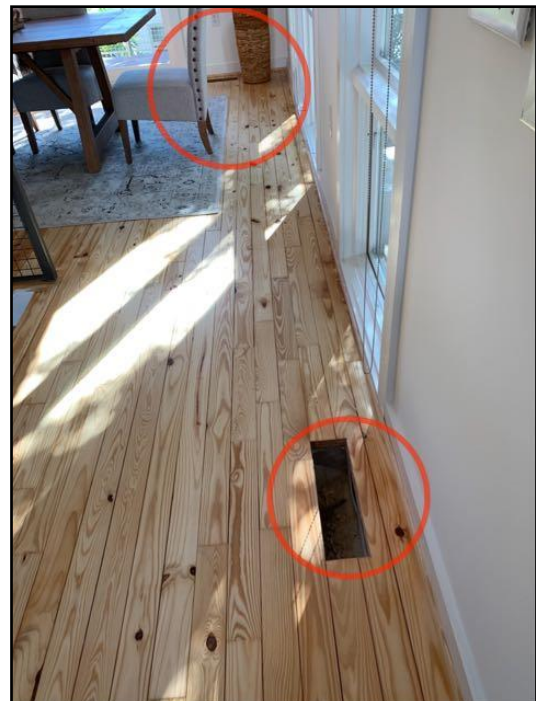
14. Condition: • Loose/Missing register or grille

Implication(s): Fall hazard | Poor performance

Location: Throughout main floor

23. Loose/Missing register or grille

24. Loose/Missing register or grille

Task: provide

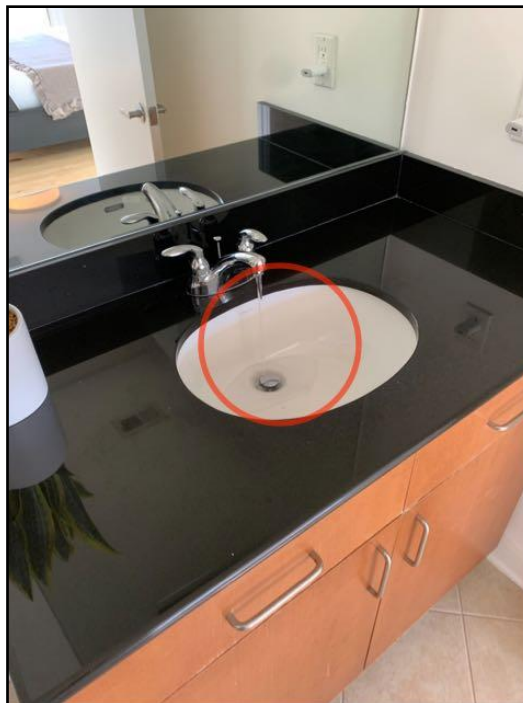
15. Condition: • [Slow drains](#)

Implication(s): Chance of water damage to structure, finishes and contents

33. Slow drains

Task: Correct

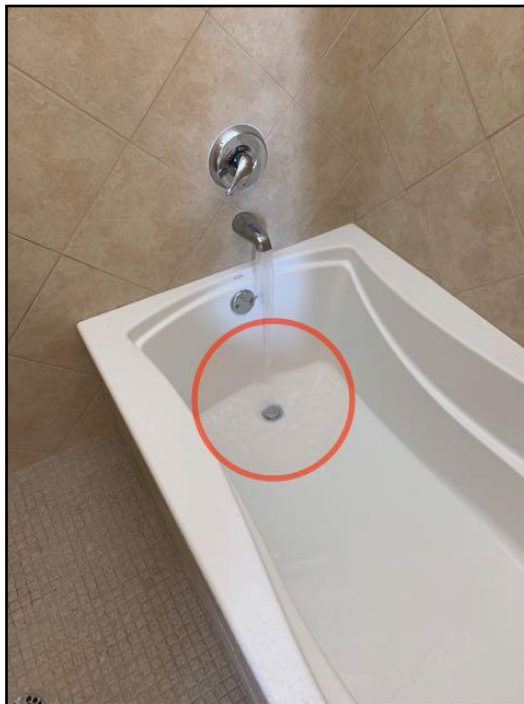
16. Condition: • Drain stop ineffective

34. Drain stop ineffective

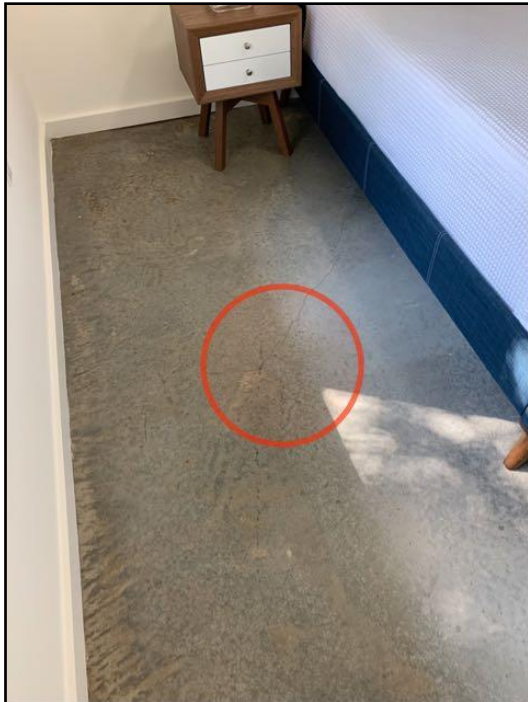
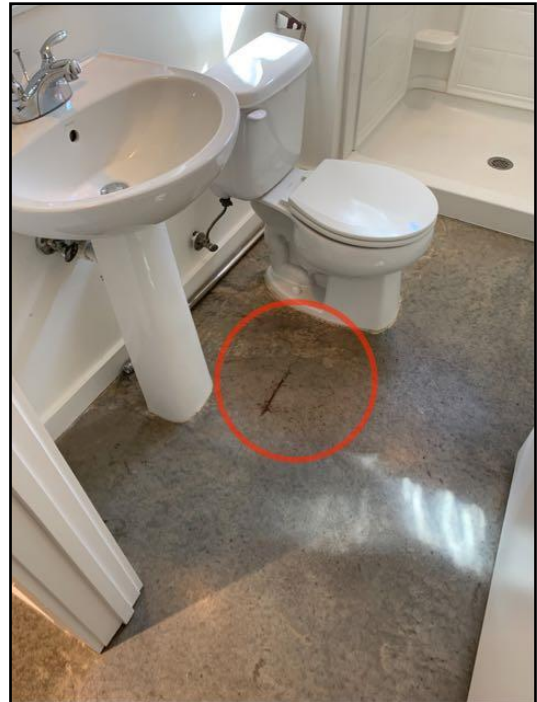
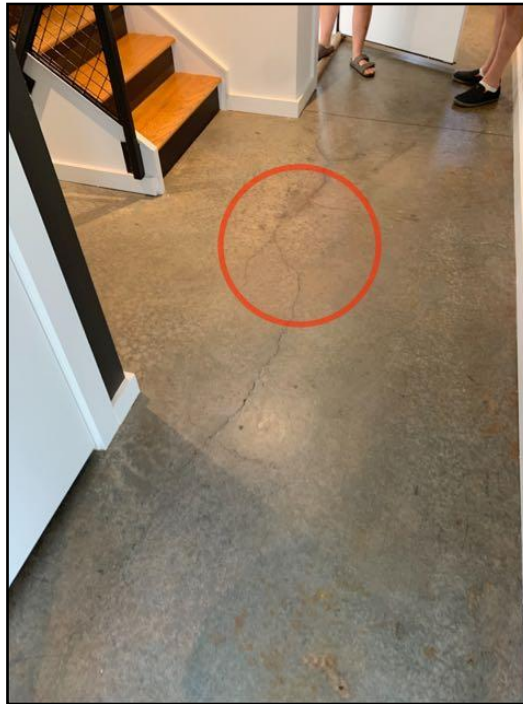
17. Condition: • Concrete Cracked

Typical cracking in concrete noted. There is no further evidence of settling, shifting or separating and considered a cosmetic issue.

38. Concrete Cracked-Basement

39. Concrete Cracked-Basement

40. Concrete Cracked-Basement

Task: Be Advised Monitor cracks to ensure they do not worsen

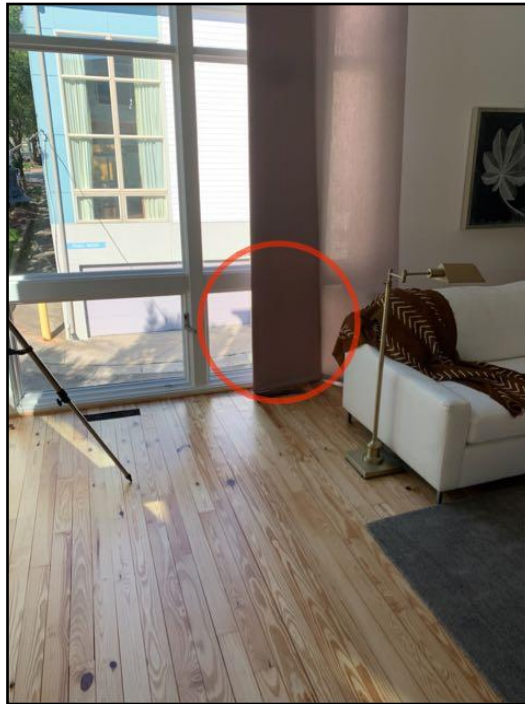
18. Condition: • Windows Painted Shut

41. Windows Painted Shut

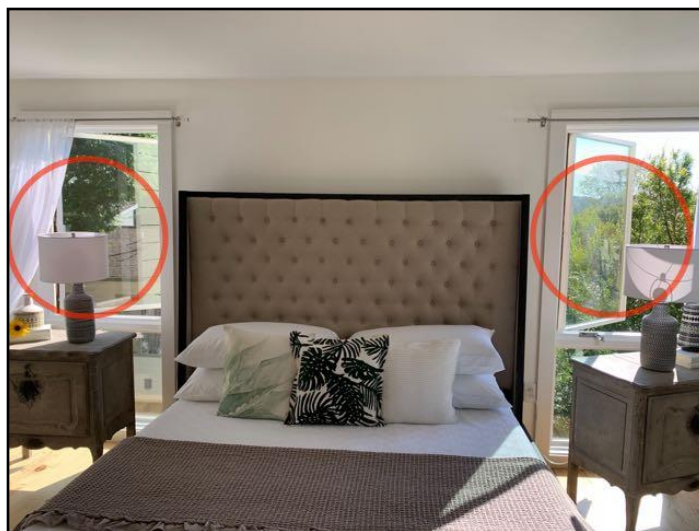
19. Condition: • Weather Stripping Needed

Weatherstripping is loose and coming apart

42. Weather Stripping Needed-Master bedroom

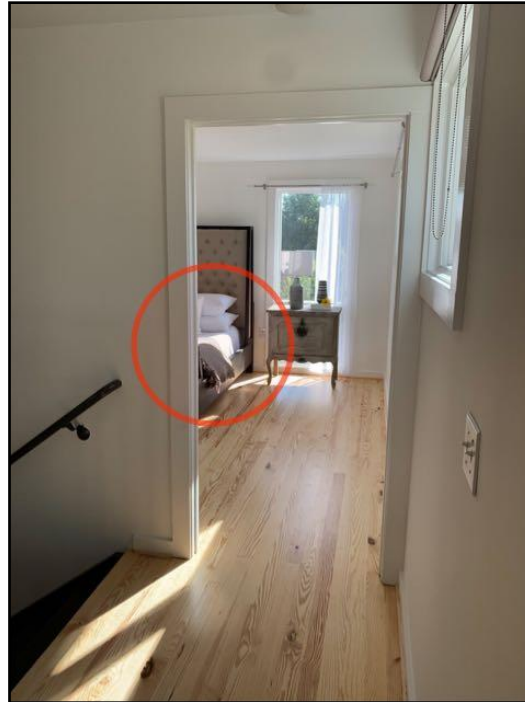
43.

20. Condition: • Door missing

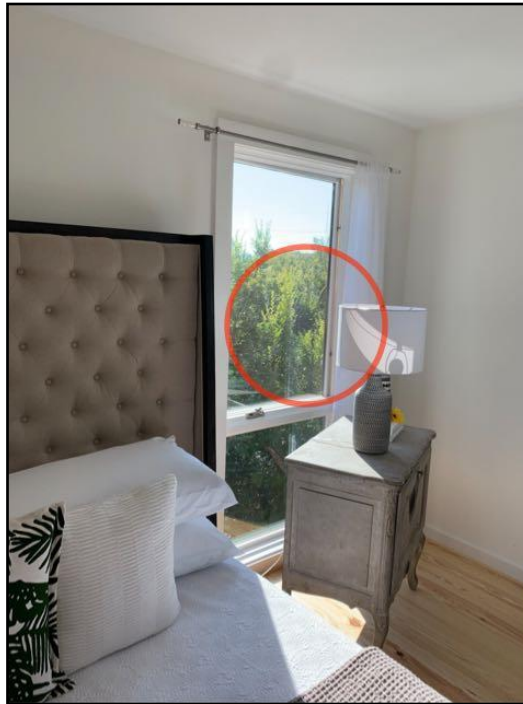
44. Master bedroom

21. Condition: • Window won't fully close easily

Task: Repair or replace

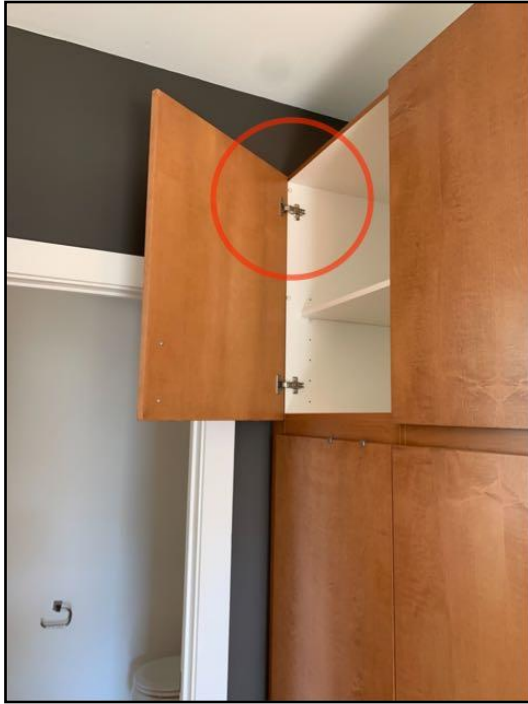
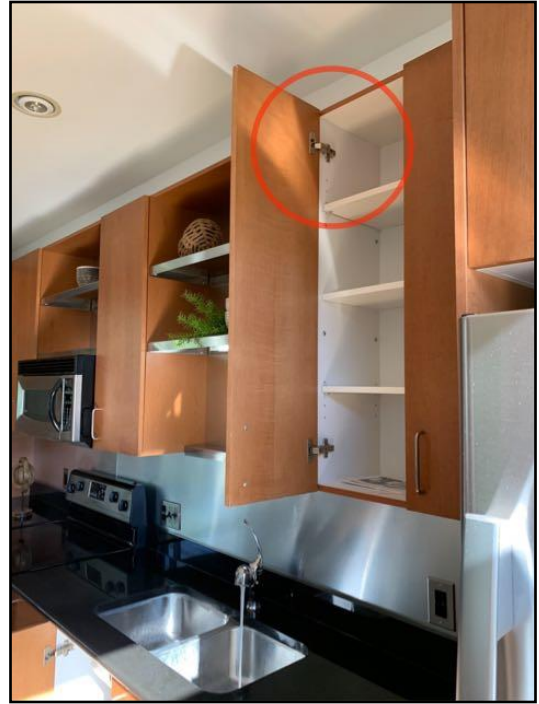
22. Condition: • [Pieces missing or loose](#)

Loose hinges

Implication(s): Damage or physical injury due to falling materials

45. Pieces missing or loose

46. Pieces missing or loose

Task: Repair or replace

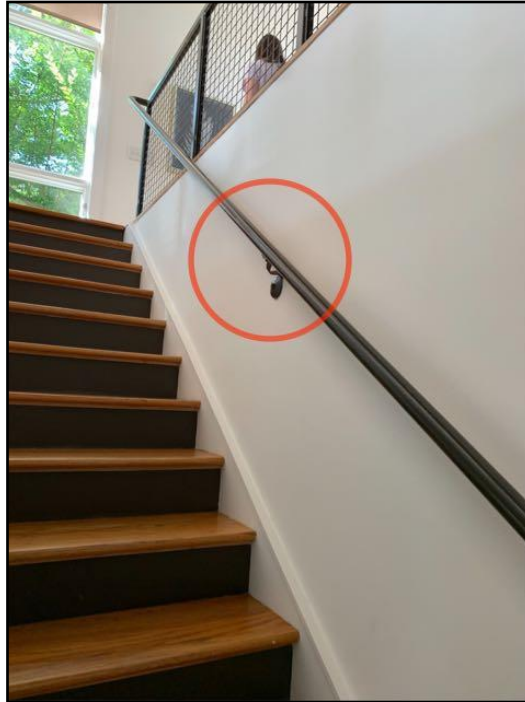
23. Condition: • Handrail Loose

47. Handrail Loose

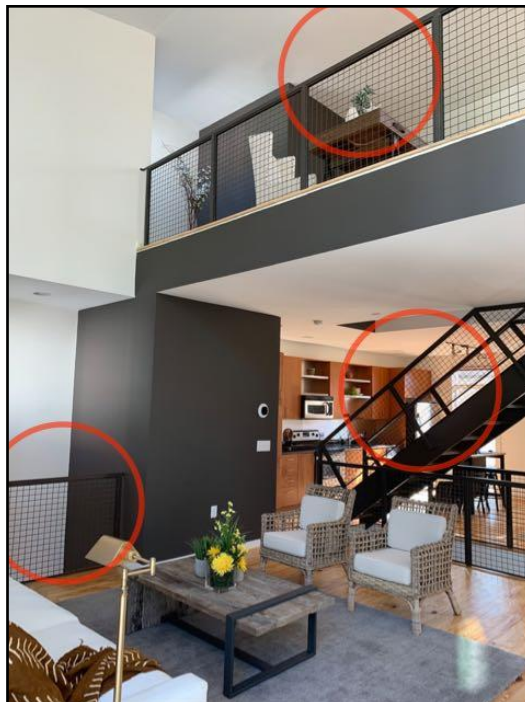
24. Condition: • Spindles/balusters climbable

48. Spindles/balusters climbable

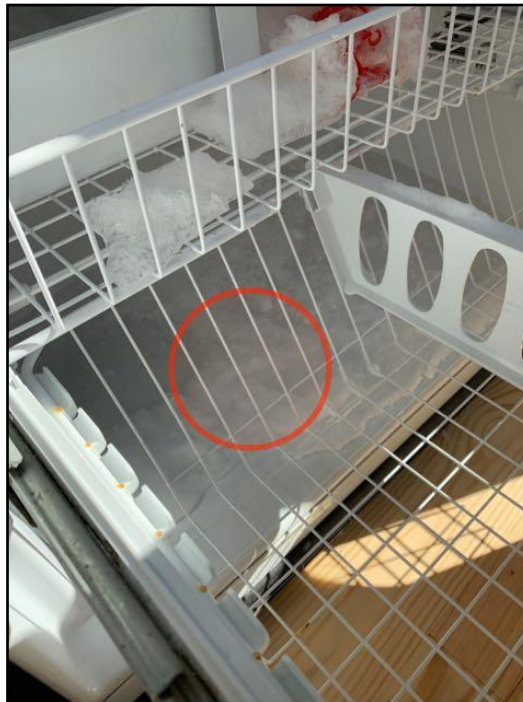
49.

25. Condition: • Possible leak in freezer. Frozen water at bottom of freezer

Task: Repair or replace

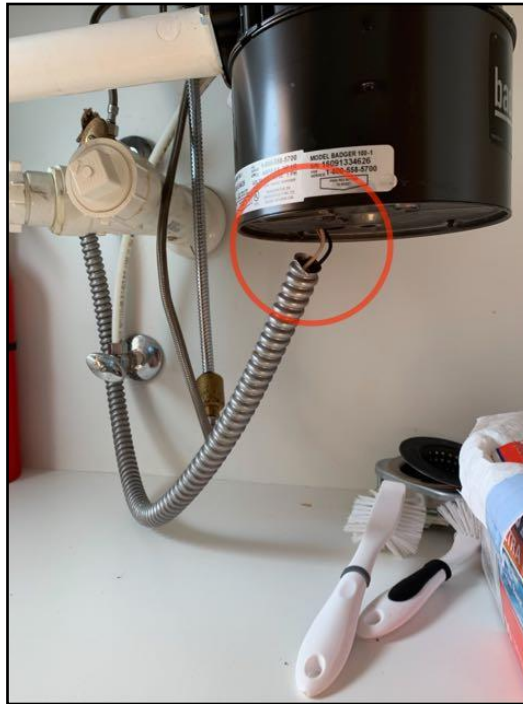
26. Condition: • Wiring exposed or loose

50. Wiring exposed or loose
