# Your Inspection Report

9427 Springs Court  
Smithtown, GA 30221

**INSPECTION DATE:**  
Tuesday, October 5, 2021

RE: Report No. 41832, v.3  
9427 Springs Court  
Smithtown, GA  
30221

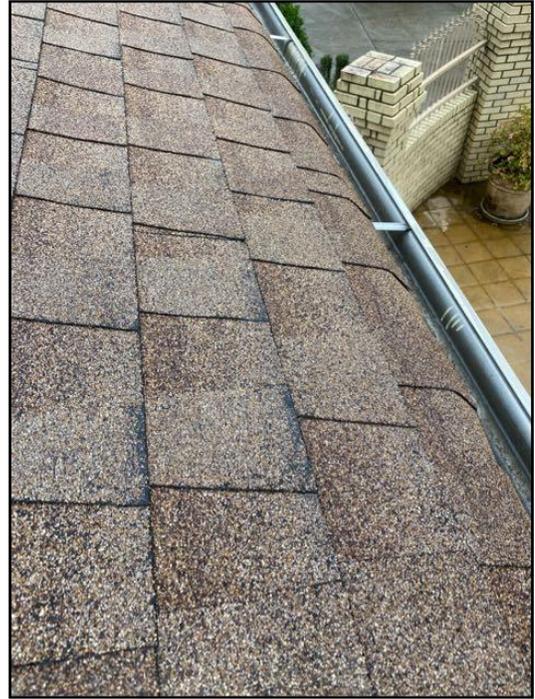
**1. Condition:** • Granule Loss

Shingles are starting to loose granules, which is an indication of wear. This shows the shingles to be brittle and dried out and as the condition deteriorates and repairs become necessary, replacement may be a better option than repair.

3. Granule Loss

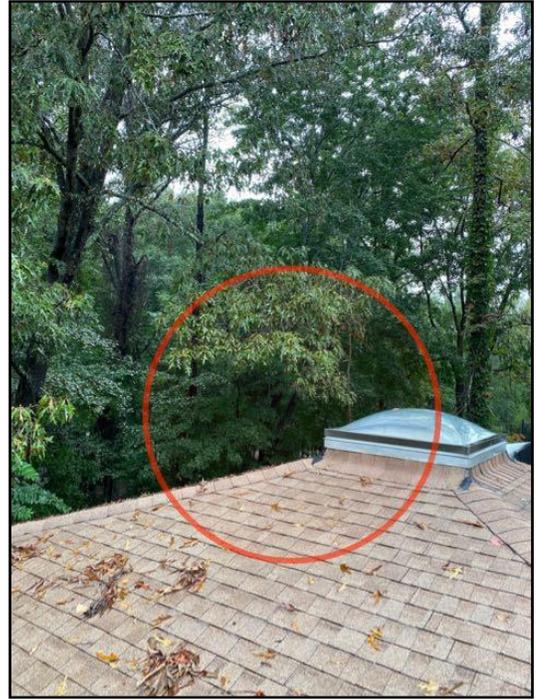
**2. Condition:** • Tree branches touching/too close to roof

5. Tree branches touching/too close to roof

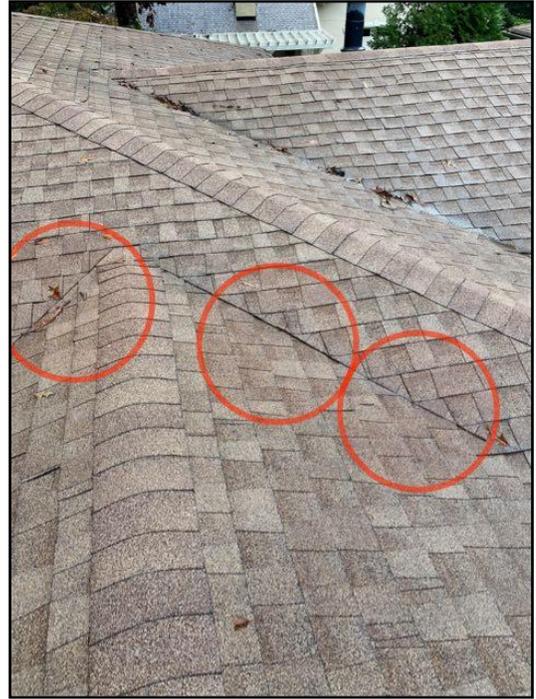
**3. Condition:** • Installation issues

7. Installation issues

**Task:** Evaluation by roofing contractor to determine necessary repairs

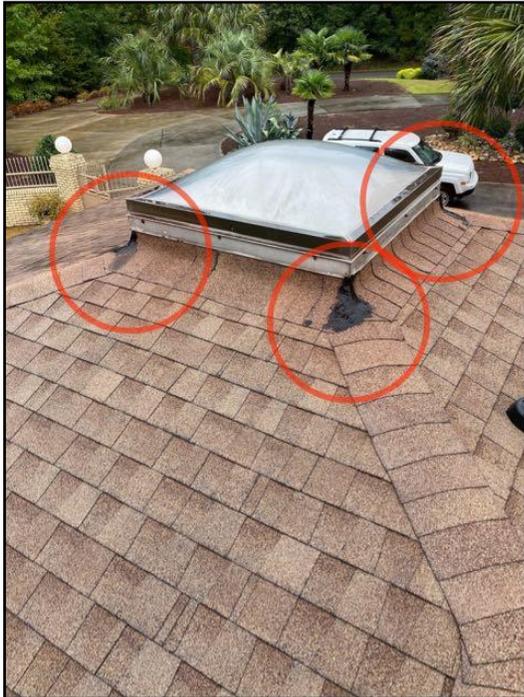
4. Condition: • Patched/Repaired

Location: Skylights

9. Patched/Repaired

Task: Be advised - Request disclosure

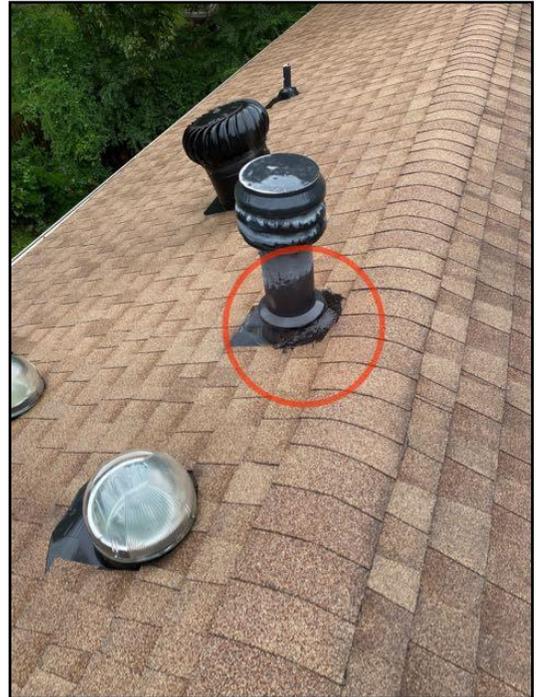
10. Patched/Repaired

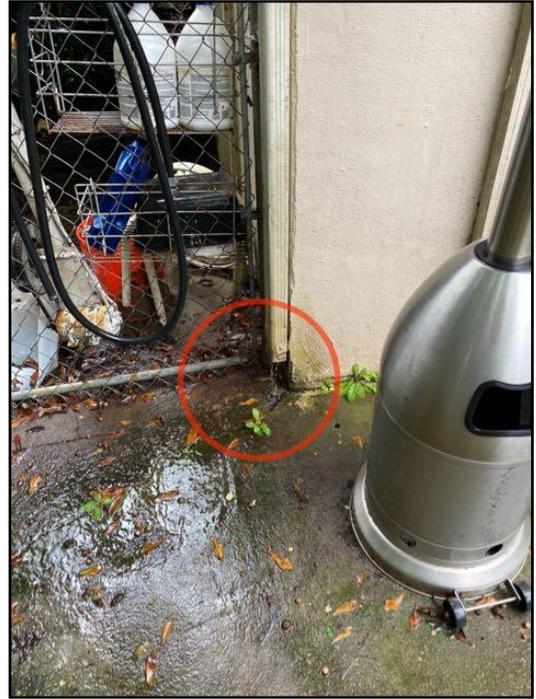
**7. Condition:** • Discharges Too Close to the Building

19. Discharges Too Close to the Building

**Task:** Extend downspout termination point at least 6 feet away from building, foundations, footings and slabs.

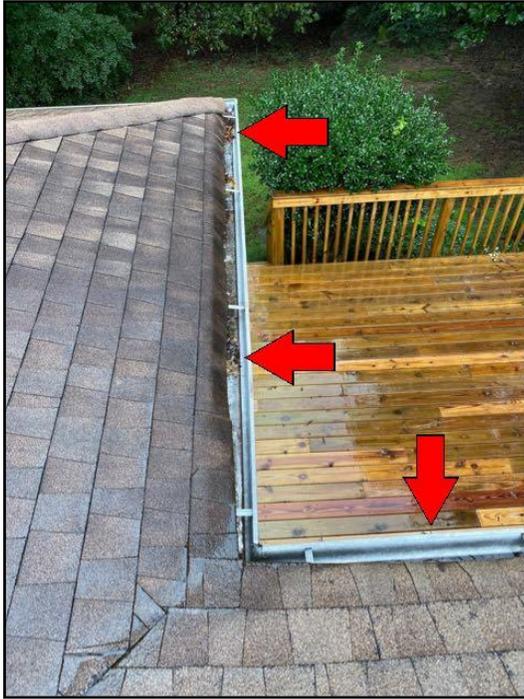
**8. Condition:** • Improper Slope/Ponding Water  
Holding water  
**Location:** Rear, right side  
**Task:** Rehang or Re-support Gutters  
**Time:** Immediate  
**Cost:** Regular maintenance item

21. Improper Slope/Ponding Water

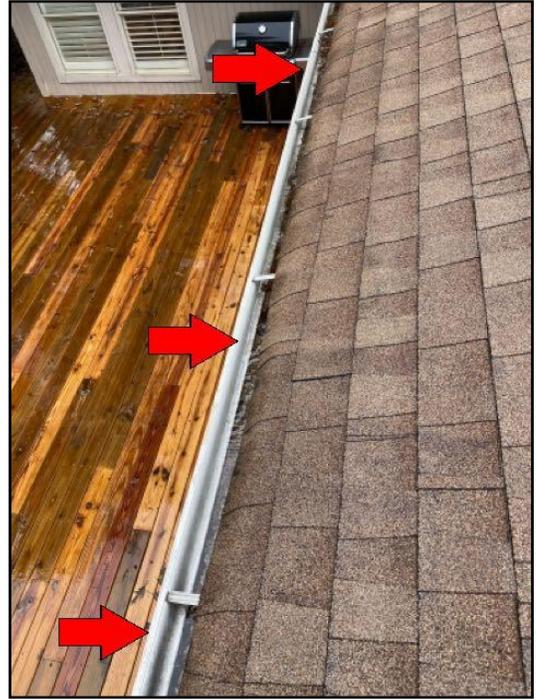
22. Improper Slope/Ponding Water

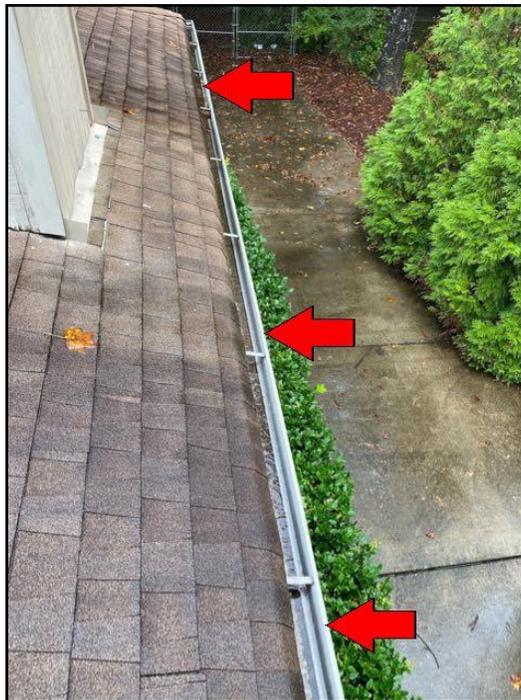
23. Improper Slope/Ponding Water

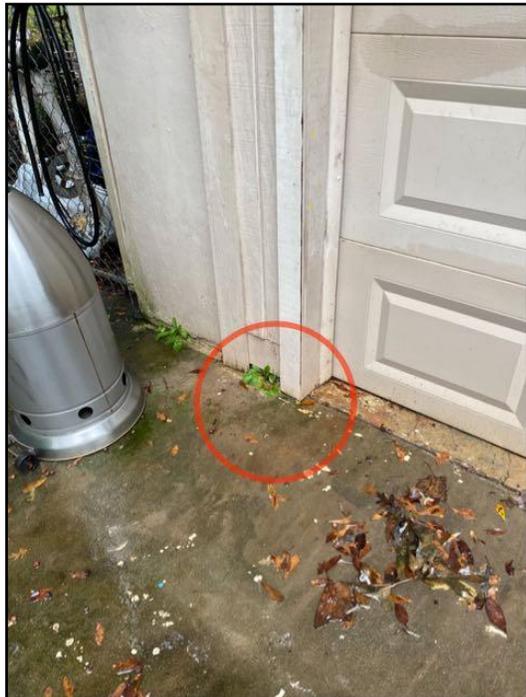
**9. Condition:** • Rot/Insect damage

24. Rot/Insect damage

**Task:** Repair or replace

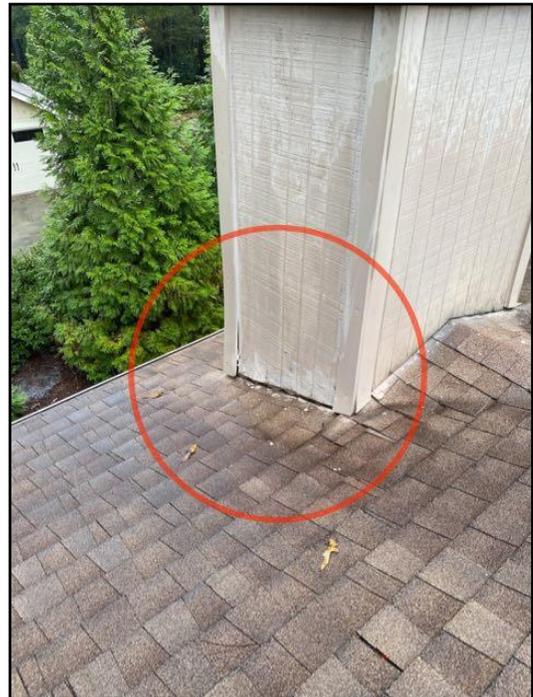
25. Rot/Insect damage

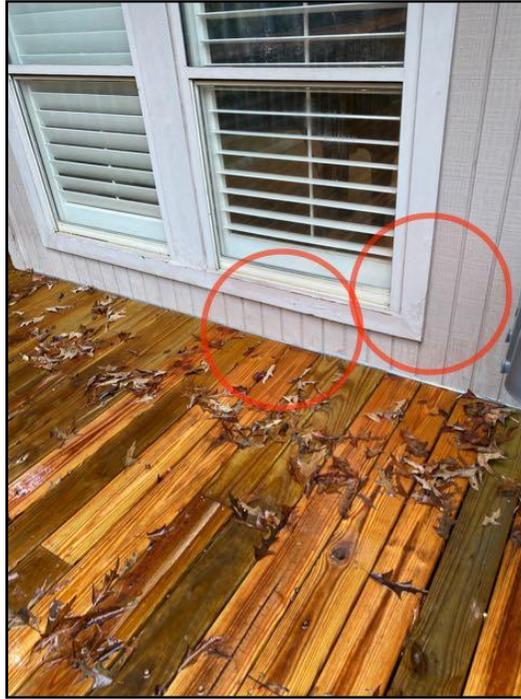
**10. Condition:** • Paint or stain needed

*27. Paint or stain needed*

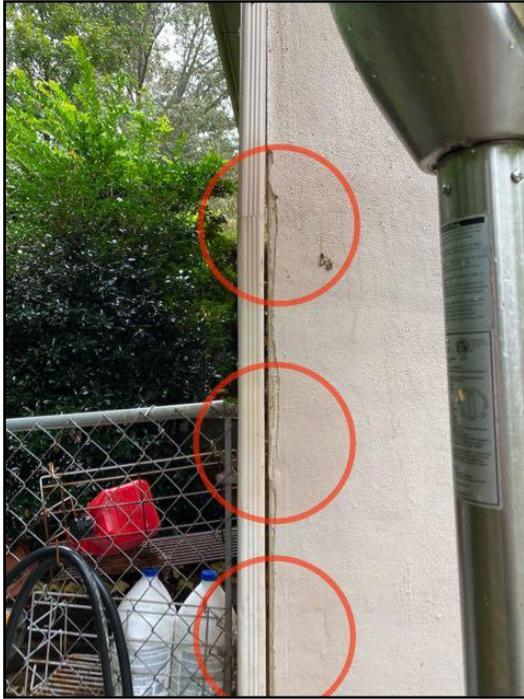
**11. Condition:** • Stucco Cracked or Damaged

More invasive testing is usually required when there are cracks or damaged. Sometimes they extend beyond the surface and recommend evaluation by a qualified contractor. If these are only surface cracks there will still be the consideration of matching existing painting which can add considerably to repair costs.

28. Stucco Cracked or Damaged

**Task:** Repair

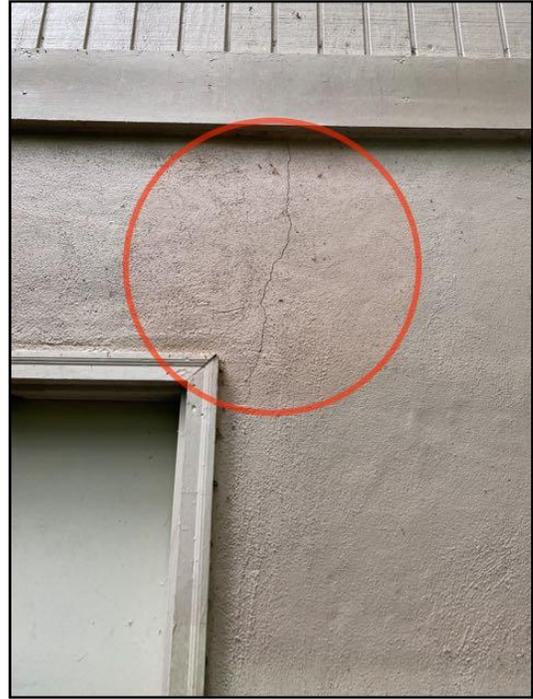
29. Stucco Cracked or Damaged

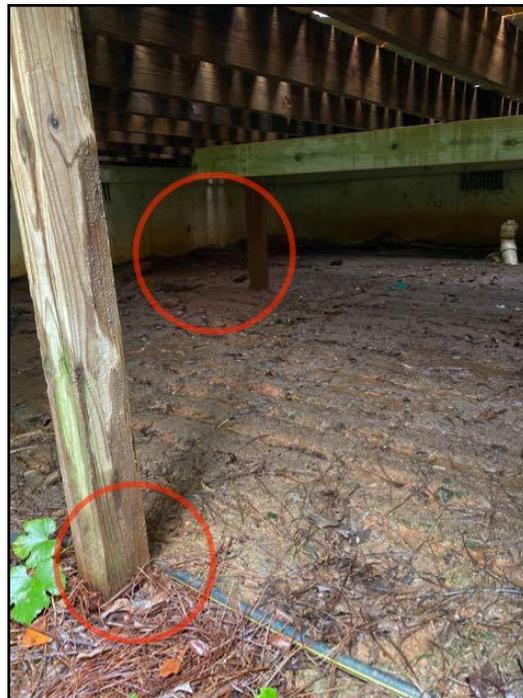
**12. Condition:** • [Wood/soil contact](#)

32. Wood/soil contact

Recommend excavating 6 to 8 inches away from the wood and replace with gravel or like material for drainage.

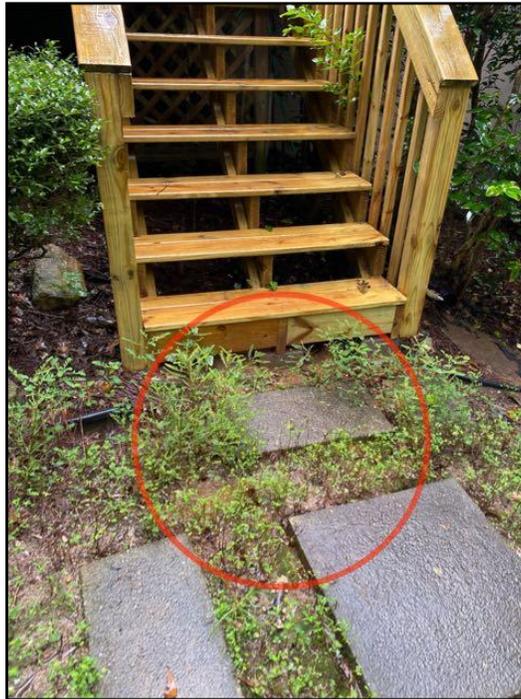
**16. Condition:** • [Landings missing/inadequate](#)

34. Landings missing/inadequate

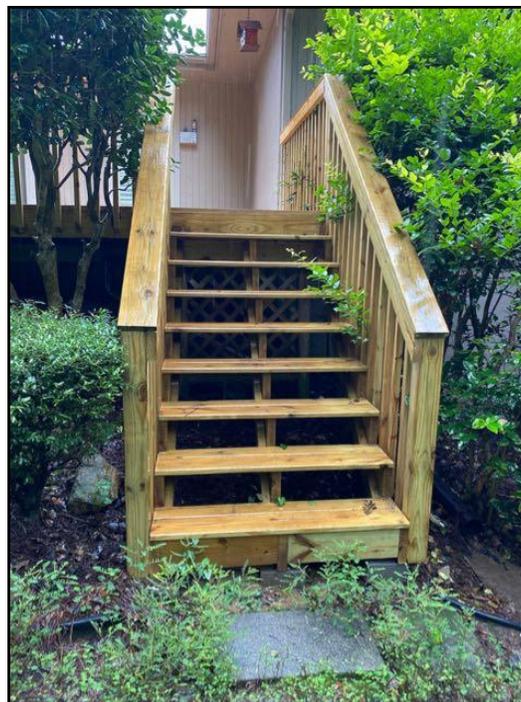
17. **Condition:** • Graspable Handrail Missing

35. *Graspable Handrail Missing*

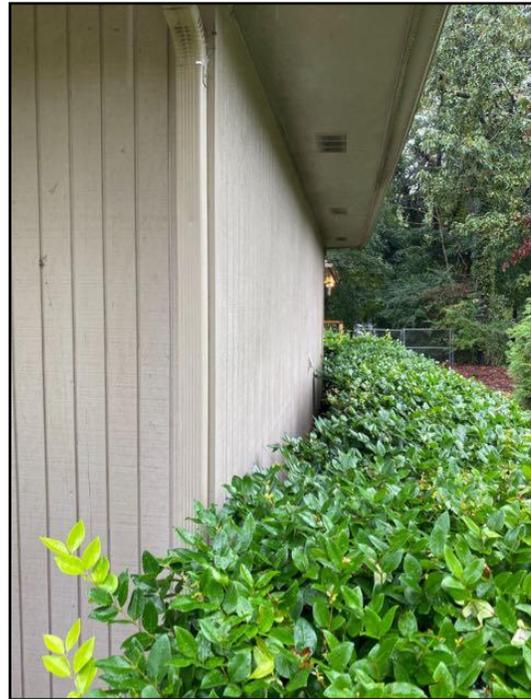
**19. Condition:** • Trees or Shrubs too close to building

38. Trees or Shrubs too close to building

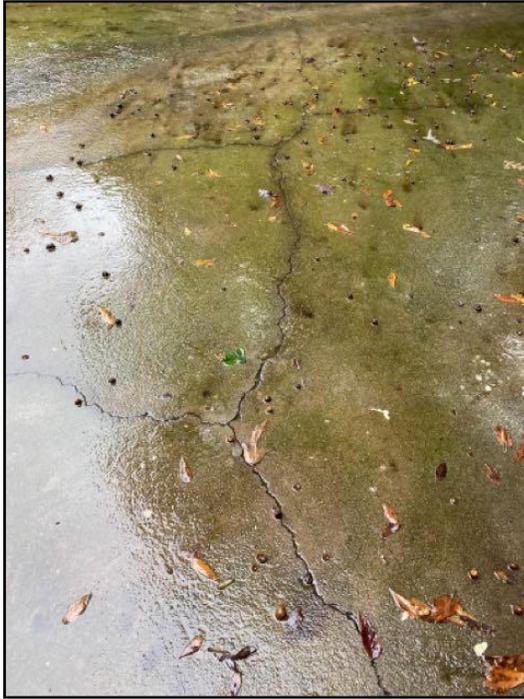
**20. Condition:** • Cracked or Damaged Surfaces

39. Cracked or Damaged Surfaces

**Task:** Repair As Needed

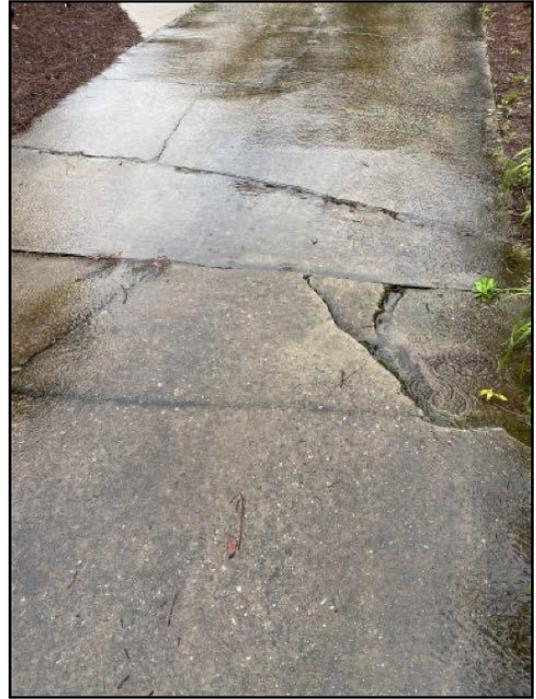
40. Cracked or Damaged Surfaces

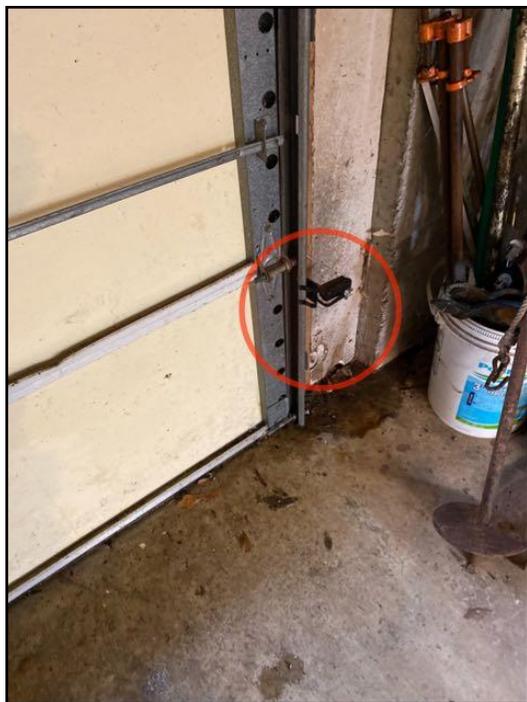
**24. Condition:** • Sensors Poorly Located  
Too high  
**Task:** Adjust Location of sensors  
**Time:** Immediate  
**Cost:** Minor

45. Sensors Poorly Located

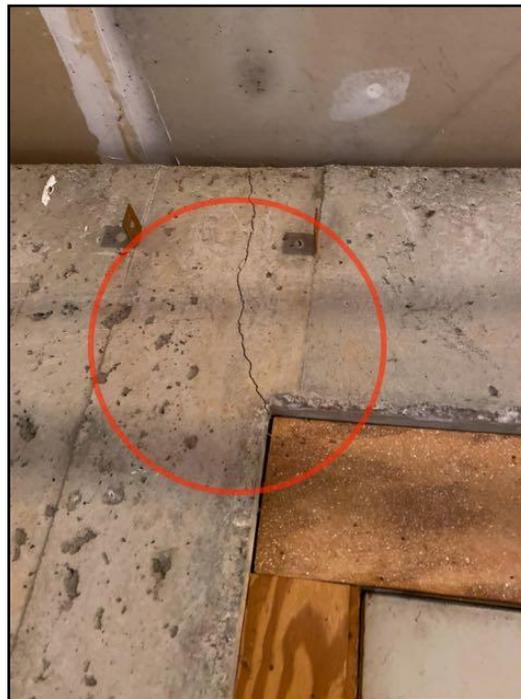
**27. Condition:** • Typical minor cracks/settling

This is consistent with a home this age and pointed out as a courtesy and no issues noted.

47. Typical minor cracks/settling

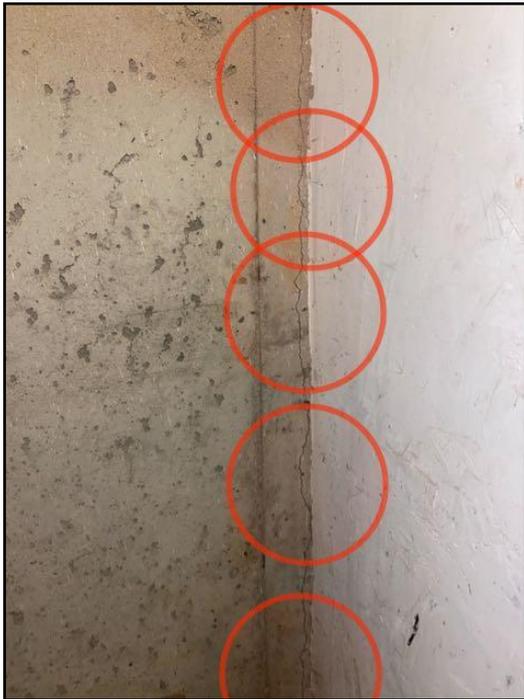
**28. Condition:** • Cracked

48. Cracked

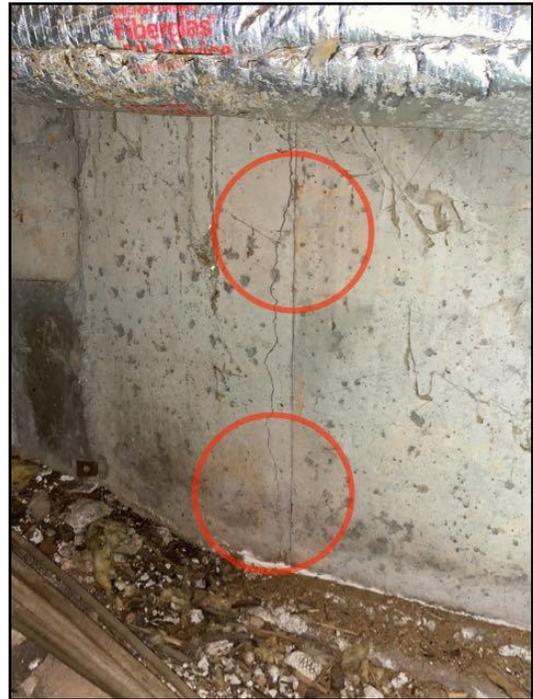
49. Cracked

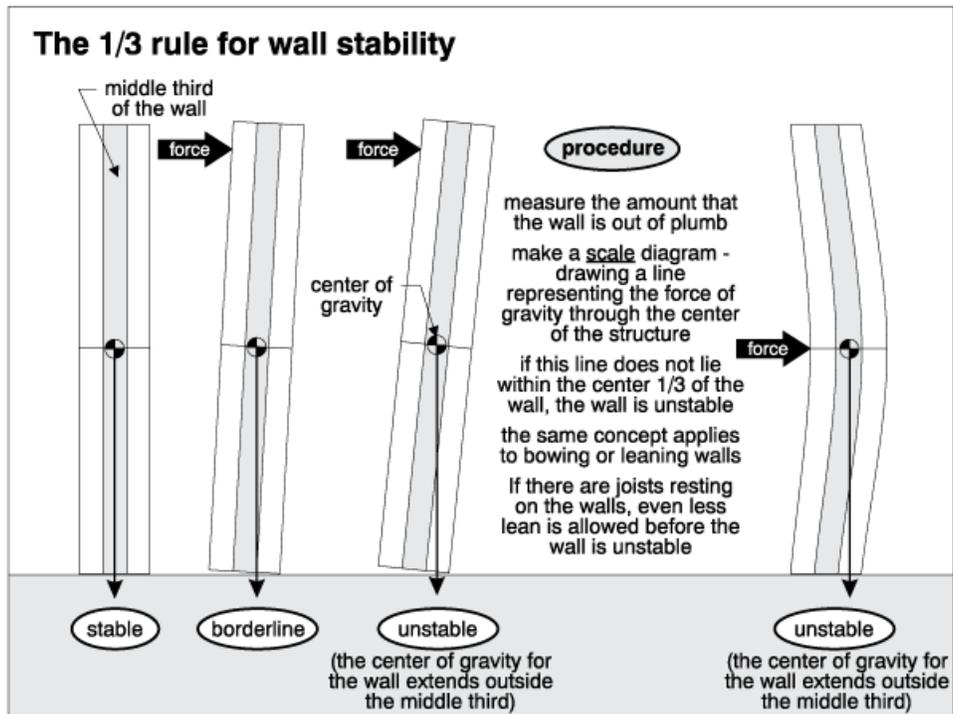
51. Leaning

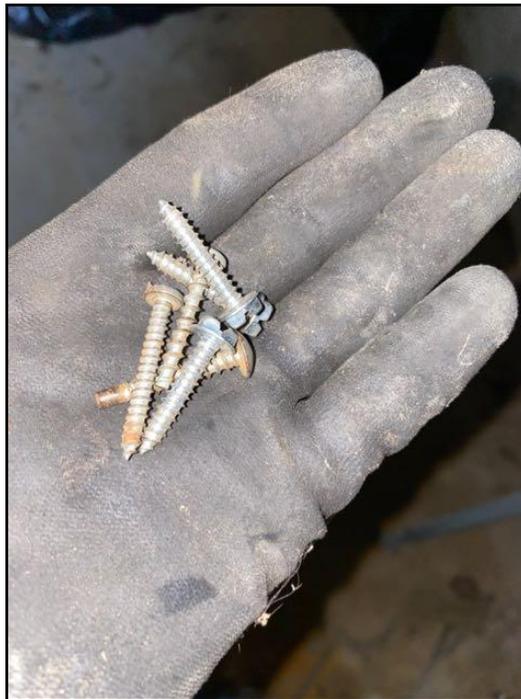
**56.** *Improper cover screws used to secure panel*

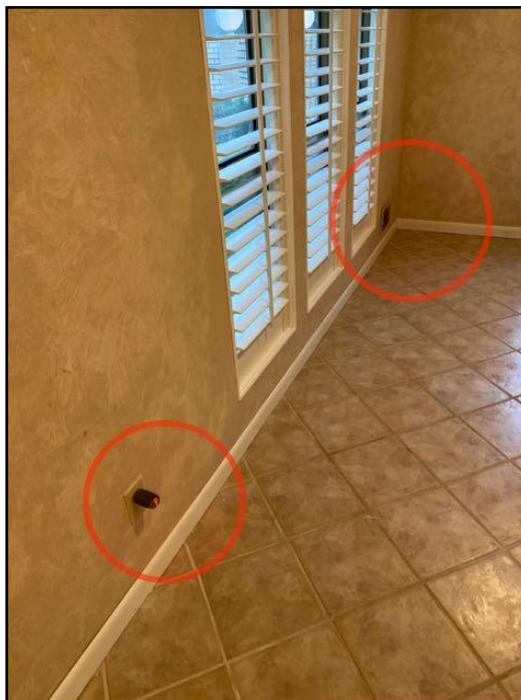
61. Ungrounded

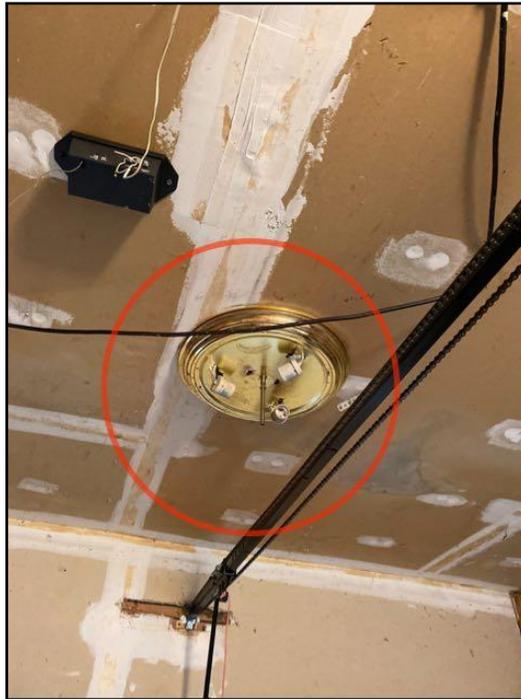
65. Damaged Fixture

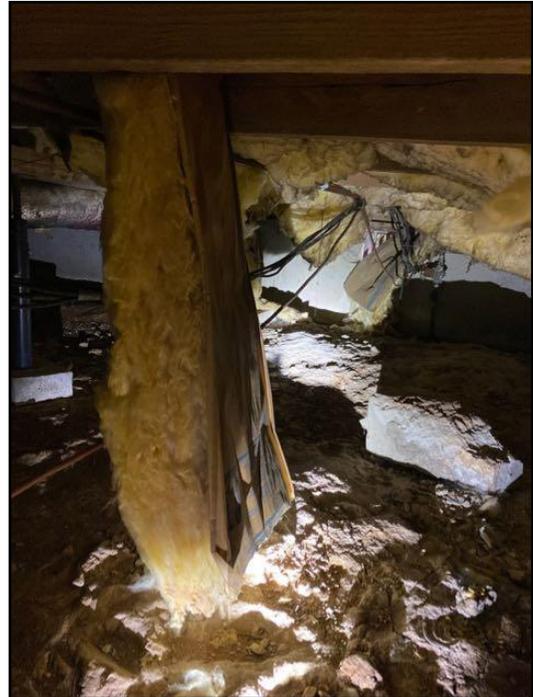
83. Insulation is falling away

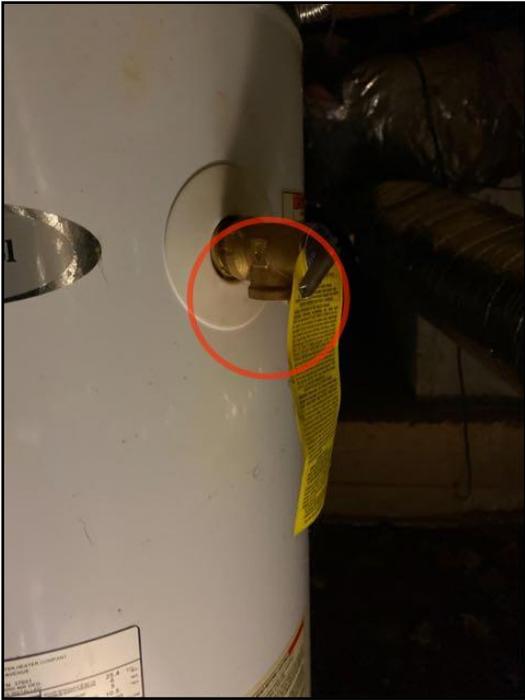
89. Discharge tube missing

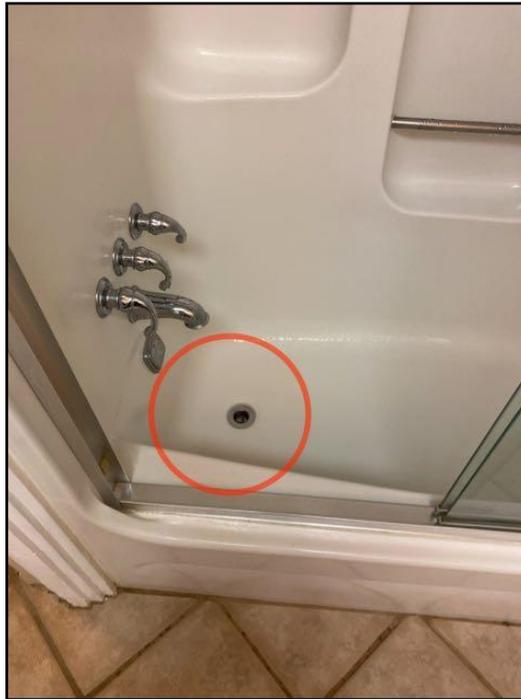
95. Drain stop missing

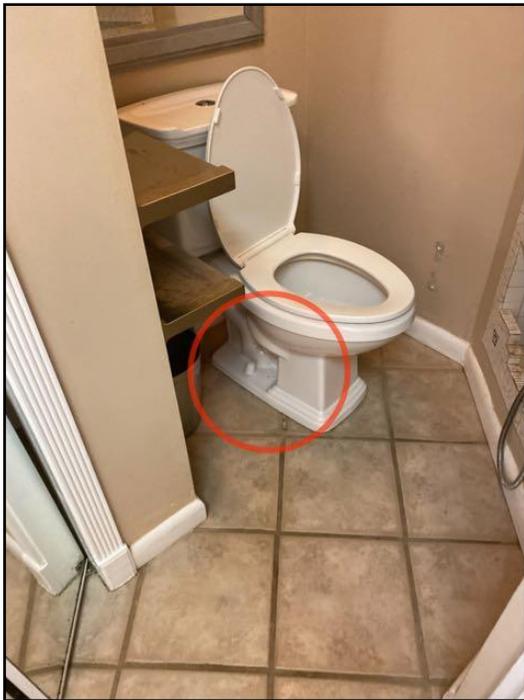
97. Loose

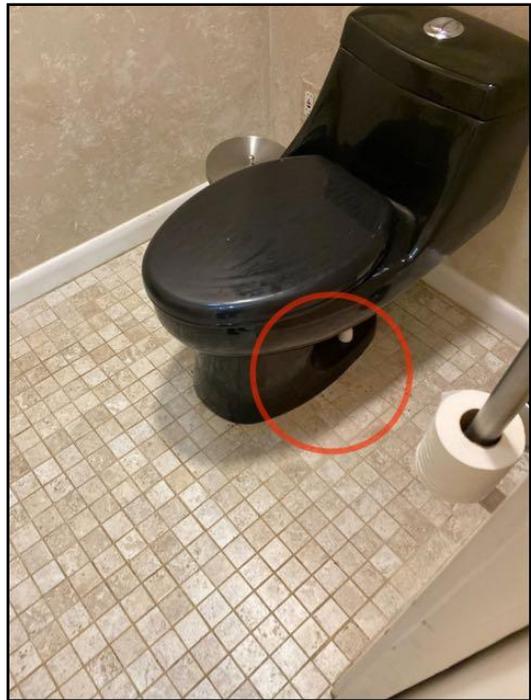
98. Loose

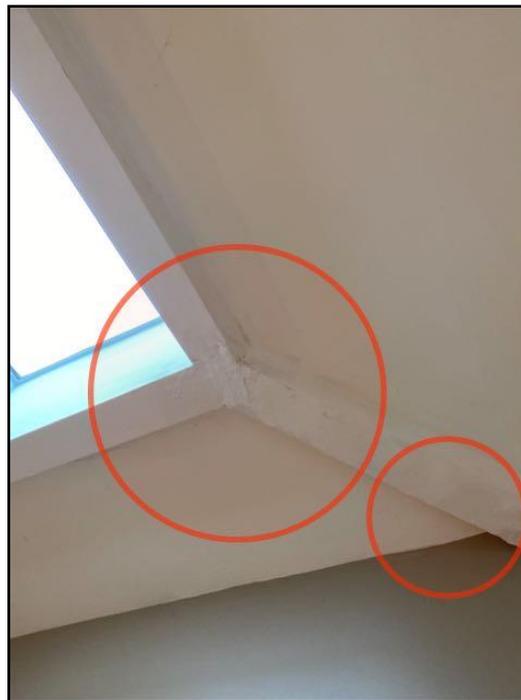
104. Water Damage

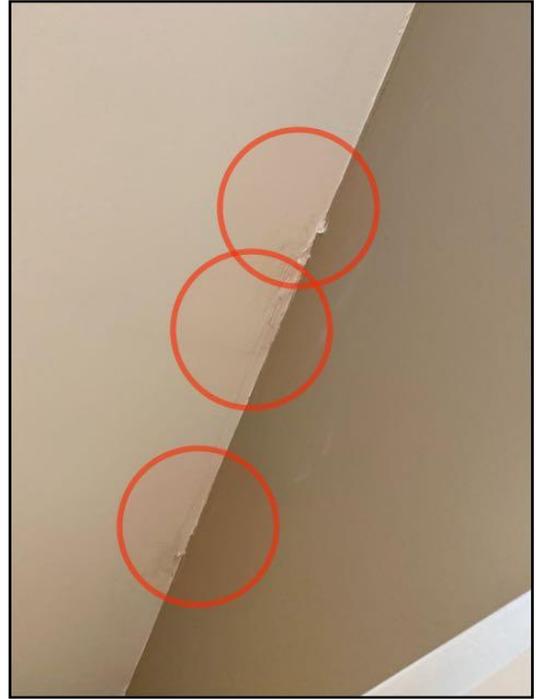
107. Patched/Painted Areas

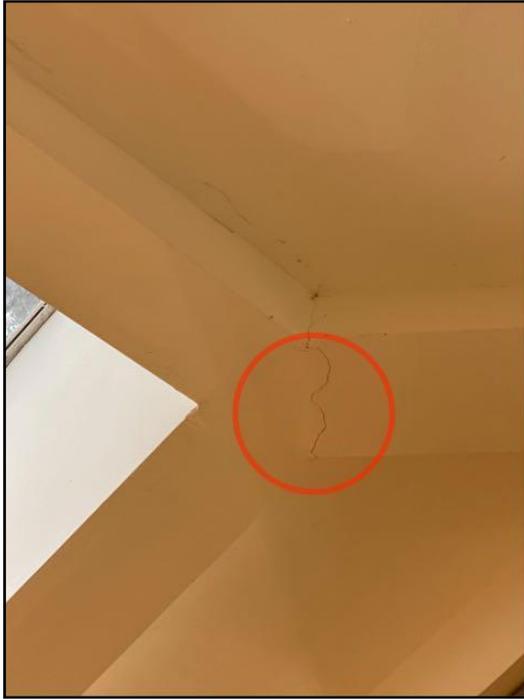
**71. Condition:** • Cracks

108. Cracks

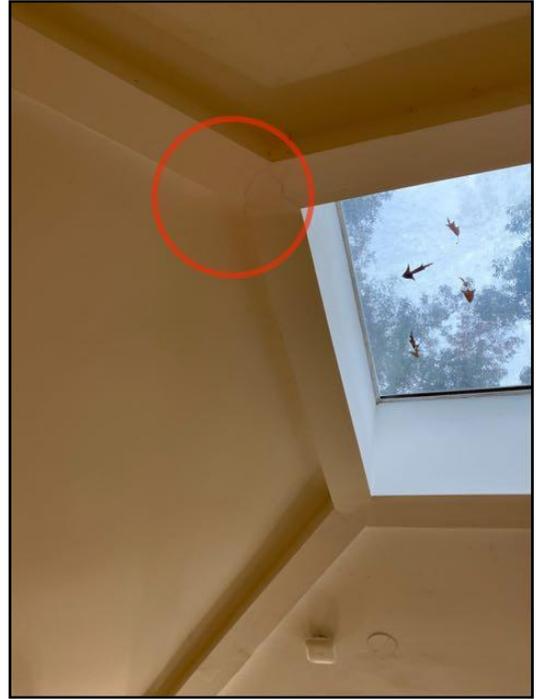
109. Cracks

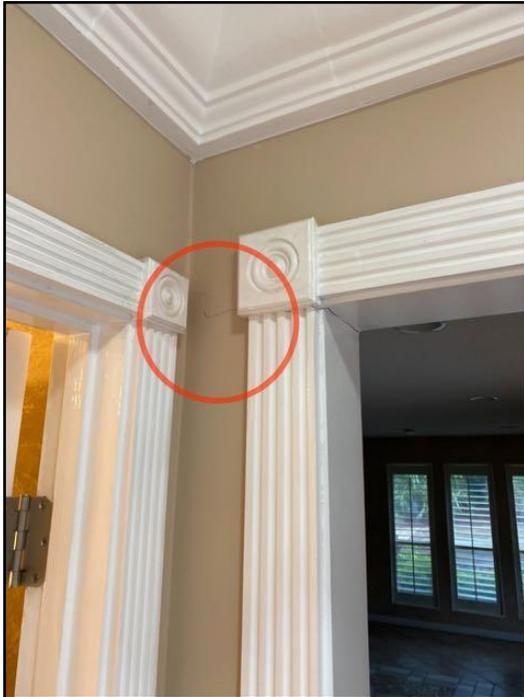
110. Cracks

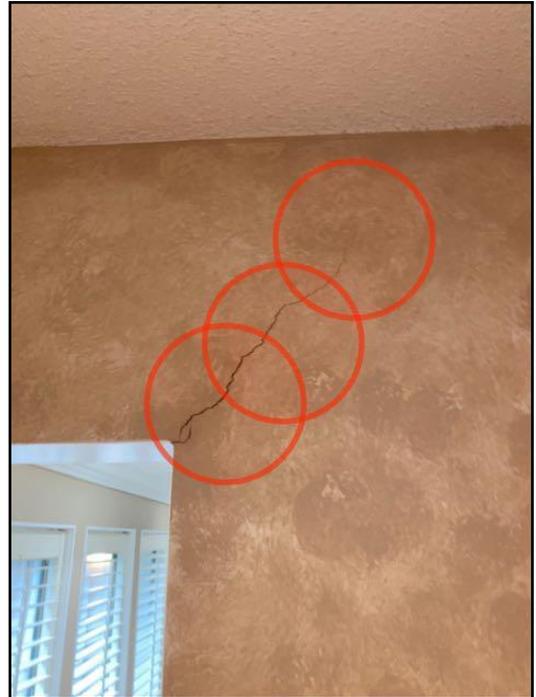
111. Cracks

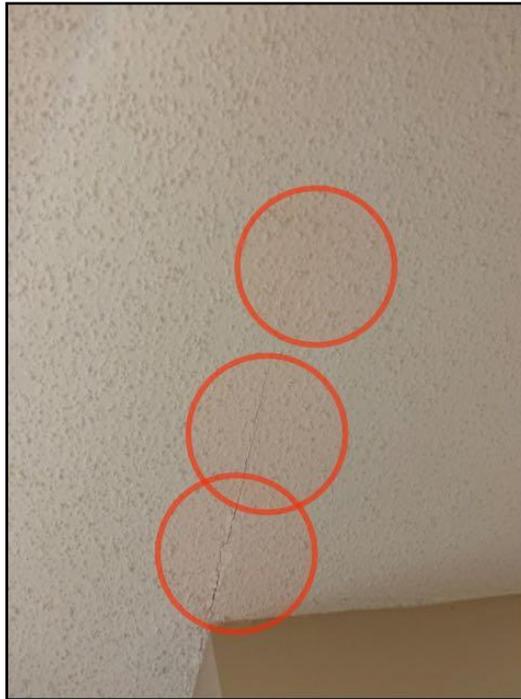
112. Cracks

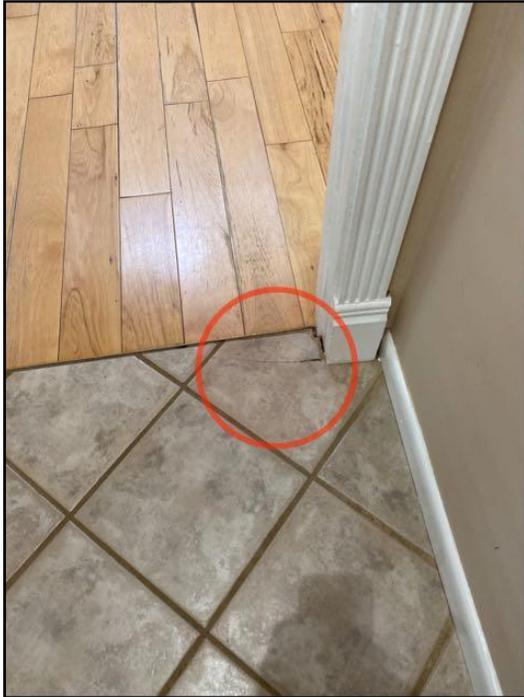
115. Tile - Cracked

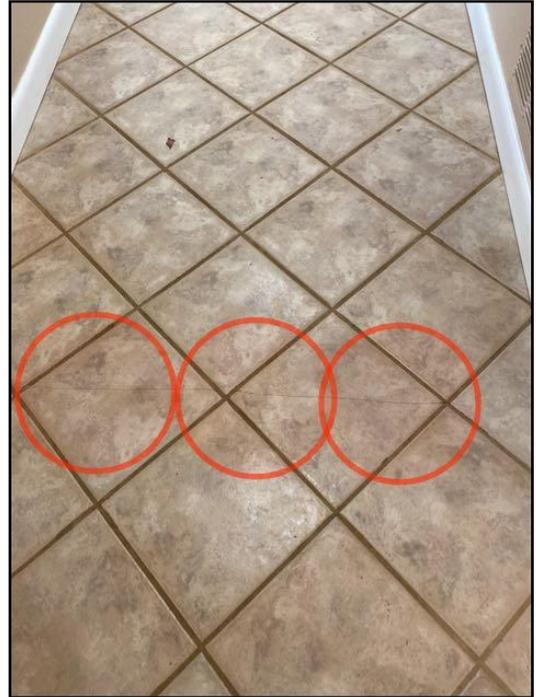
116. Tile - Cracked

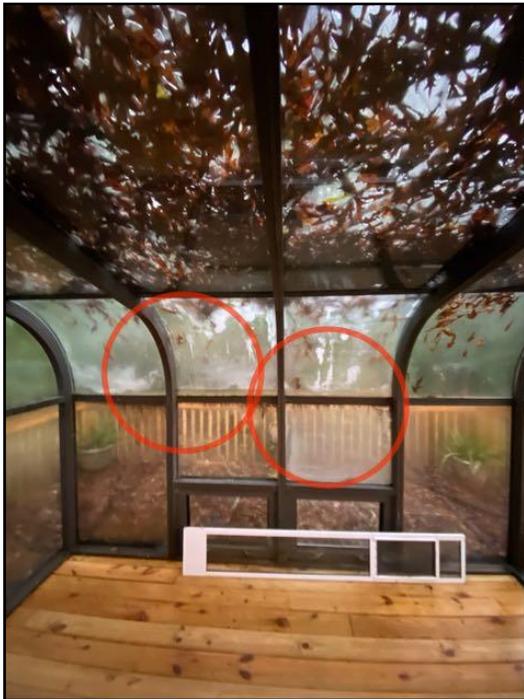
118. Lost/Broken Seals in Double or Triple Pane...

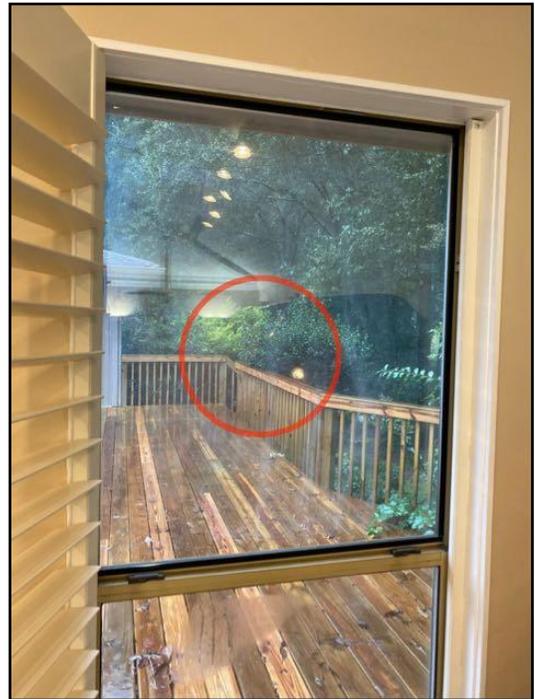
119. Lost/Broken Seals in Double or Triple Pane...

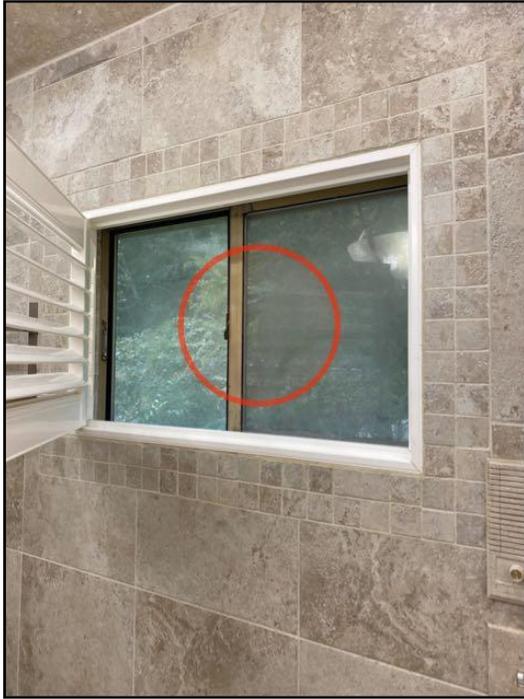
120. Lost/Broken Seals in Double or Triple Pane...

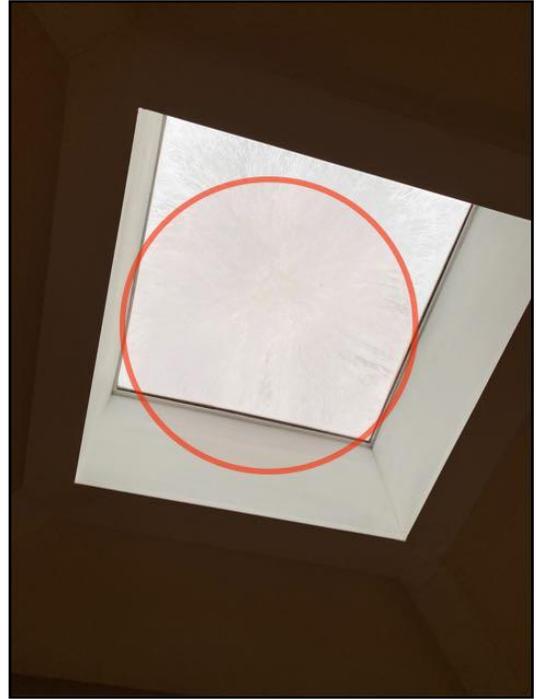
121. Lost/Broken Seals in Double or Triple Pane...

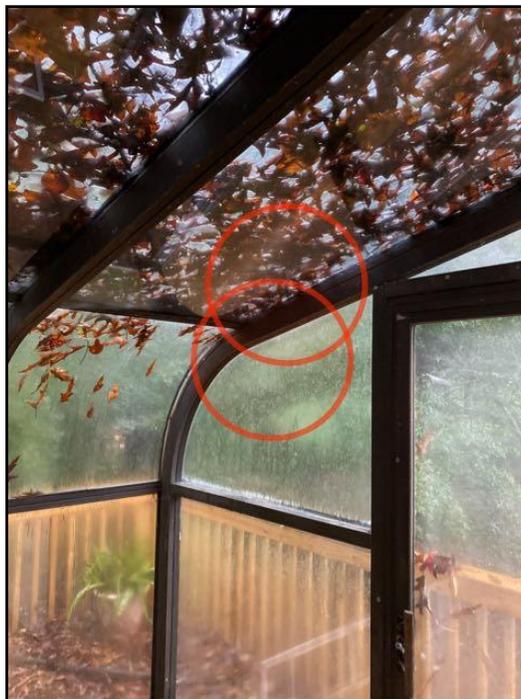
**77. Condition:** • Water Leaks

**122. Water Leaks**

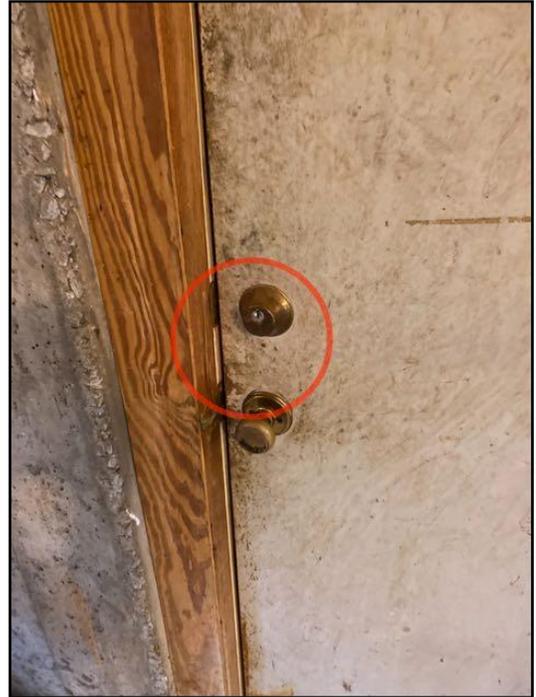
126. Key Required for Deadbolt

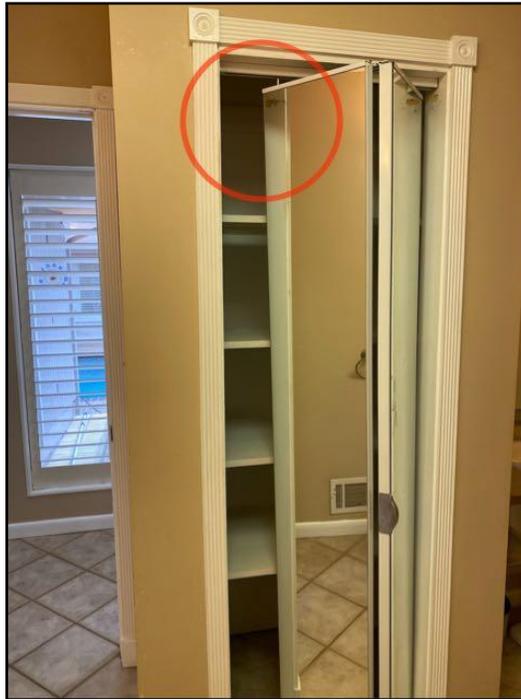
**81. Condition:** • Poor Installation  
**Location:** Left side hall bathroom  
**Task:** Improve or Re-install  
**Time:** As Soon As Possible  
**Cost:** Minor

**127.** *Poor Installation*

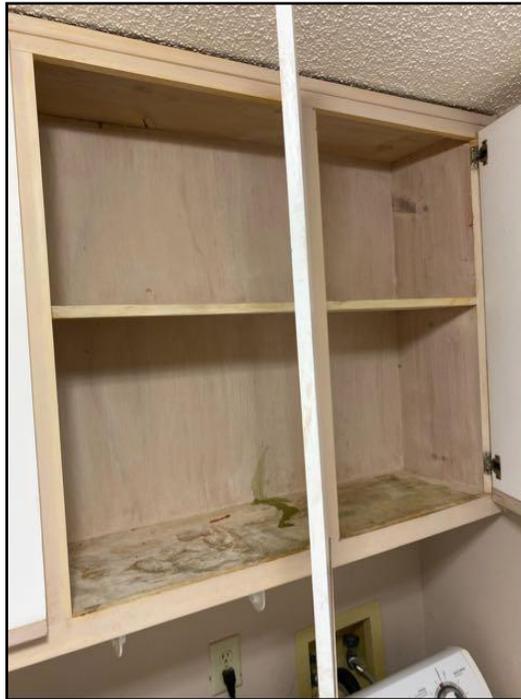
130. Stained, worn, damaged

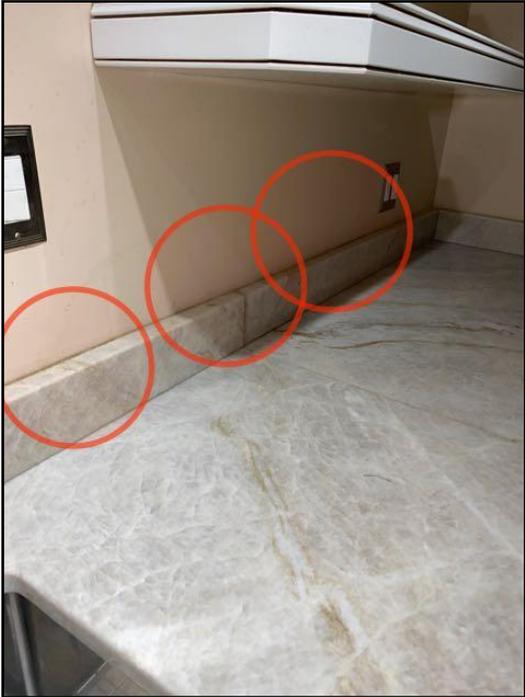
131. Caulking/Grout loose or missing

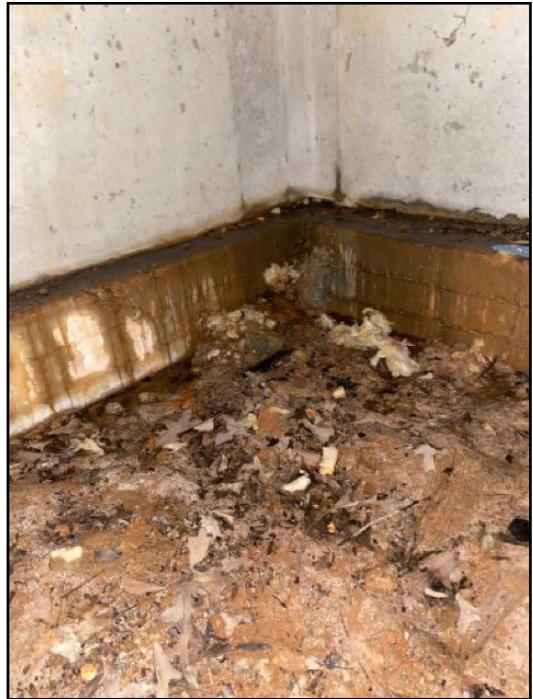
133. Dampness on floor or walls
