Your Inspection Report

142 Cherokee Village Lane
Kennesaw, GA 30067

INSPECTION DATE:
Monday, April 19, 2021

RE: Report No. 38856, v.2
142 Cherokee Village Lane
Kennesaw, GA
30067

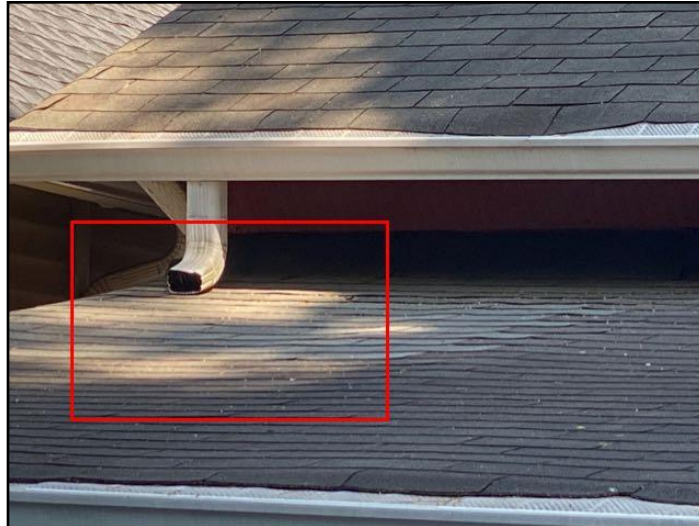
1. Condition: • Patched/Repaired

1. Patched/Repaired

Task: Be advised - Request disclosure

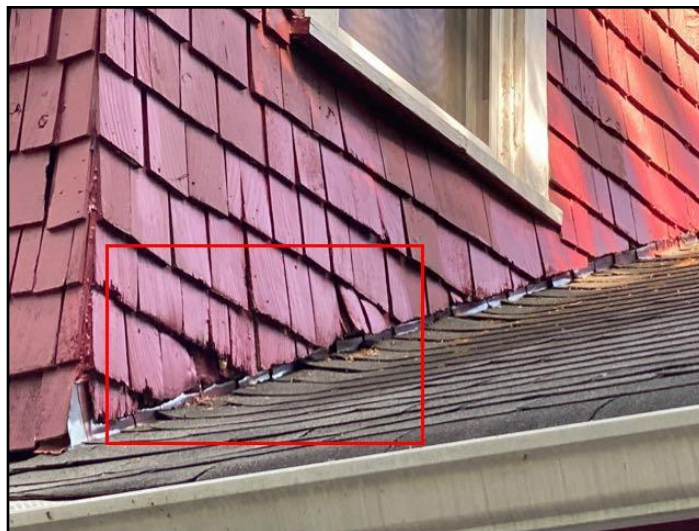
2. Condition: • Rot/Insect damage

In the process of repairing the areas outlined in this report, it is possible there will be additional areas requiring repair when the process has been started. The photos and locations noted in this report should only be considered representative of the condition and not all encompassing.

9. Rot/Insect damage

Task: Repair or replace

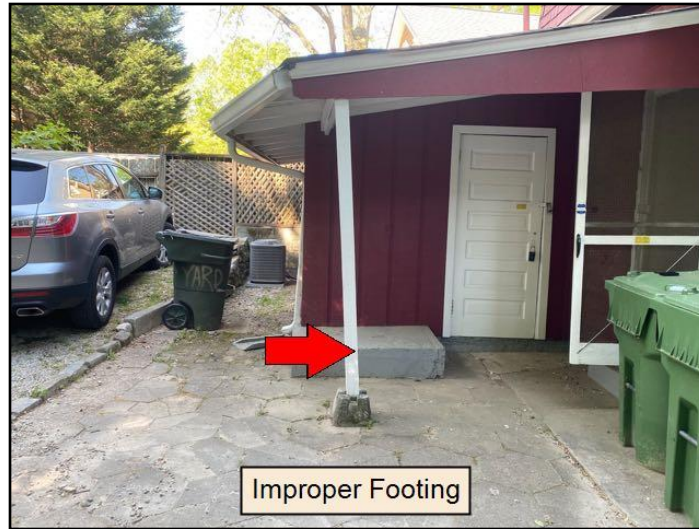
3. Condition: • [Columns leaning](#)

10. Columns leaning

Task: Repair or replace

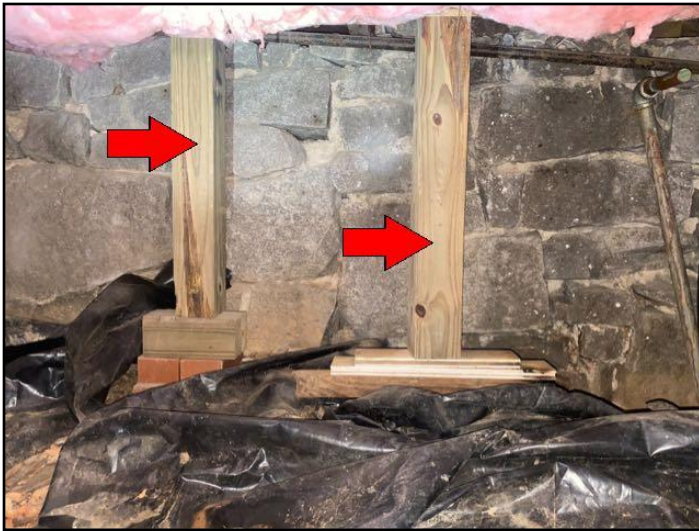
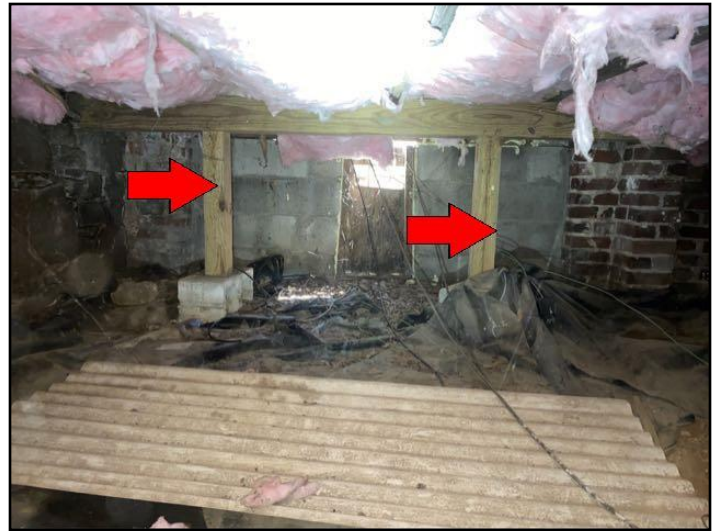
4. Condition: • Temporary Support with Issues.

NOTE: Area identified and photos are representative only. A qualified contractor will need to evaluate the entire system to determine extent of damage and necessary repairs to prepare an estimate or invoice to know the true cost associated with remediation of this condition

11. Temporary Support with Issues.

12. Temporary Support with Issues.

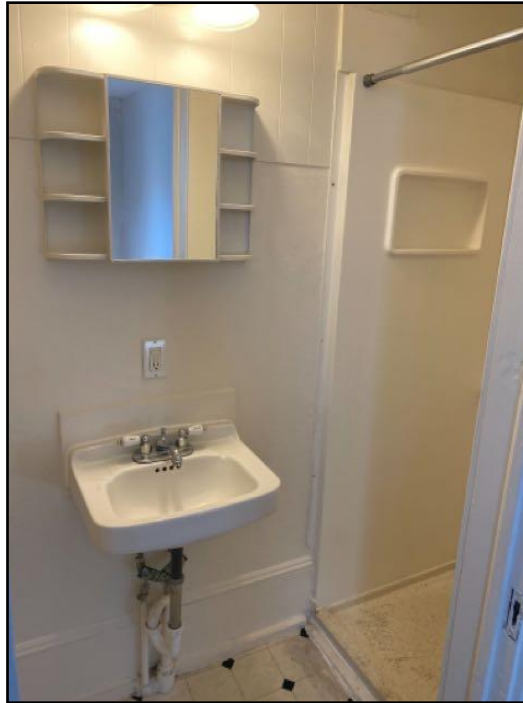
13.

5. Condition: • Light switch must be ON for outlet and vent fan to operate.

Location: Unit 1 Bathroom

Task: Be Advised

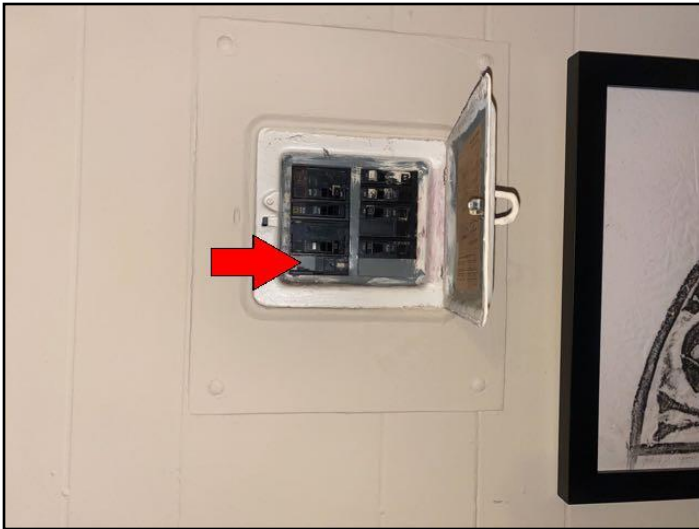
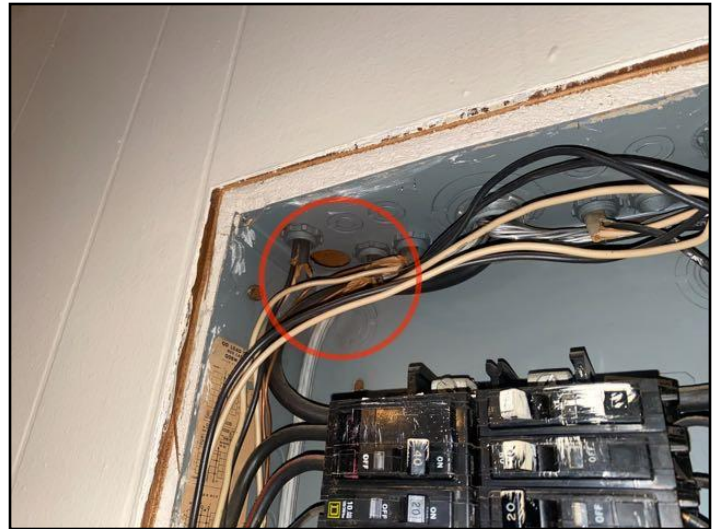
6. Condition: • Openings in Panel

14. Openings in Panel

15. Openings in Panel

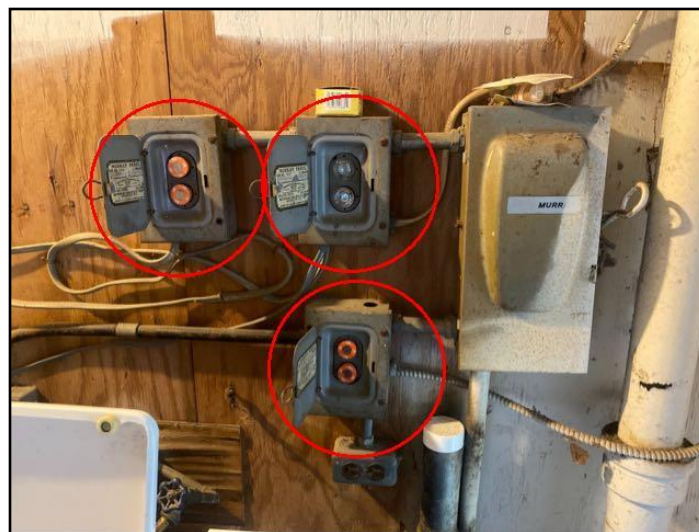
7. Condition: • Obsolete Fuse Box

This fuse style electrical panel is older, obsolete equipment. While the panel may still be in good and serviceable condition it is recommended that all conditions outlined in the report be repaired or evaluated by a qualified electrician.

16. Obsolete Fuse Box

SHORT-TERM RECOMMENDATION: Where insurance is not an issue and the panel and wiring is serviceable, GFI (Ground Fault Interrupter) outlets or breakers can be provided as an interim safety improvement before replacing the system. The cost for GFI outlets may be roughly \$100 each. One GFI protects one entire circuit.

LONG-TERM RECOMMENDATION: Replace the fuse style wiring during renovation or remodeling projects.

Task: Replace/Upgrade

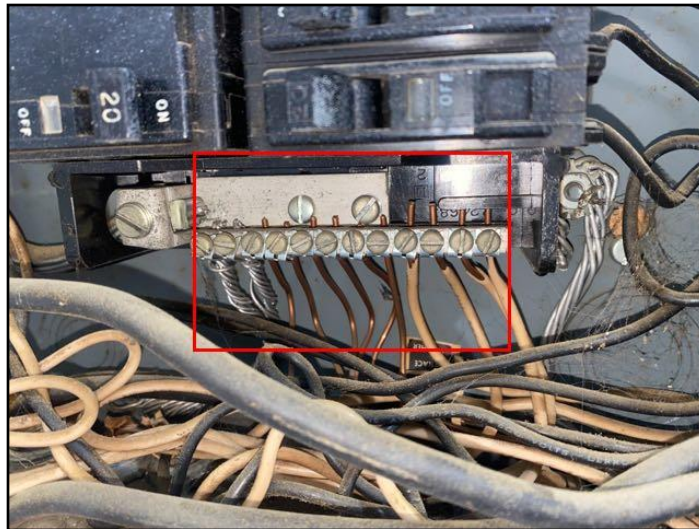
8. Condition: • Neutral and ground bonded at subpanel

17. Neutral and ground bonded at subpanel

Task: Repair

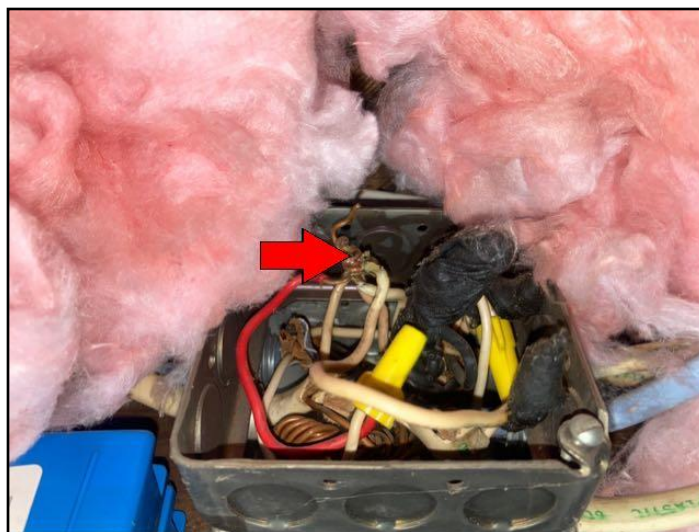
9. Condition: • Open splices

18. Open splices

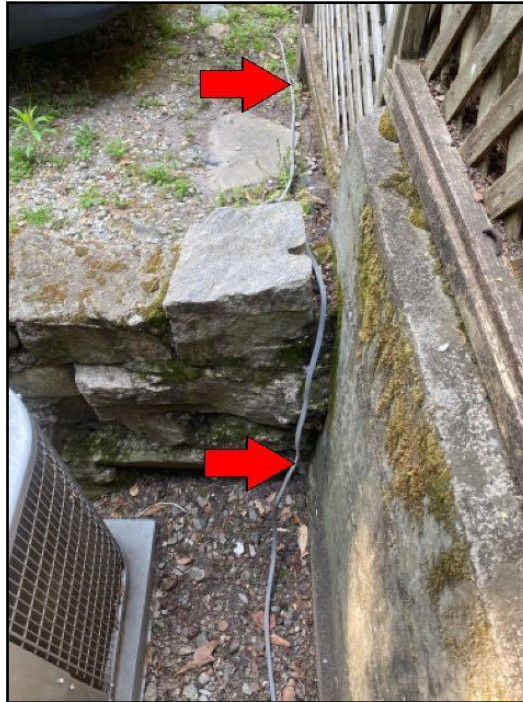
10. Condition: • Conduit needed

19. Conduit needed

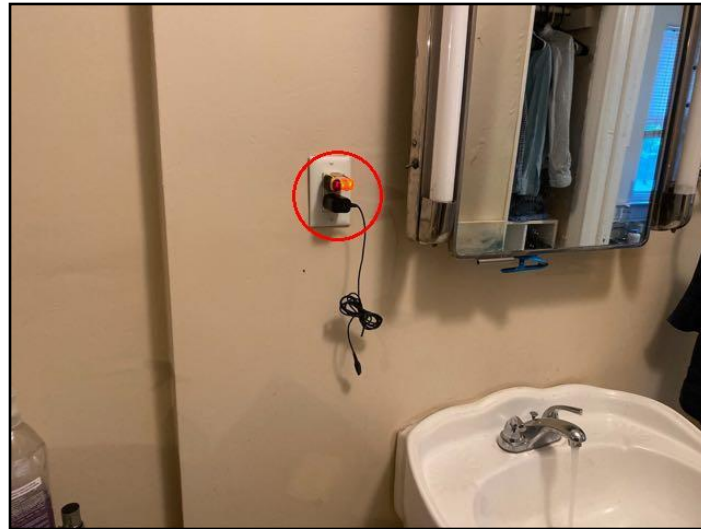
11. Condition: • Test faulty on GFCI (Ground Fault Circuit Interrupter)

20. Test faulty on GFCI (Ground Fault Circuit...

Task: Repair or replace

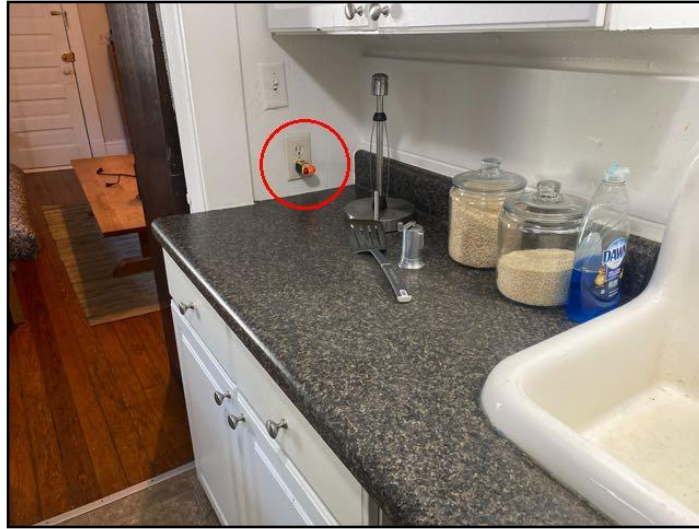
12. Condition: • No GFCI/GFI (Ground Fault Circuit Interrupter)

21. No GFCI/GFI (Ground Fault Circuit...

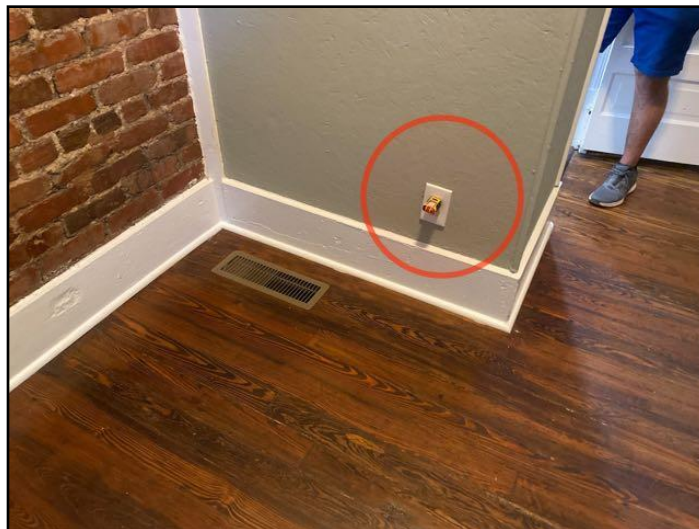
13. Condition: • Inoperative

22. Inoperative

Task: Replace

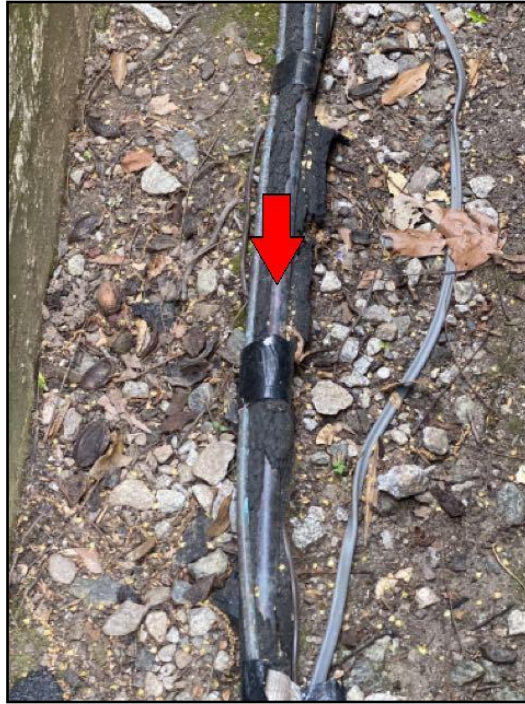
14. Condition: • Missing Insulation

27. Missing Insulation

Task: Replace insulation wrap

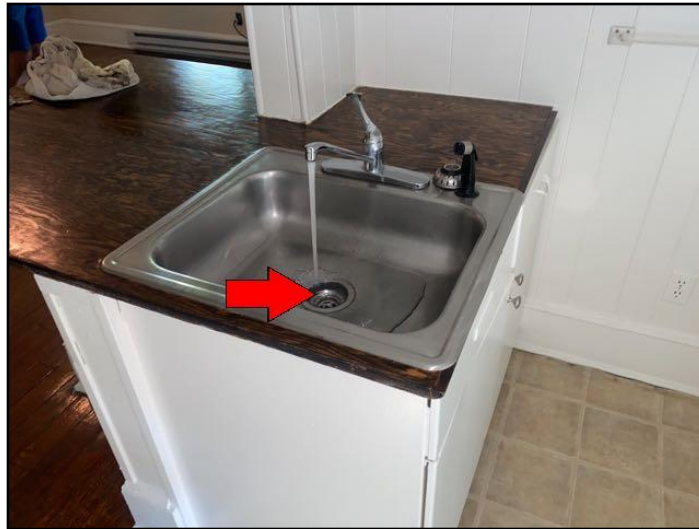
18. Condition: • [Slow drains](#)

33. Slow drains

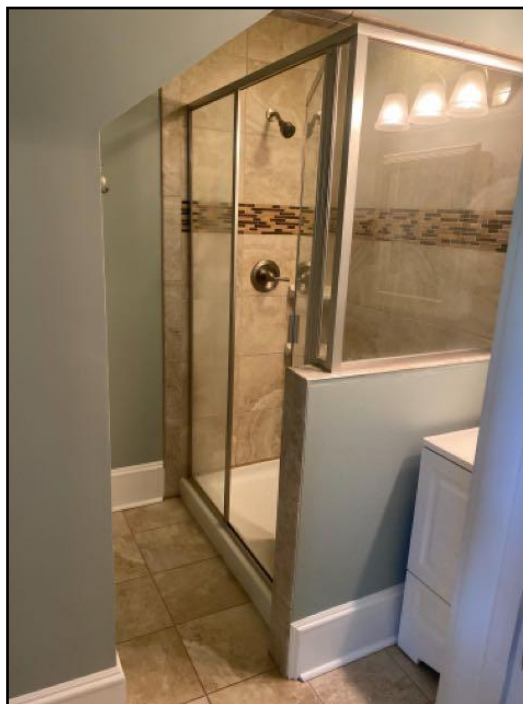
19. Condition: • Sill, Threshold or Door problems

34. Sill, Threshold or Door problems

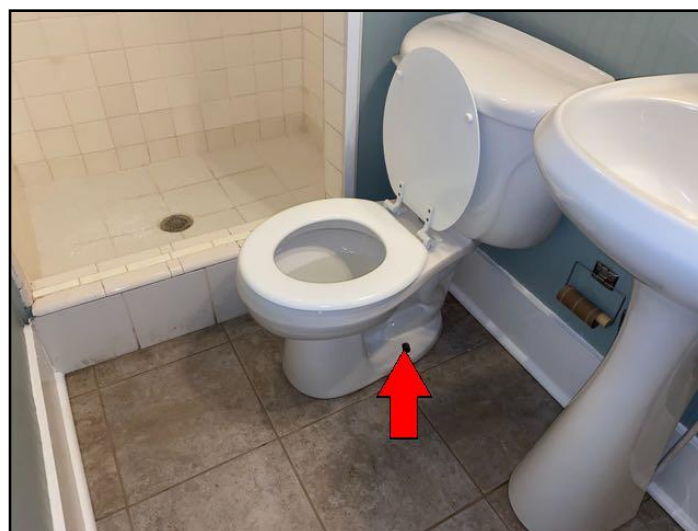
20. Condition: • [Loose](#)

35. Loose

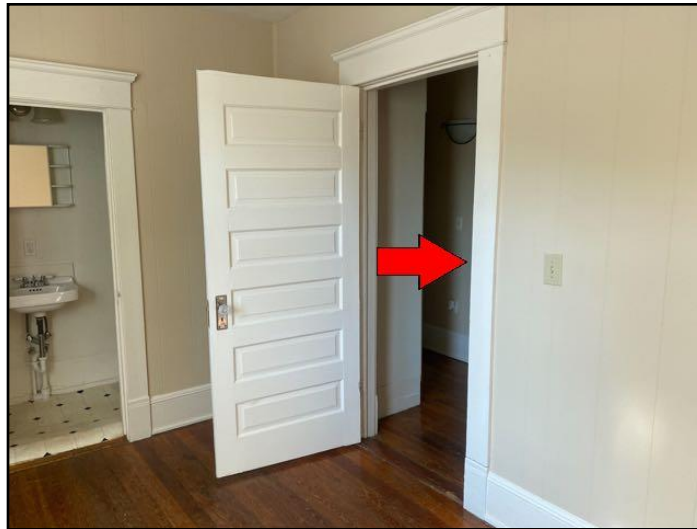
21. Condition: • Door Binds

37. Door Binds

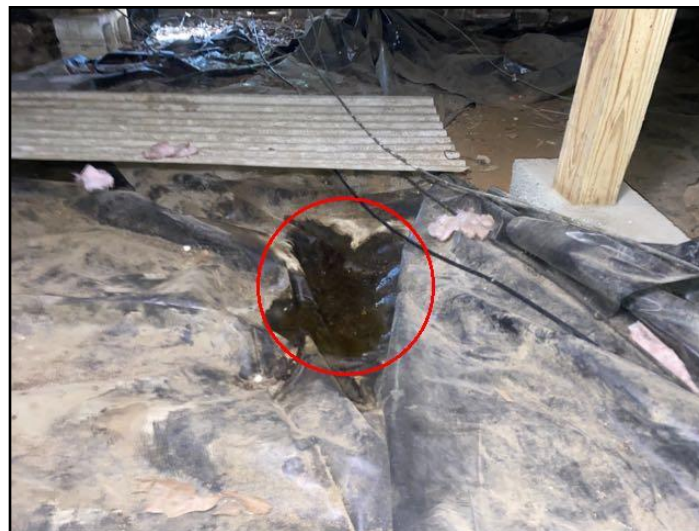
22. Condition: • [Water on floor](#)

38. Water on floor

Task: Consult with a foundation or waterproofing company

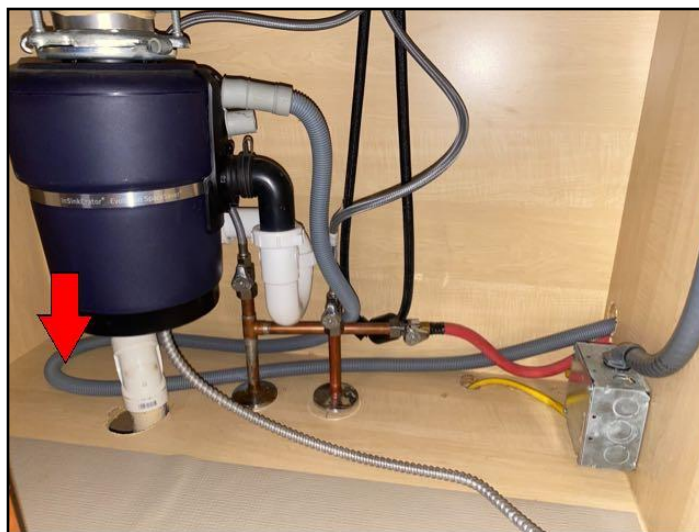
23. Condition: • Backflow prevention high loop missing

39. Backflow prevention high loop missing
