Your Inspection Report

435 North Valley Brook, #327
Atlanta, GA 30318

Thursday, June 17, 2021

RE: Report No. 39963, v.2
435 North Valley Brook, #327
Atlanta, GA
30318

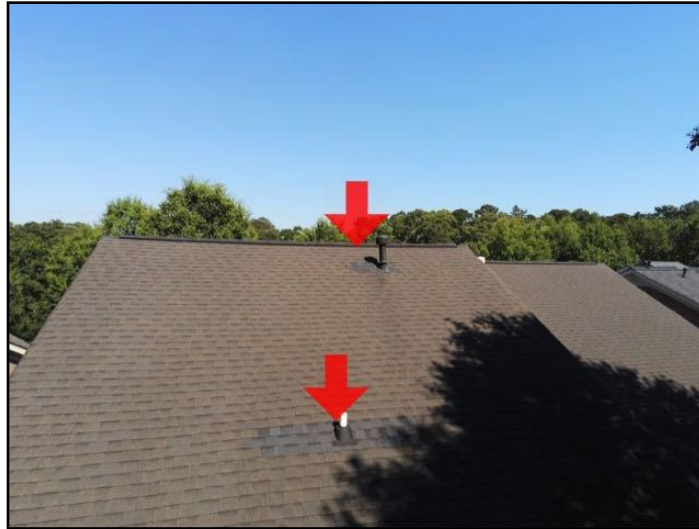
1. Condition: • Patched/Repaired

Location: Rear Roof

Task: Be advised - Request disclosure

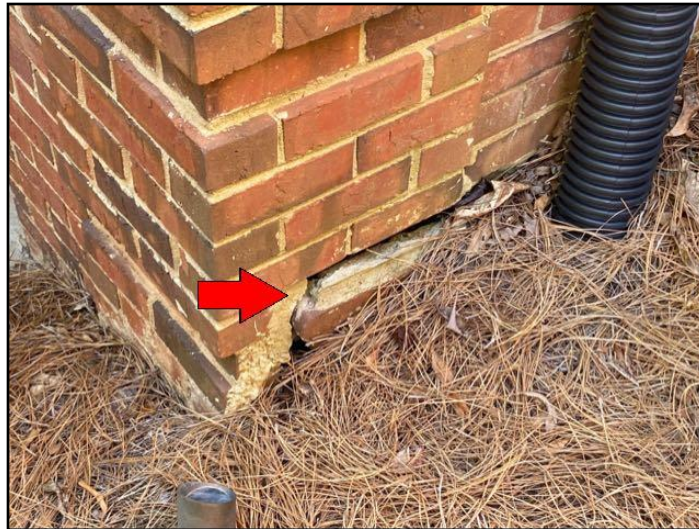
2. Condition: • Cracks in Brick/Masonry

7. Cracks in Brick/Masonry

Task: Monitor

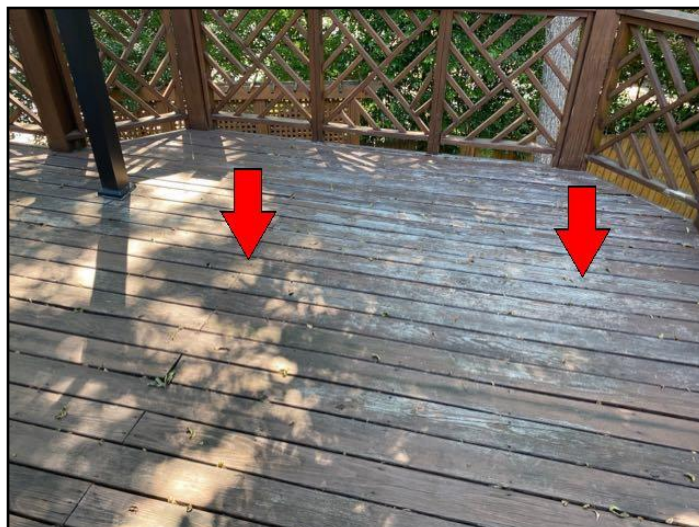
3. Condition: • [Maintenance needed](#)

Recommend re-paint/stain, re-setting fasteners and replacing warped/damaged/rotted deck boards as needed.

8. Maintenance needed

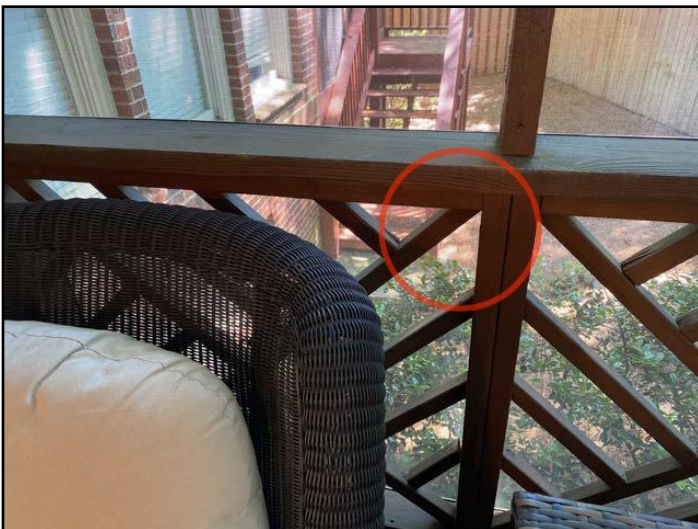
4. Condition: • Spindles (balusters) loose, damaged or missing

9. Rear porch

Task: Repair or replace

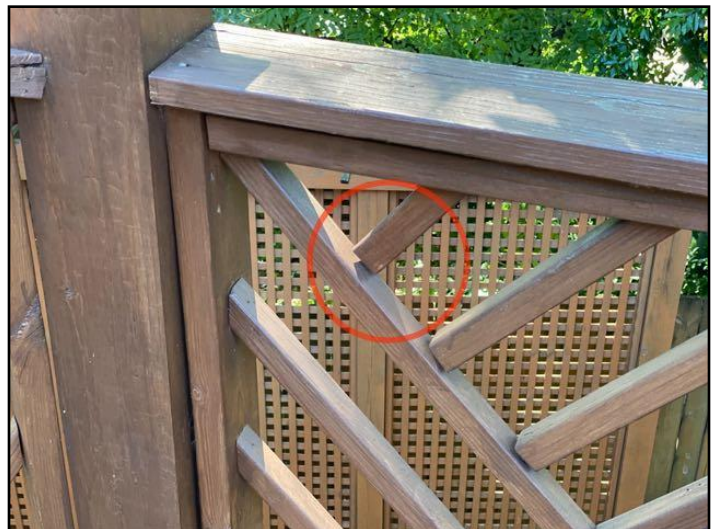
10. Rear Deck

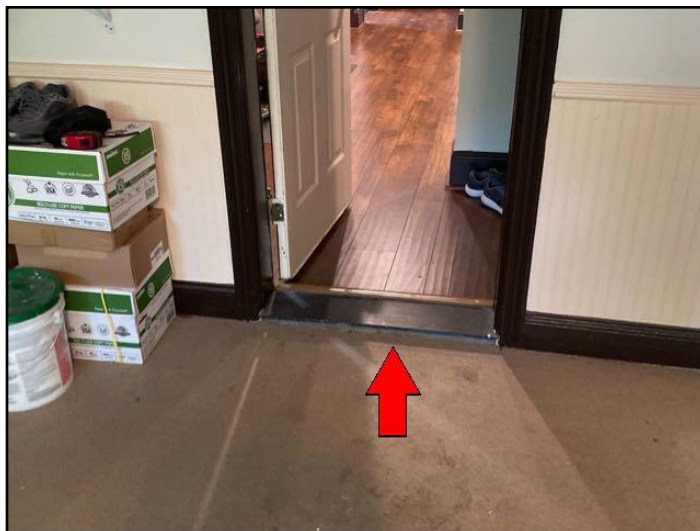
5. Condition: • No Step Up Into Home

Location: Garage

11. No Step Up Into Home

Task: Be advised

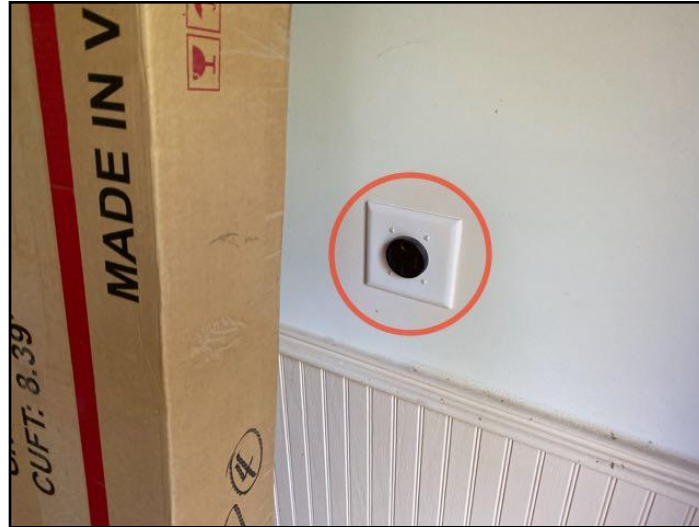
6. Condition: • Inoperative

13. Inoperative

Task: Replace

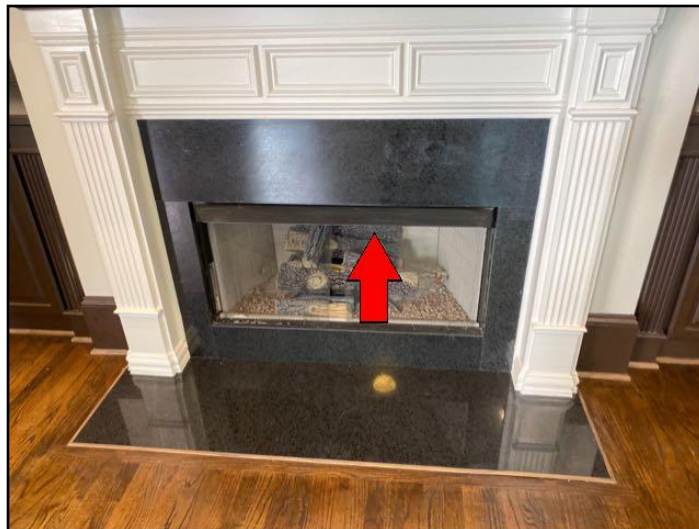
10. Condition: • [Unvented \(Vent free, Ventless\)](#)

16. *Unvented (Vent free, Ventless)*

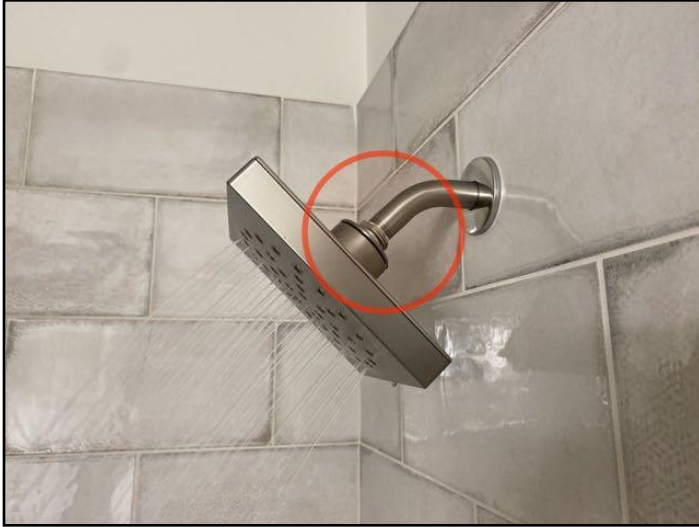
12. Condition: • Leaking Shower Head

29. First Floor Bathroom

Task: Repair

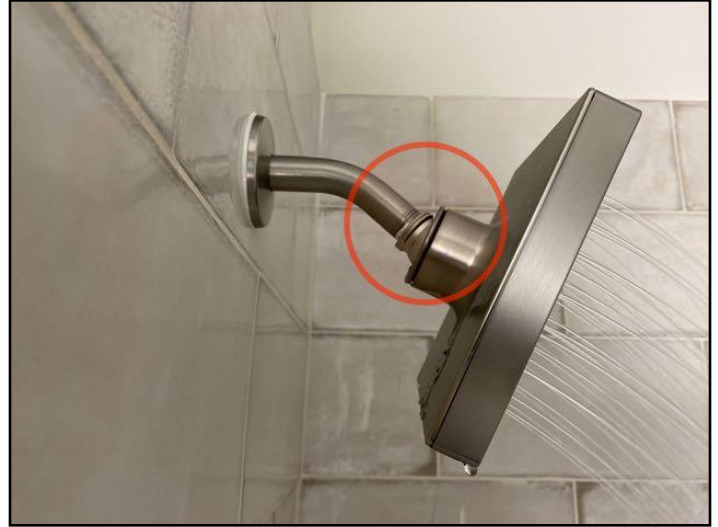
30. Third floor guest bathroom

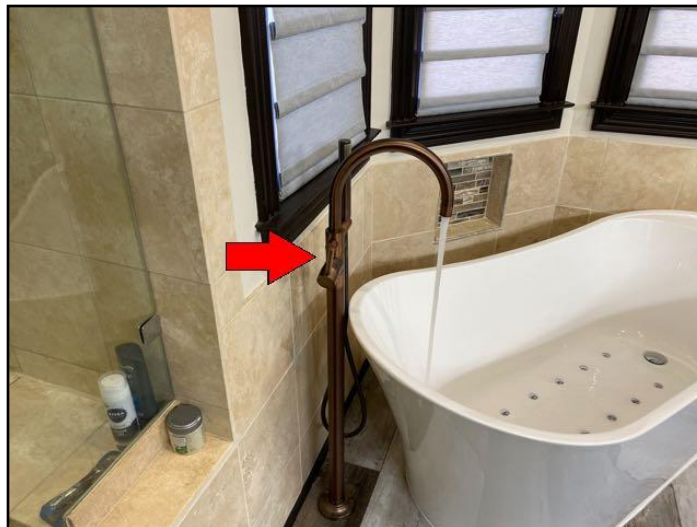
13. Condition: • Loose Faucet

31. Loose Faucet

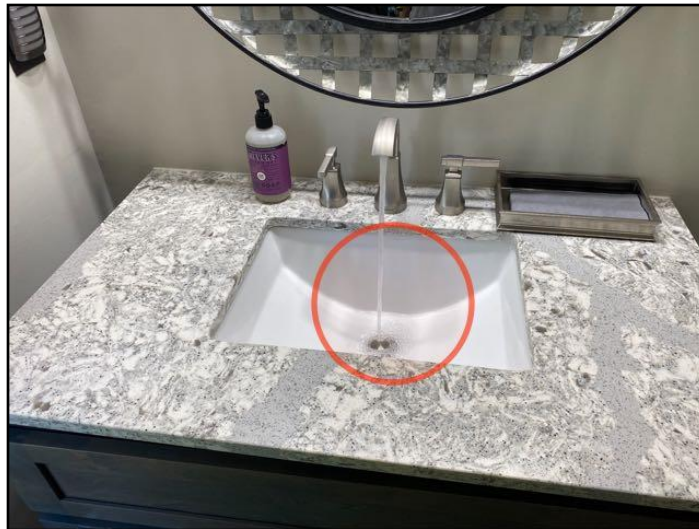
14. Condition: • Drain stop ineffective

32. *Drain stop ineffective*

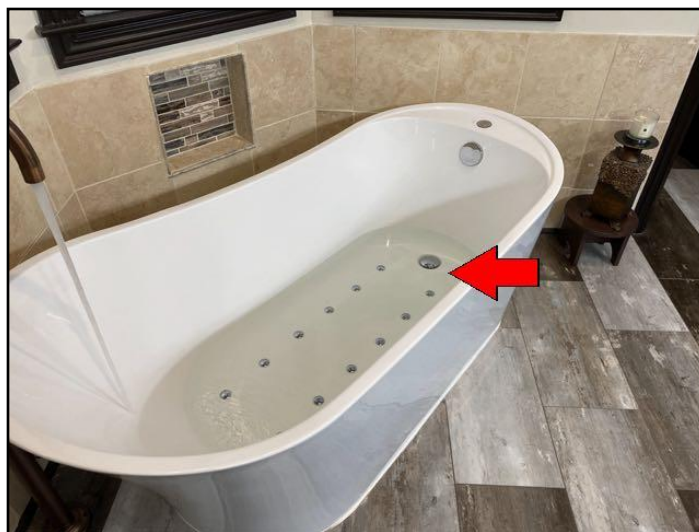
15. Condition: • Inoperative

33. *Inoperative*

Task: Repair or replace

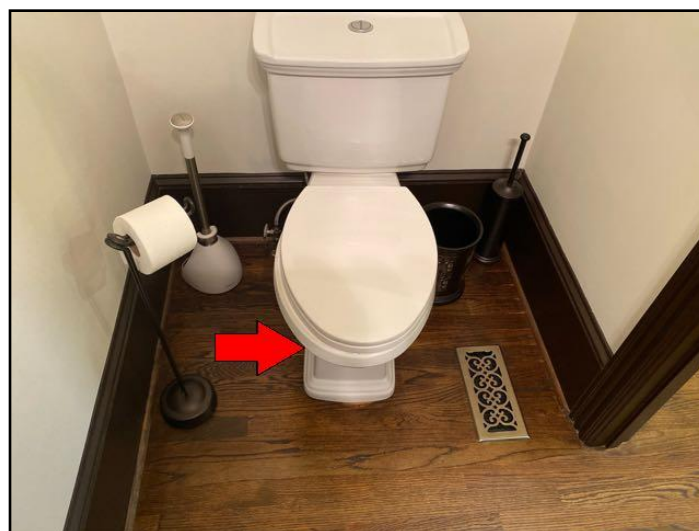
16. Condition: • [Loose](#)

Loose toilet

34. Loose

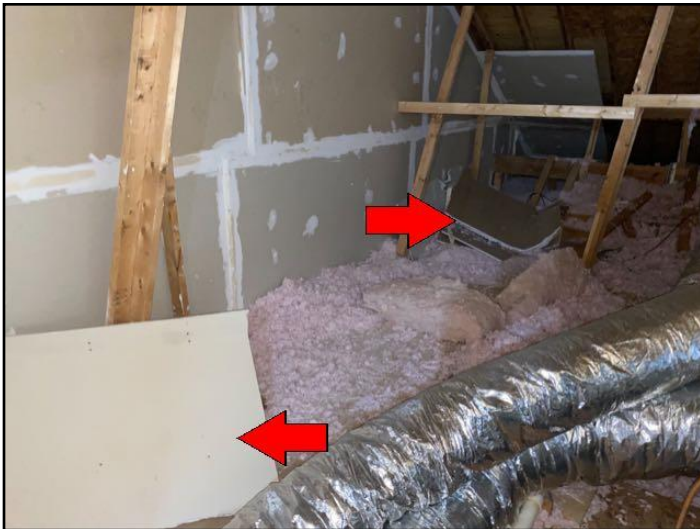
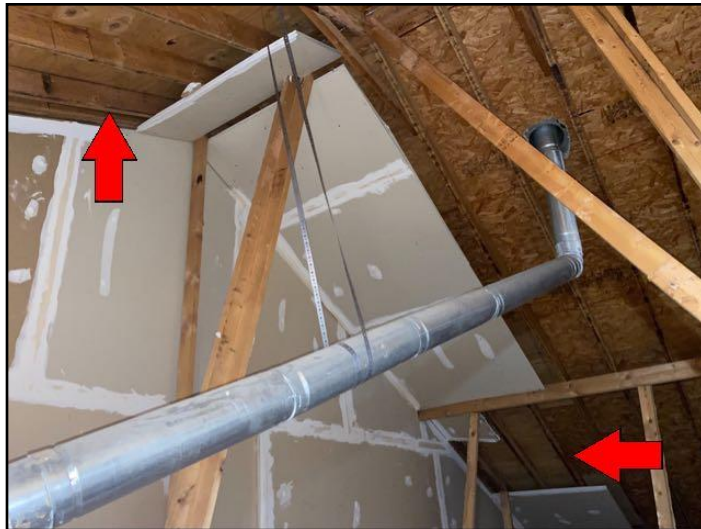
17. Condition: • Missing Sections

38. Loose or missing pieces

39. Loose or missing pieces

Task: Replace

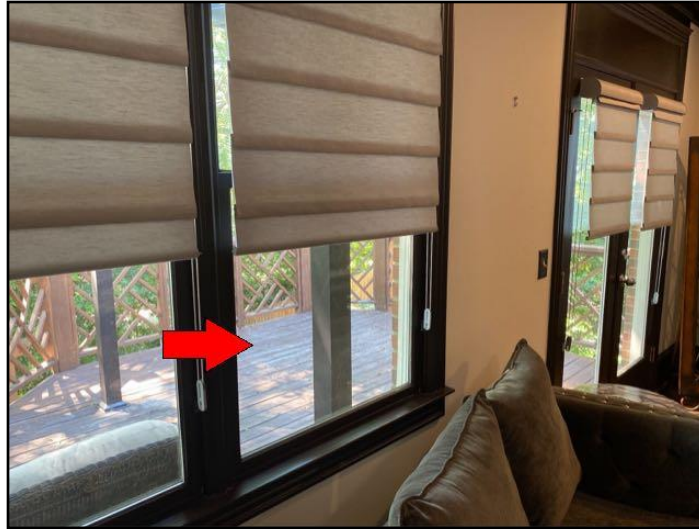
18. Condition: • Sash Won't Stay Open or Closed

40. Sash Won't Stay Open or Closed

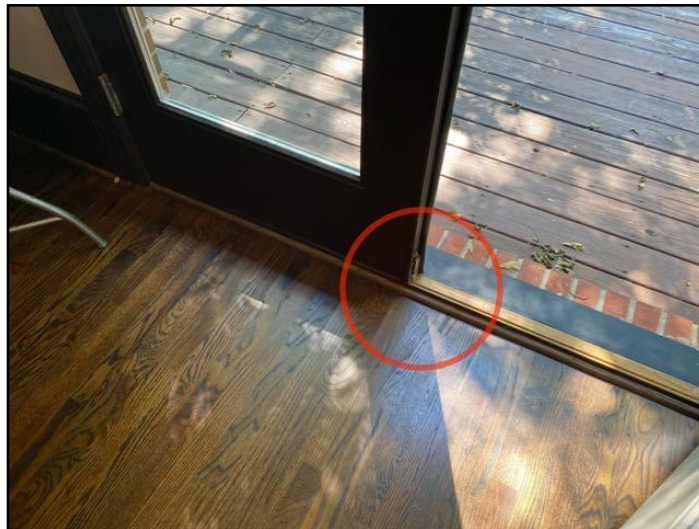
19. Condition: • Door Binds

41. Door Binds

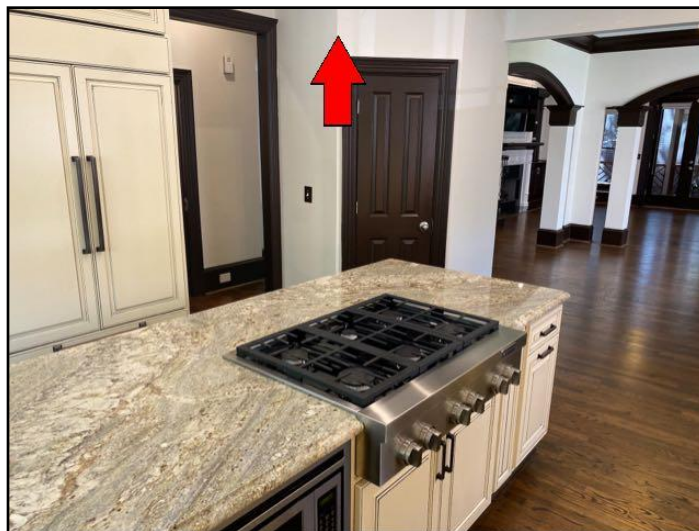
20. Condition: • [Missing](#)

42. Missing
