TECHNICAL NOTE 002

Lessons Learnt: Collapse of Nicoll Highway in Singapore, 2004

Version 02, Jul 2013

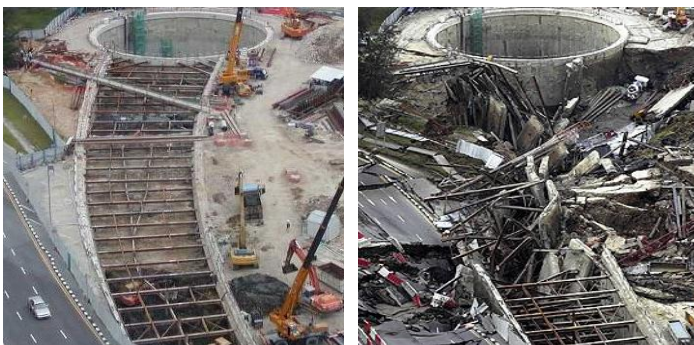
The excavation concerned was 20m wide and 33m deep, measuring from the ground level, supported by 10 layers of waling and strutting, and 2 layers of jet-grout props. The failure started at the **9th level strutting connection**. Yielding of the connection allowed the diaphragm walls to deform, overloading the struts in levels above, causing them to buckle. This triggered a progressive collapse of the diaphragm walls. The failure was very rapid; only an hour elapsed between failure of the first strutting connection and the total collapse of the excavation.

- In the finite element analysis of the ground conditions, the mechanical properties of 'drained' soil were used for the highly plastic marine clays. This was a substantial error, leading to serious under-prediction of the forces acting on the temporary works. This in turn led to under-design in the temporary works in general.

- In terms of the structural design of the waling and strutting system, the contractor's designer also misinterpreted the design code BS5950 in that the stiff bearing lengths were grossly over-estimated.

In the installation of the waling and strutting system, the **load-spreading sprays** at the ends of the struts were **omitted**; and this omission was not picked up during the routine works supervision. Consequently, the entire axial load of each strut was directed into the waling beam through a single point of contact. Forces of about 4,000kN were being channeled through a detail designed with a capacity of 2,551kN.

- Trends of the temporary work during critical periods must be capable of being monitored.
 - Those interpreting the analysis outputs must be competent to do so. The dangers of drawing conclusions from past behaviour, without careful consideration of the actual conditions, must be recognised.
 - The management of uncertainty must be robust. There must be approved and tested contingency plans.
 - The project must operate within a safety culture conducive to safe working. This means:
 - A 'stop work' procedure to be in place, clearly understood by all, and supported by management
 - Clarity in the chain of command and in responsibilities
- End -
