We're Here to Help You with Your Next Project

Focus On: Horizontal Floor-Ceiling Fire Testing

Fire Resistant After an Earthquake?

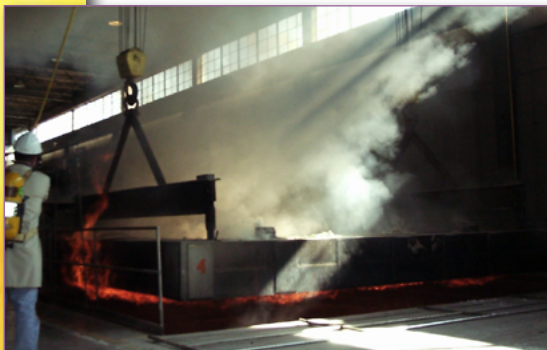
Full-scale (14' x 18') horizontal floor-ceiling furnaces are extremely rare, and we have one of the best. This furnace, built in place when the building was constructed, is flush with the lab floor for superior access and test observation.

It extends down two stories, including a control center/internal observation area and a sub-basement for maintenance. We can test a wide range of horizontal assemblies for fire endurance such as roof assemblies, floor-ceiling

assemblies, columns and beams, wood assemblies, penetrations, building joints — even subway cars — in this furnace! It meets ASTM E 119 requirements and features:

- A 30-ton overhead crane
- Large access openings and truck access into building to accommodate any type or size of material, and the largest pre-assembled test specimens.
- 4 test frames
- 80 burners
- 16 thermocouples (to measure within the furnace)
- Up to 165 unexposed thermocouples to measure the unexposed and internal test specimen temperatures
- Full loading capabilities
- Full hose stream test capabilities
- For conducting a wide range of tests, including those in accordance with the following standards:

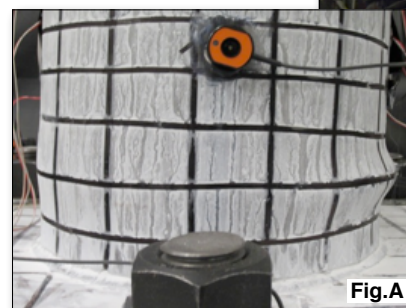
Fig.A

The fire testing facilities at NGC Testing Services simulated a fire scenario on the columns following the ASTM E 119 standard fire test for building construction and materials. The 10' long columns were tested while carrying an axial load of 70 kips. Results of these tests have shown, as expected, local buckling at one end of the column due to the expansion and global buckling. This is due to significant degradation of the material properties. Two photos of one specimen (above) show the damage following seismic loading (Fig. A) and after the fire test (Fig. B). The test program is currently underway.

In this study, three specimens are subjected to a simulated earthquake loading in the Structural Engineering and Earthquake Simulation Laboratory (SEESL) at the University at Buffalo. The seismic tests induced varying levels of damage, ranging from no damage to visible moderate damage. The three specimens were then transported to NGC Testing Services to evaluate their load-carrying capacity under fire.
