TECHNICAL NOTE 014

Internal Climbing Tower Cranes – Load Effects on Supporting Steel Brackets

Version 01, Nov 2013

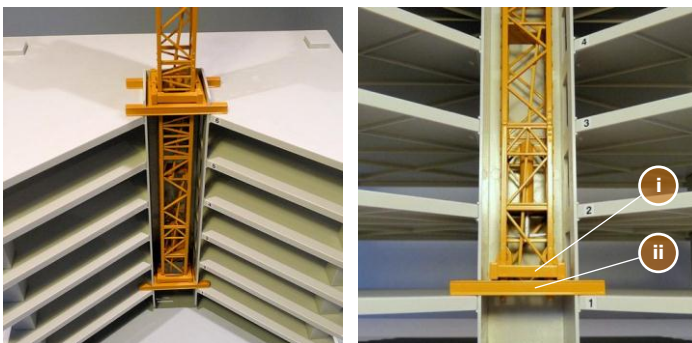
Tower crane mast supported by two sets of support (should be three sets)

(i) Proprietary tower crane collar; and
(ii) non-proprietary steel beam support

As shown in the figures above, the proprietary tower crane collar (i) is supported by a pair of steel beams (ii). The steel beams are in turn supported on the floor plate through openings pre-formed in the vertical walls. More often than not, the steel beams are supported on steel brackets which are bolt-fixed to the nearby structural walls.

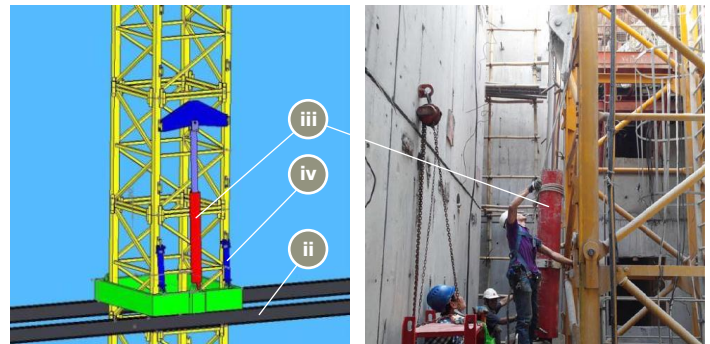
The mechanism that enables the climbing of the tower crane is shown in the figures below. The mechanism comprises a hydraulic jack (iii) and a pair of interim supports (iv). The hydraulic jack is used for pushing the tower crane upwards. Upon reaching the full stroke length of the jack, two interim supports are inserted to upkeep the tower crane, allowing the hydraulic jack to be retracted for the next push.

It should be noted that during climbing, all vertical supports to the tower crane are released, and the self-weight of the tower crane rests only on the hydraulic jack which is placed on one side of the tower crane mast. It follows that the self-weight of the entire tower crane is supported only by one steel beam (ii), ie, the one in the near face in the above figure. The load effects under this condition appear to be critical as demonstrated below.

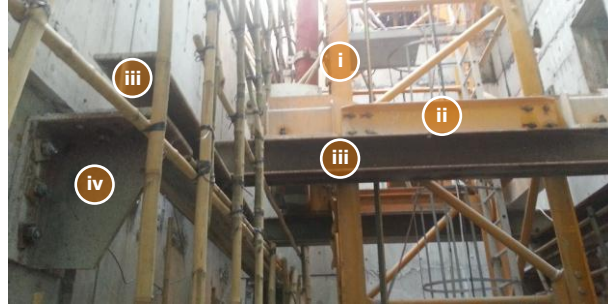
In the above two conditions, all four legs of the tower crane mast are properly secured to the support, and therefore the resulting load effects are shared amongst all the supporting steel beams and steel brackets. Whereas in the climbing condition, only one steel beam and the respective steel brackets are loaded. As such, the load effects in these brackets need to be ascertained carefully.

View of tower crane support system
(i) Tower crane mast
(ii) Proprietary tower crane collar
(iii) Steel beams
(iv) Wall-mounted steel bracket

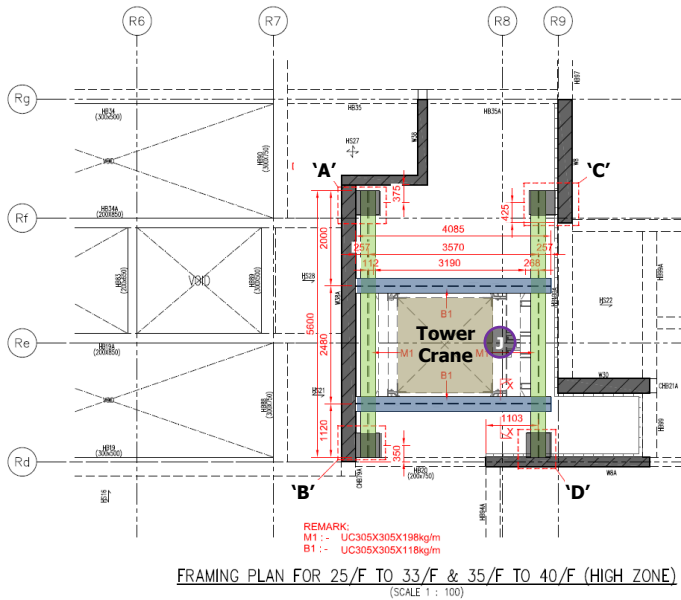
For the particular climbing process in question, the setting out of the tower crane and the respective supports, ie, steel beams + steel brackets 'A' to 'D', are shown in the figure below. Given the height of the tower crane, the jib length (radius) and the tip load, the loading on each steel bracket has been calculated, and is shown in the table further below.

NB – J denotes the position of the hydraulic jack for climbing of the tower crane.

Conditions	Bracket Reactions (kN)			
	'A'	'B'	'C'	'D'
In-Service	314	278	225	318
Out-of-Service	227	201	162	230
Climbing (Static)	33	29	314	445
Climbing (×1.25)	41	36	393	556

The reactions in the table above are all UNFACTORED. During climbing, the reactions in the brackets are due only to the self-weight of the tower crane. However, it must be noted that these reactions will be magnified by the starting / stopping of the hydraulic jack in each push. The dynamic magnification factor could be taken as **1.25** if no information (such as jacking speed) is available for a more accurate assessment.

As can be seen from the previous table, the reaction in Bracket 'D', **556 kN**, under the climbing condition should have been selected by the tower crane designer for relevant structural design and assessment. Instead, the reaction in Bracket 'D', **318kN**, under the in-service condition was chosen, noting perhaps that the climbing condition was not considered at all.

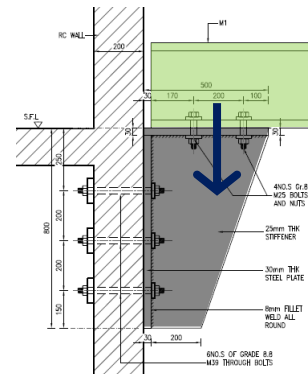
Apart from the above underestimation, the eccentricity value adopted by the designer was questionable too. According to the detail of Bracket 'D', the eccentricity should be in the order of **300mm**. However, for some reasons, a nominal eccentricity of only **20mm** was assumed in the checking.

The above double-inaccuracies meant that the structural wall (W8A to which Bracket 'D' was fixed) was only checked for an ULS moment of **11.70 kNm**. However, according to this study, the ULS moment could be up to **167 kNm**, depending on the actual scale of the dynamic magnification.

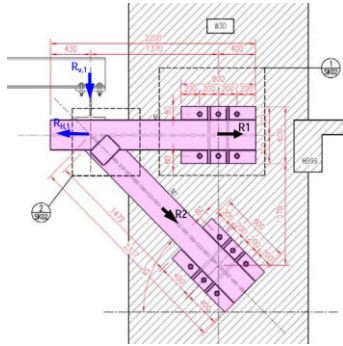
Remedial works proposed by the tower crane designer – A pair of steel brackets fixed on structural wall W30.

The structural wall (W30) that could be used for fixing the steel brackets was very close to the mast of the tower crane. As a result, the new brackets had to be designed to take up most of the loading from the tower crane. The steel brackets, during and after installation, are shown in the figures below.

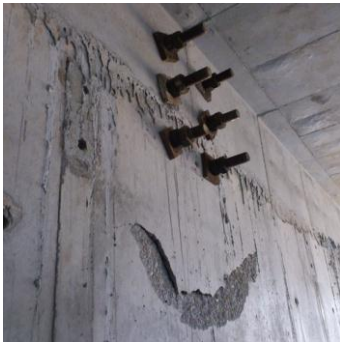
With the bending moment of 167 kNm in structural wall W8A, the rebars would be stressed locally to around 439 N/mm² in tension, which is way higher than the normal SLS stress level of 280 ~ 300 N/mm², for high-yield rebars. It is almost certain that the concrete within the affected zone would crack and de-bond from these highly stressed rebars.

Structural cracks in wall W8A
(Steel Bracket 'D' on the other face)

In light of the cracks and spalling concrete noted in structural wall W8A, the climbing process of the tower crane was suspended immediately. It was subsequently decided that separate steel brackets had to be installed to replace the defunct Bracket 'D'.

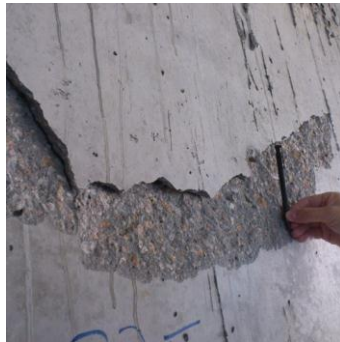
Close-up view of the structural cracks

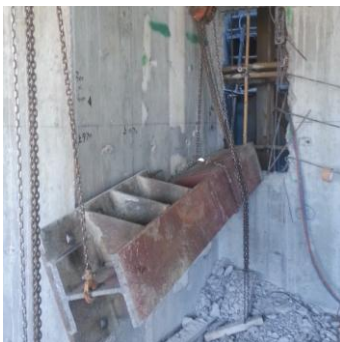
Installation of steel bracket member

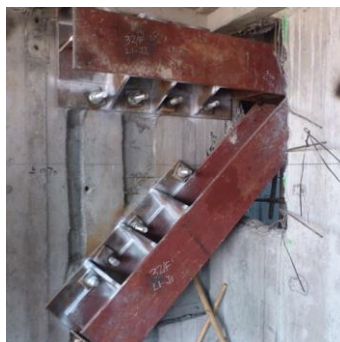
Completed steel bracket
(with MPI tests for the fillet welds)
