# EpoxxiShield™ COR Elite Coating vs. Hot Dip Galvanized Coating

## 2,000-HOUR SALT FOG EXPOSURE TEST

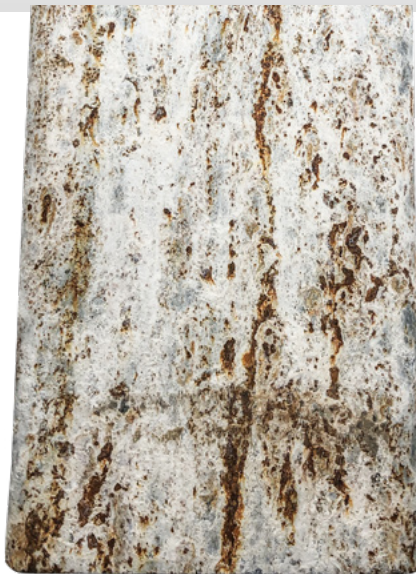
**HDG** **Hot-Dip Galvanized**

The HDG sample showed both general rust (3% to 10%) and pinpoint rust (1% to 3%) after the test.

As shown, the galvanized member showed significant white and red corrosion throughout the entire sample. This is a stark visual reminder that galvanization only slows the corrosion process, while the EpoxxiShield™ COR products

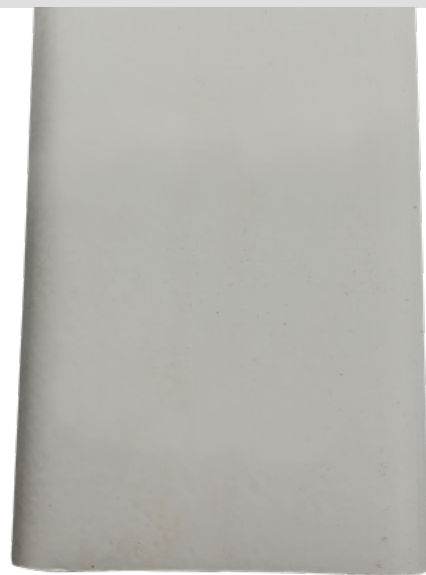
**EpoxxiShield™ COR Elite**

The EpoxxiShield™ COR Elite sample had negligible corrosion (0.01% or less).

showed no rust proving they are the ultimate defense against corrosion. EpoxxiShield™ can provide long-term protection for your building frames.
