# Your Inspection Report

9427 Springs Court  
Smithtown, GA 30221

**INSPECTION DATE:**  
Tuesday, October 5, 2021

RE: Report No. 41832, v.3  
9427 Springs Court  
Smithtown, GA  
30221

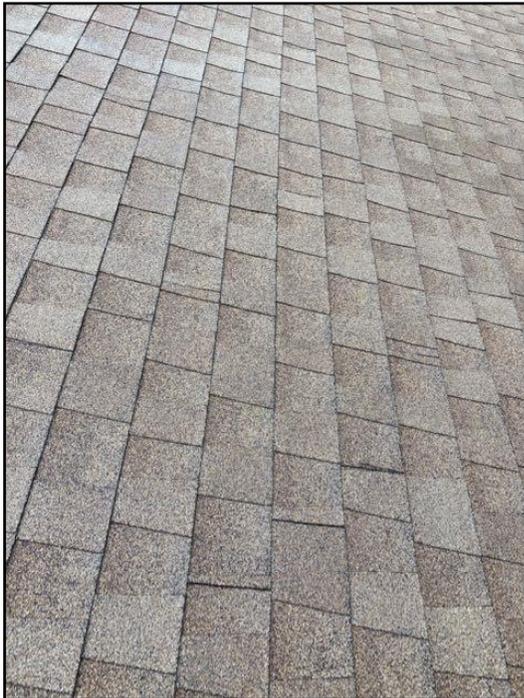
**1. Condition:** • Granule Loss

Shingles are starting to loose granules, which is an indication of wear. This shows the shingles to be brittle and dried out and as the condition deteriorates and repairs become necessary, replacement may be a better option than repair.

1. Granule Loss

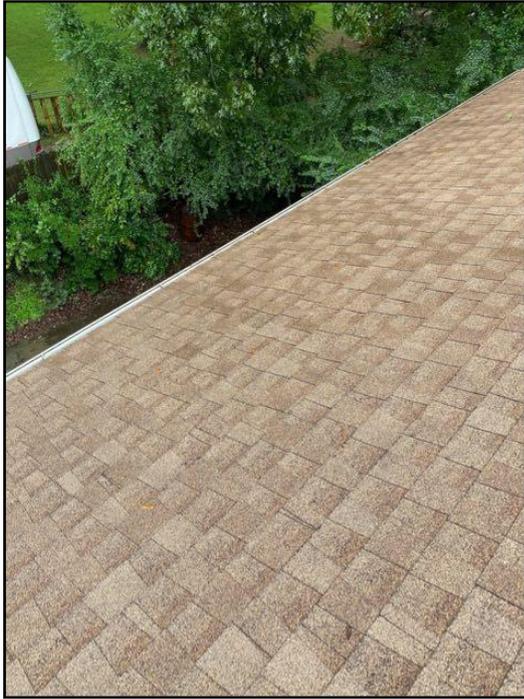
3. Granule Loss

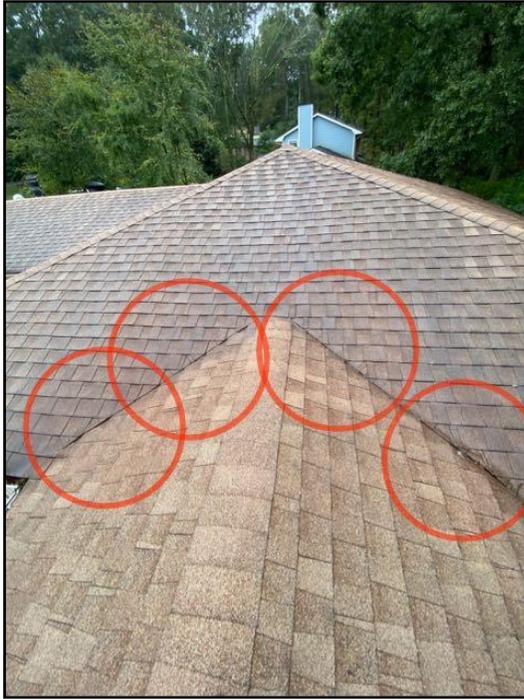
**3. Condition:** • Installation issues

7. Installation issues

**Task:** Evaluation by roofing contractor to determine necessary repairs

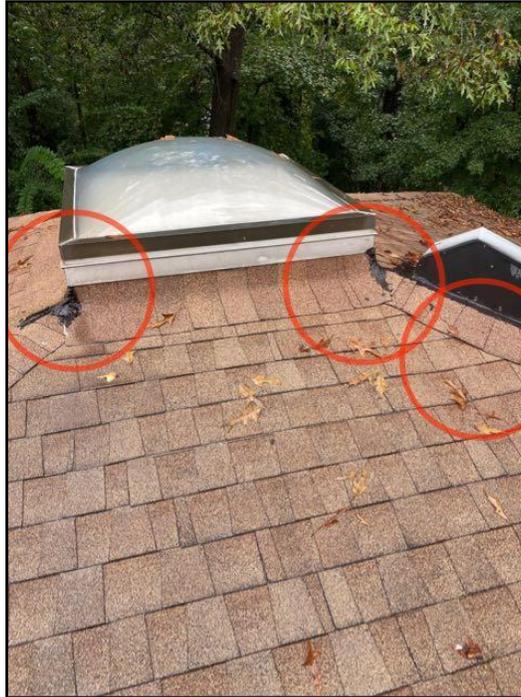
11. Patched/Repaired

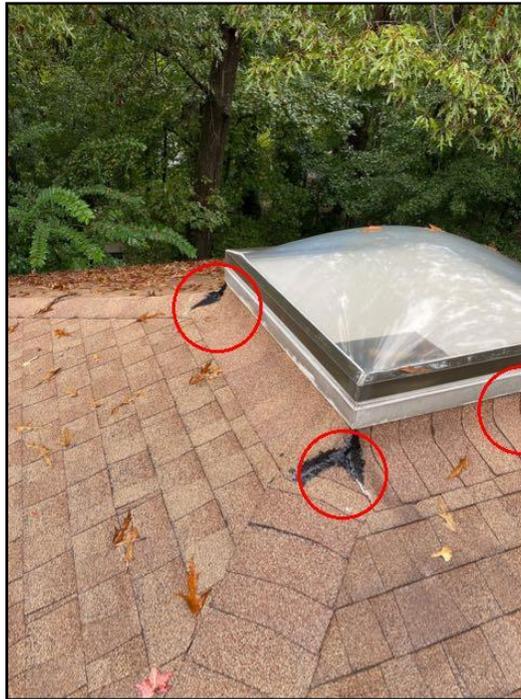
**6. Condition:** • Skylight flashing issues

12. Skylight flashing issues

**Task:** Repair As Needed

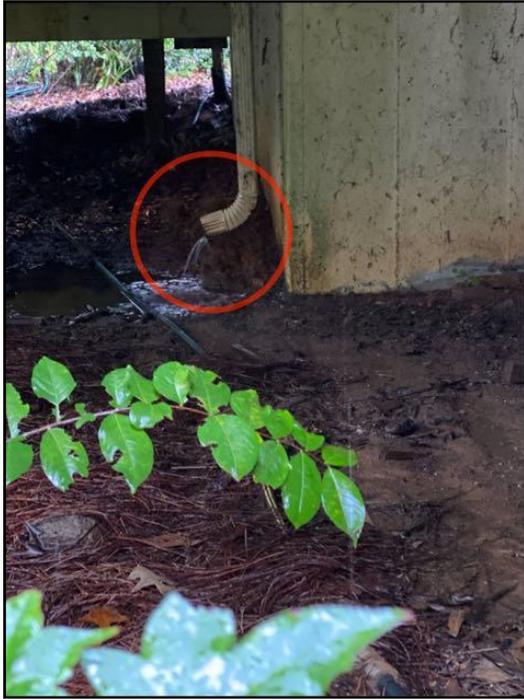
**7. Condition:** • Discharges Too Close to the Building

19. Discharges Too Close to the Building

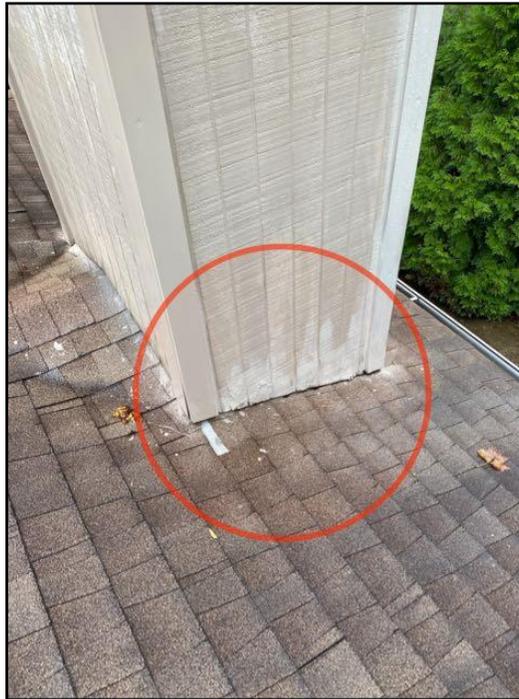
26. Rot/Insect damage

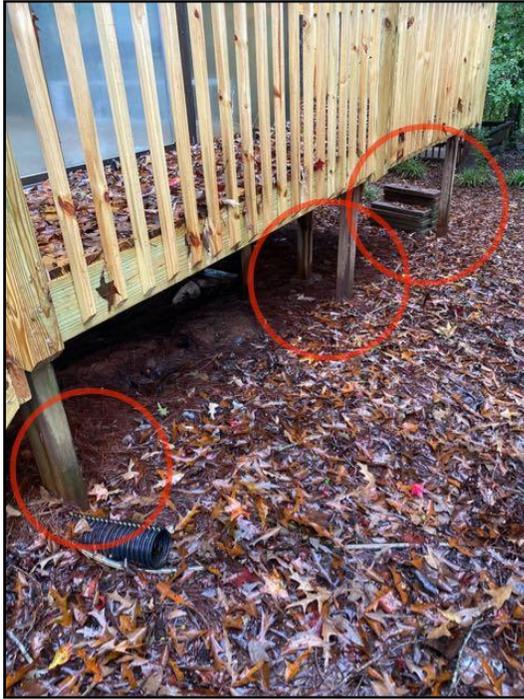
30. Wood/soil contact

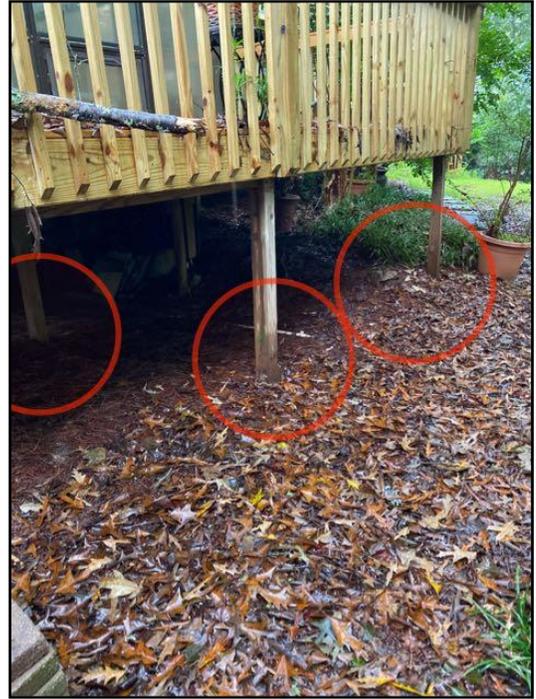
31. Wood/soil contact

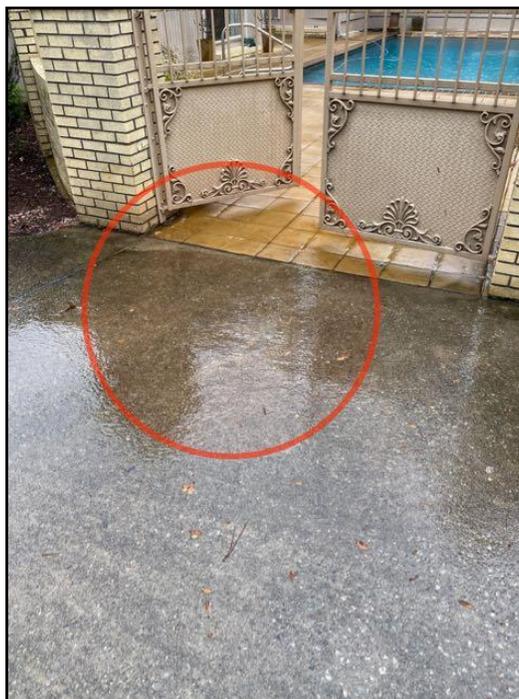
**36. Improper Slope or Drainage**

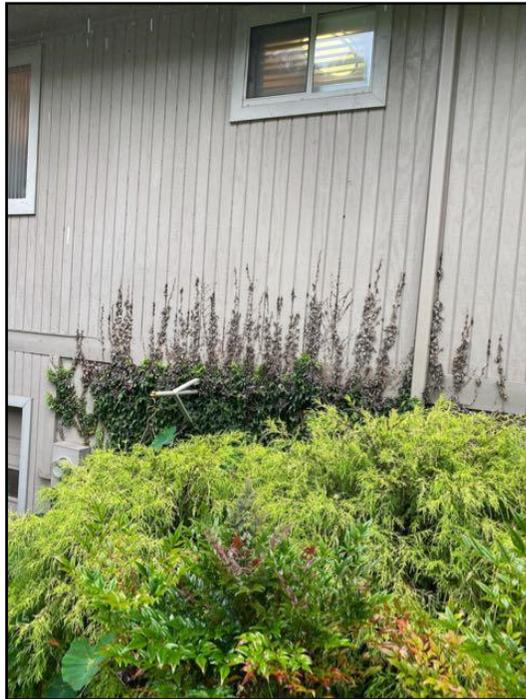
**19. Condition:** • Trees or Shrubs too close to building

37. Trees or Shrubs too close to building

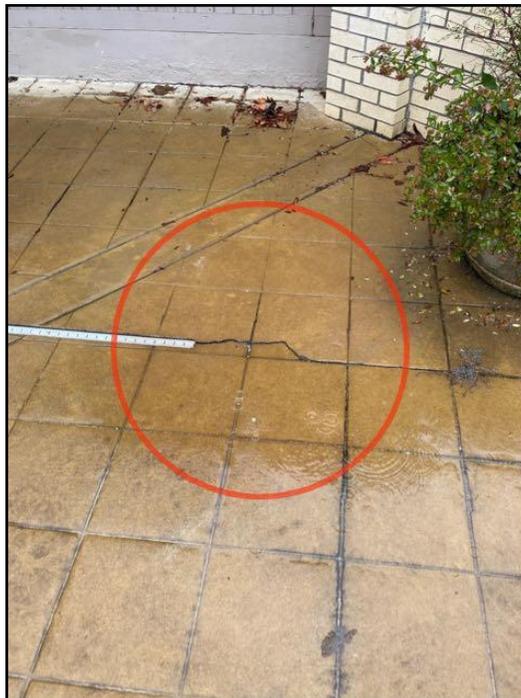
41. Cracked or Damaged Surfaces

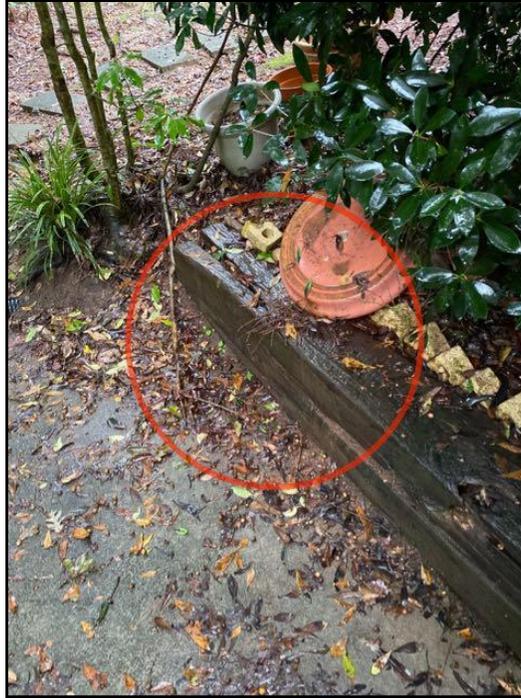
**Condition:** • Rotten Retaining Wall

**21. Condition:** • Rotten Retaining Wall

42. Rotten Retaining Wall

**Task:** Repair or replace

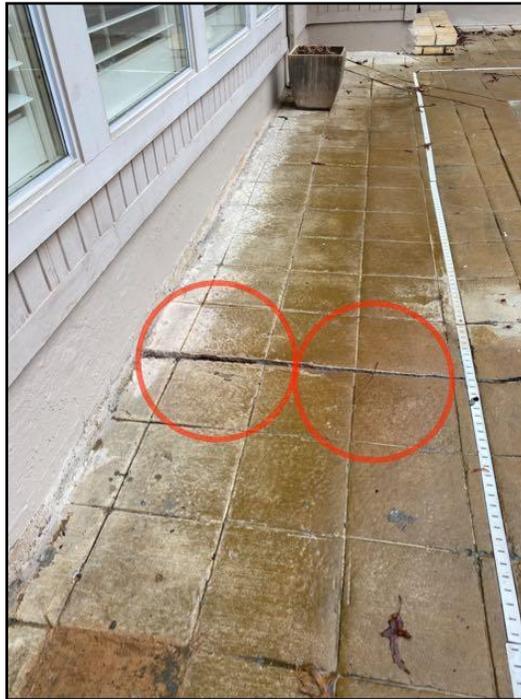
43.

**22. Condition:** • Heaved

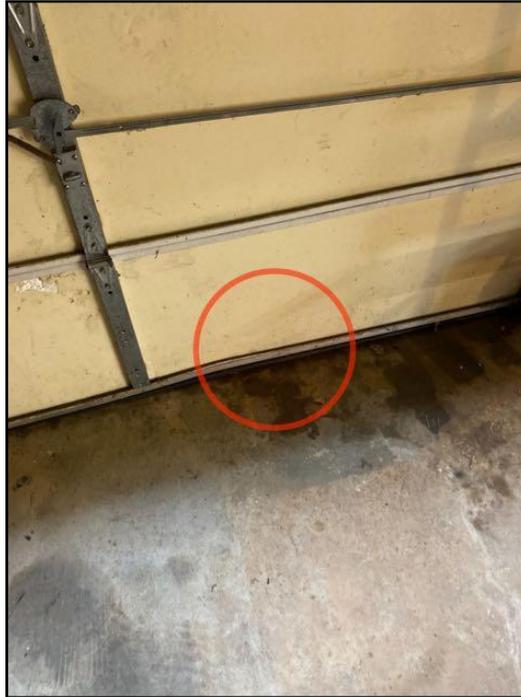
44. *Vehicle Door is Dented/Damaged*

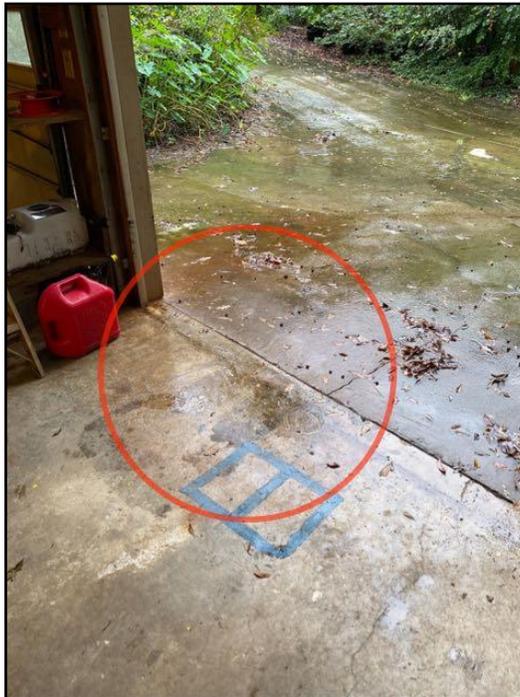
25. Condition: • Water Intrusion

46. Water Intrusion

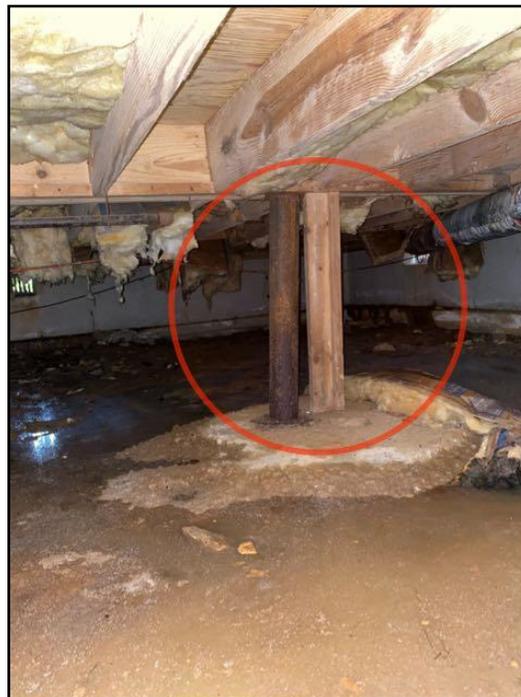
51. Leaning

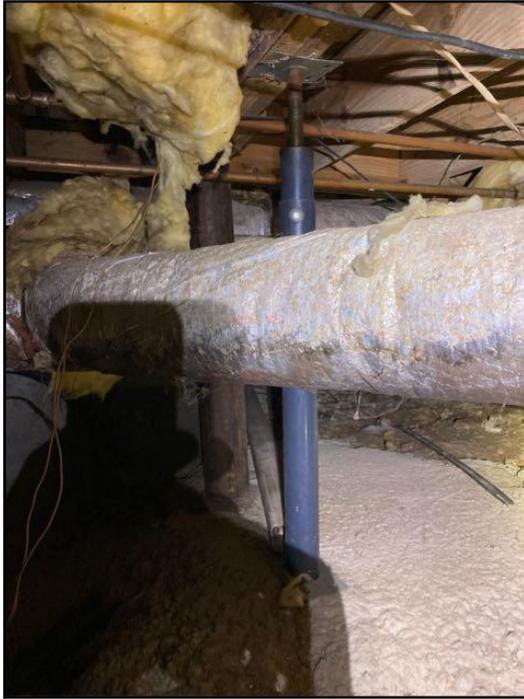
**31. Condition:** • Temporary Support with Issues.

52. Temporary Support with Issues.

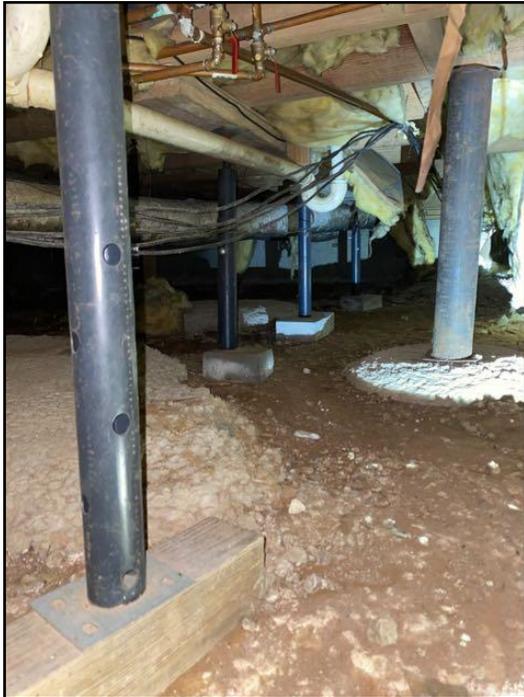
54. Temporary Support with Issues.

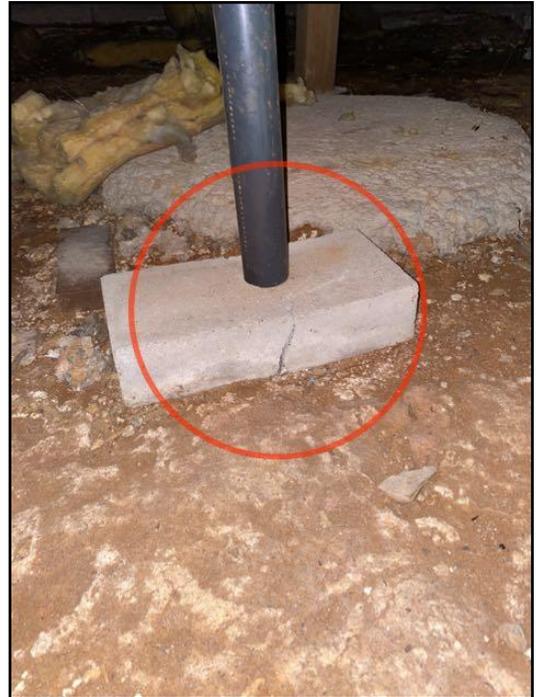
55. Temporary Support with Issues.

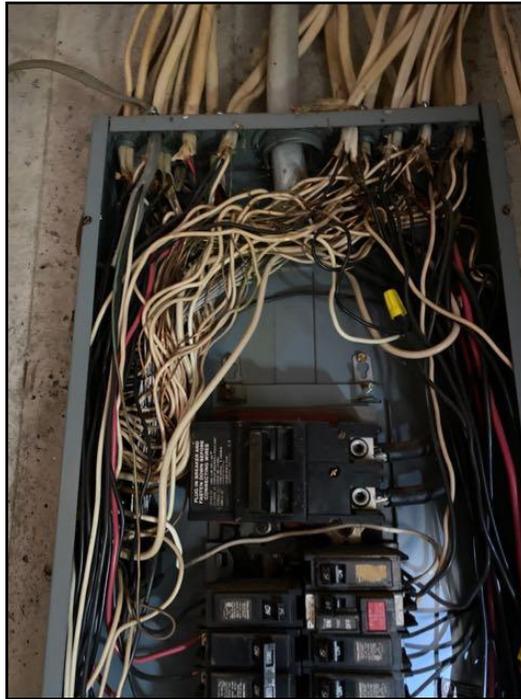
**35. Condition:** • Crowded

*57. Crowded*

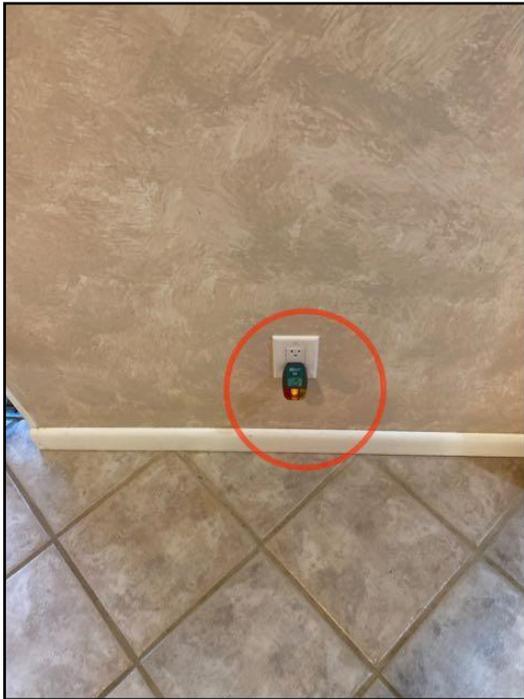
**37. Condition:** • Ungrounded

59. Ungrounded

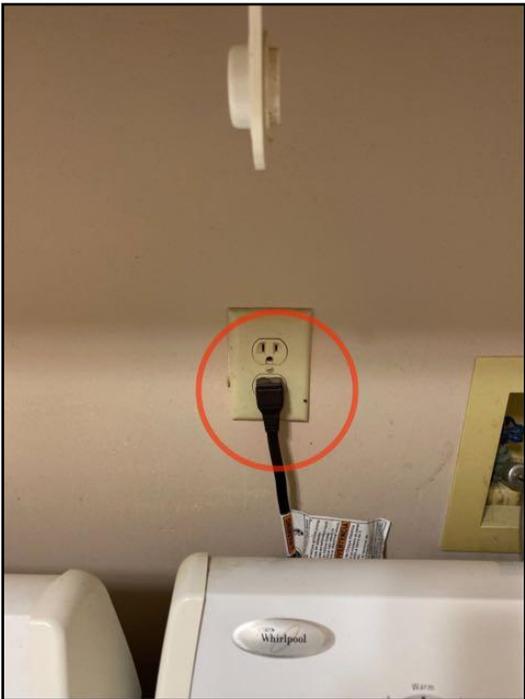
**38. Condition:** • No GFCI/GFI (Ground Fault Circuit Interrupter)

62. No GFCI/GFI (Ground Fault Circuit...

**Location:** Laundry room  
**Task:** Upgrade  
**Time:** Immediate  
**Cost:** Less than \$100 - Each

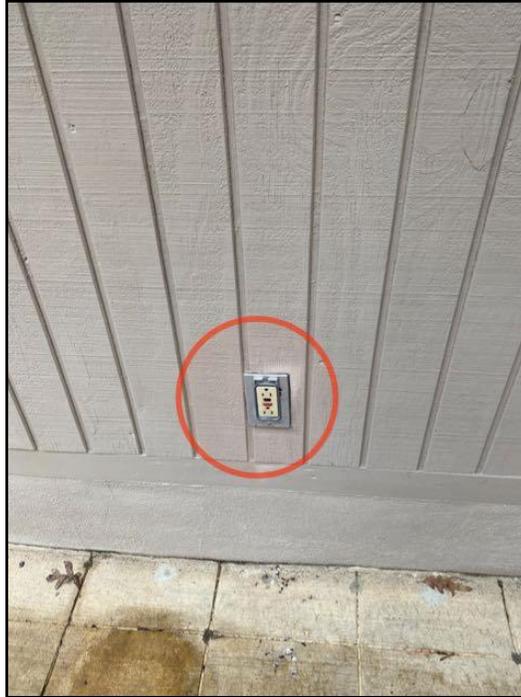
**39. Condition:** • Inoperative

**63.** *Inoperative*

**Task:** Replace

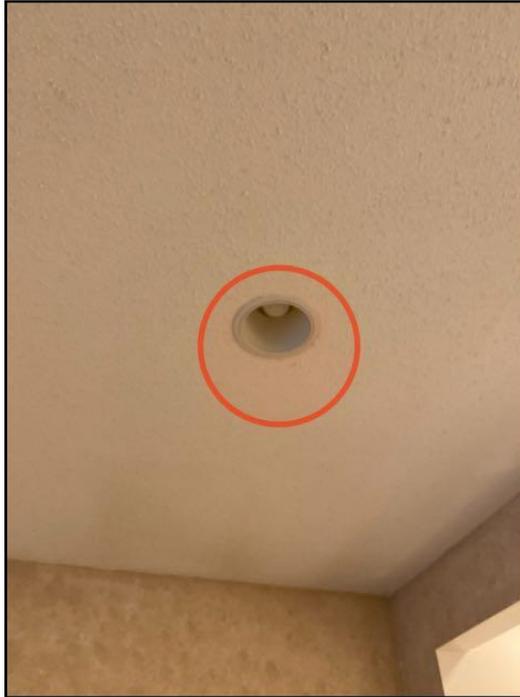
**41. Condition:** • Inoperative

This is most likely blown bulbs and recommend confirming operation from the seller. The photos and locations noted in this section should only be considered representative of the condition and not all encompassing.

64. *Inoperative*

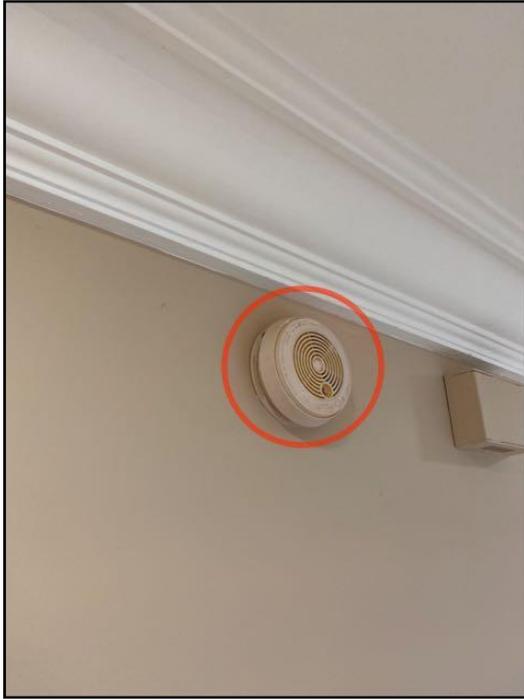
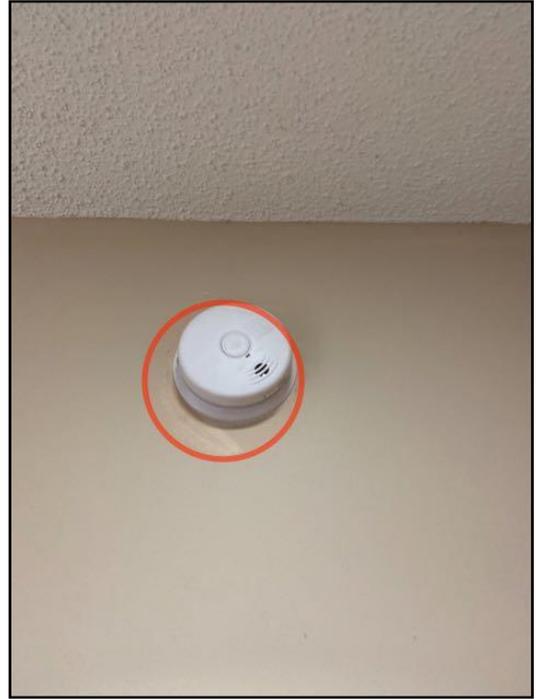
**43. Condition:** • [Over 10 Years Old](#)

The smoke detectors in this home are most likely over 10 years old. NFPA recommends they be replaced every 10 years and suggest doing so upon taking ownership.

66. Over 10 Years Old

67. Over 10 Years Old

**Task:** Replace

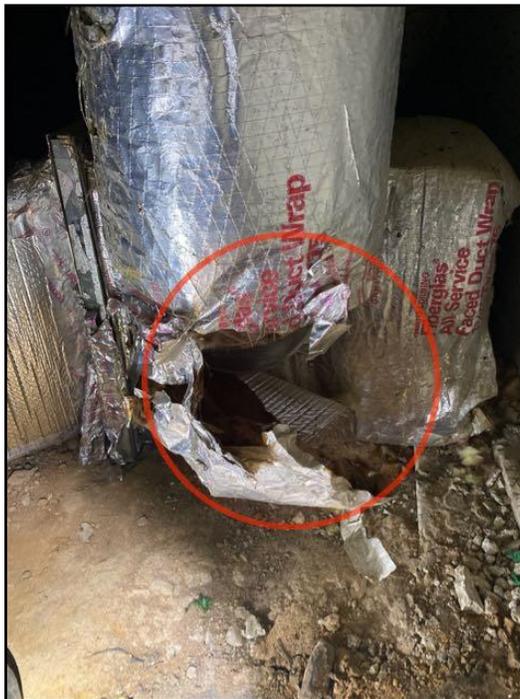
**46. Condition:** • Insulation Missing or Damaged

**70.** *Insulation Missing or Damaged*

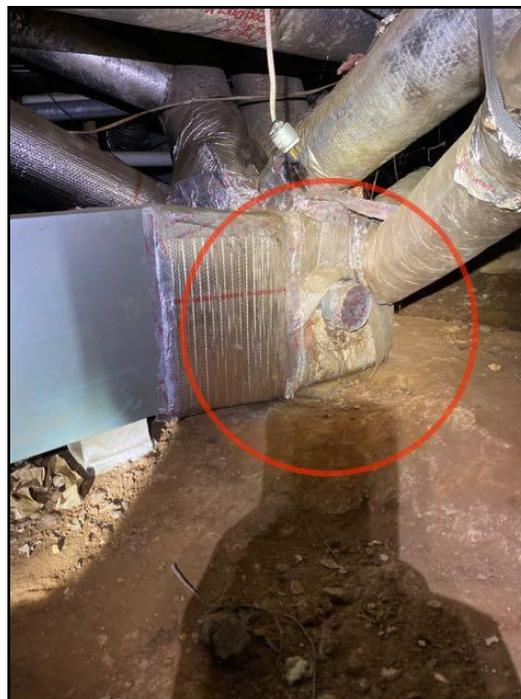
**47. Condition:** • Poor Support

71. Poor Support

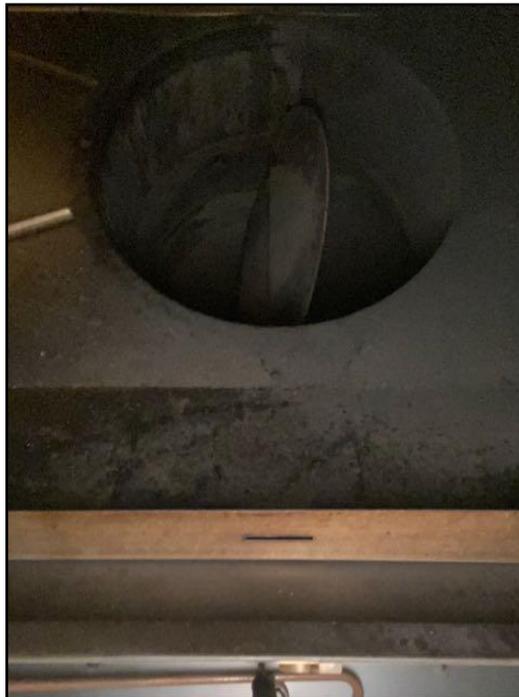
**49. Condition:** • [Inoperative](#)

*72. Inoperative*

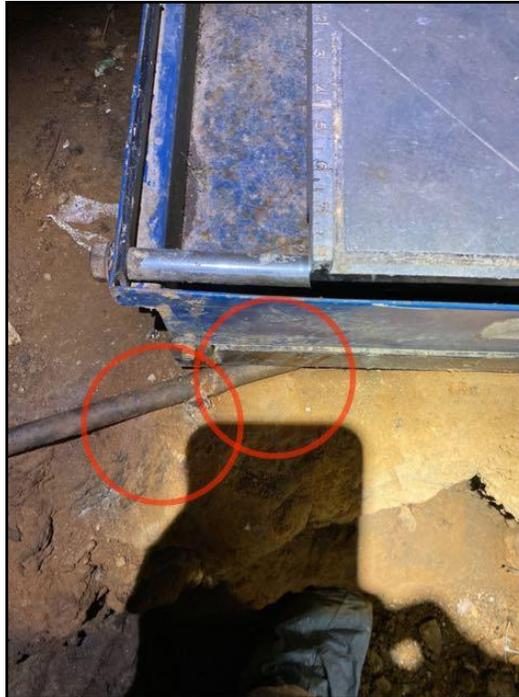
79.

**50. Condition:** • Improper discharge

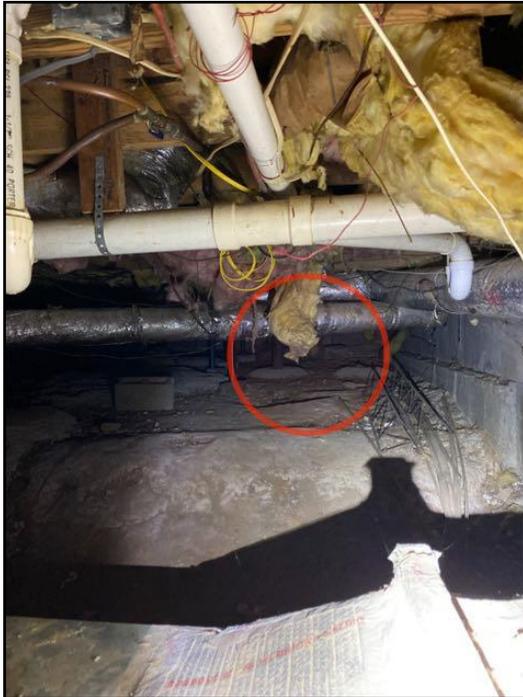
**51. Condition:** • Insulation is falling away

82. Insulation is falling away

**Task:** Improve or Replace

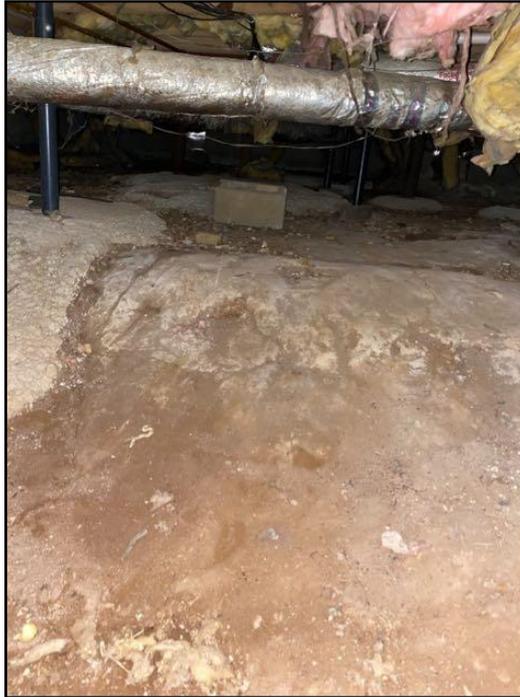
**52. Condition:** • [No vapor barrier](#)

84. No vapor barrier

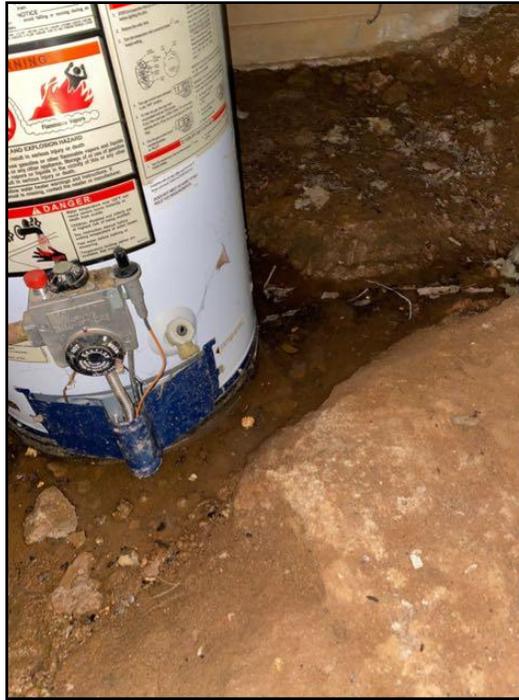
**55. Condition:** • Leaking Tank

**87. Leaking Tank**

**Task:** Replace

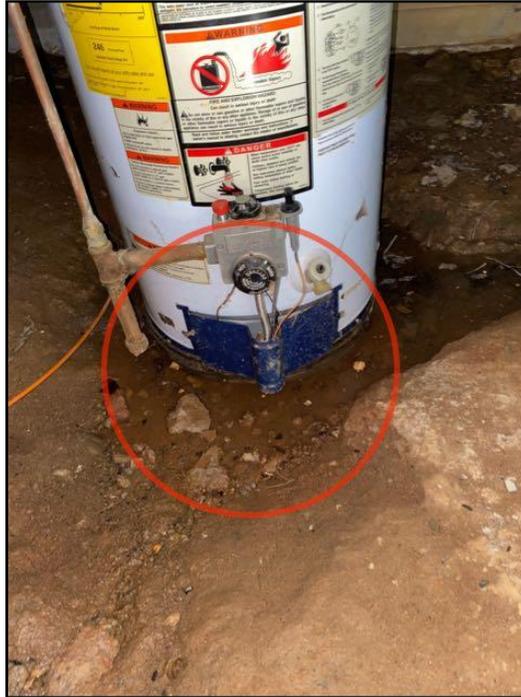
**56. Condition:** • Tank Sitting Directly on Dirt

88. Tank Sitting Directly on Dirt

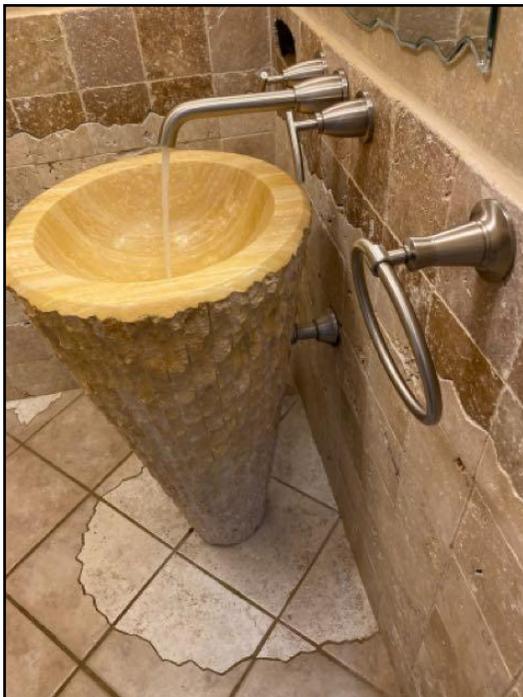
61. Condition: • [Not visible](#)

Location: Right side half bathroom, master bathroom

91. Not visible

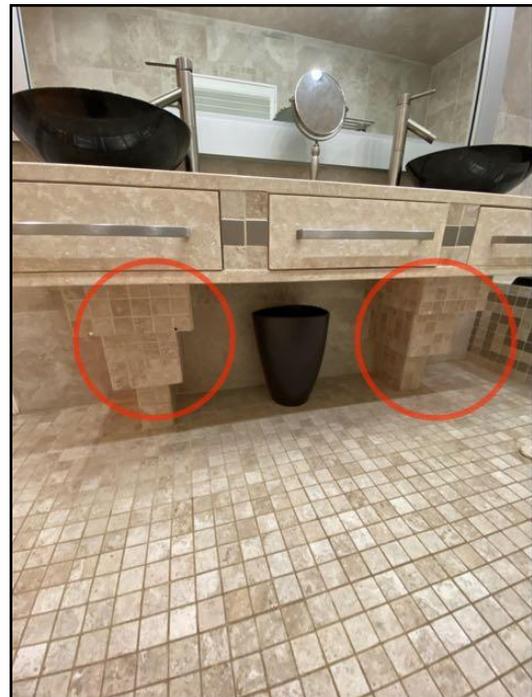
92. Not visible

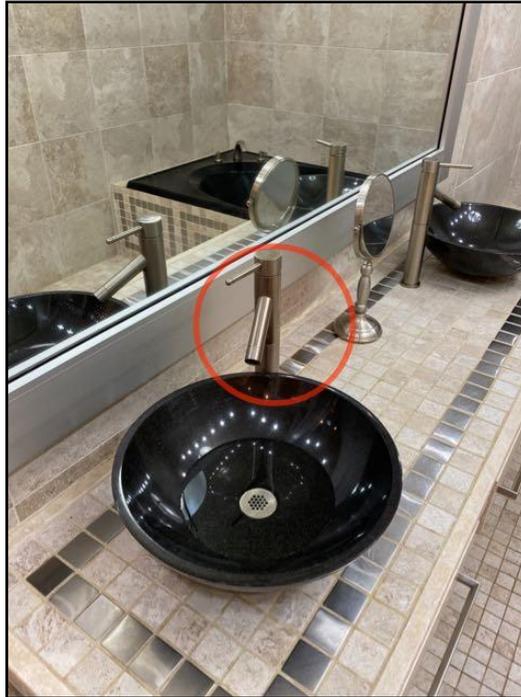
93.

**62. Condition:** • No hot water at master bathroom left vanity

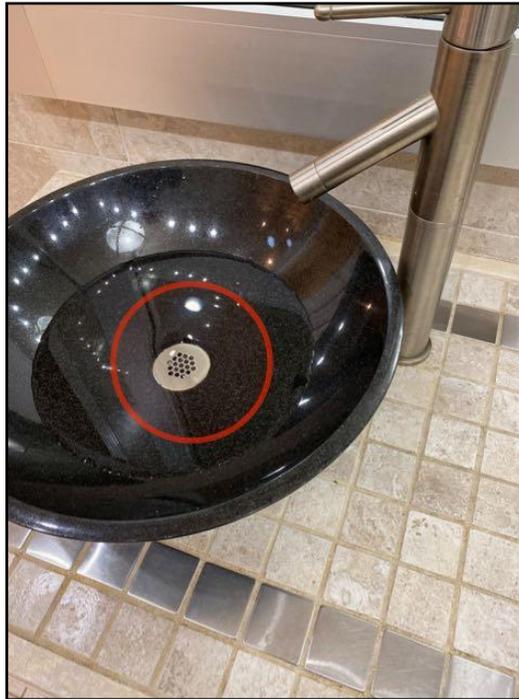
**63. Condition:** • [Slow drains](#)

94. *Slow drains*

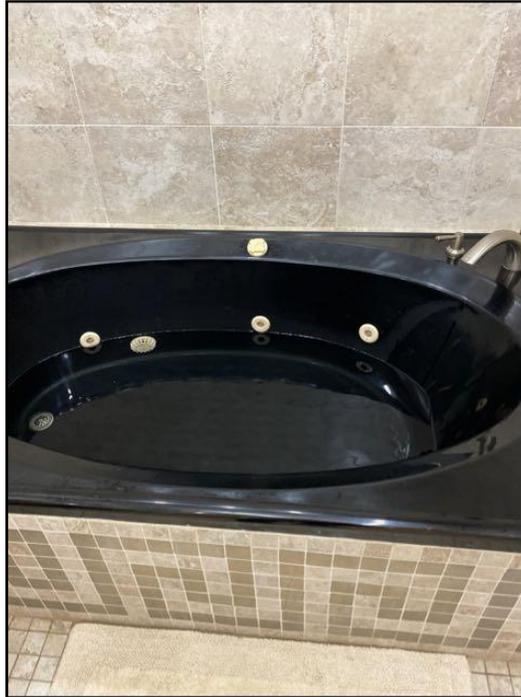
**66. Condition:** • Inoperative

96. Inoperative

**Task:** Repair or replace

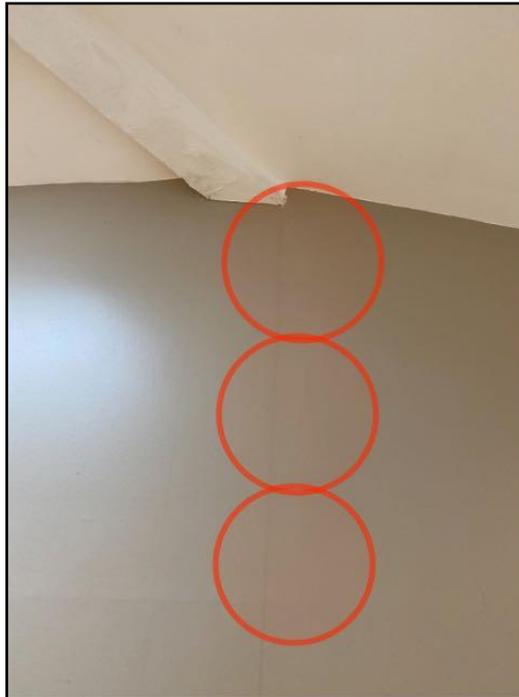
**69. Condition:** • Water Stains

Could not recreate leak at the time of inspection and suggest consulting with seller as to what repairs have been done.

105. *Water Stains*

**Task:** Request disclosure

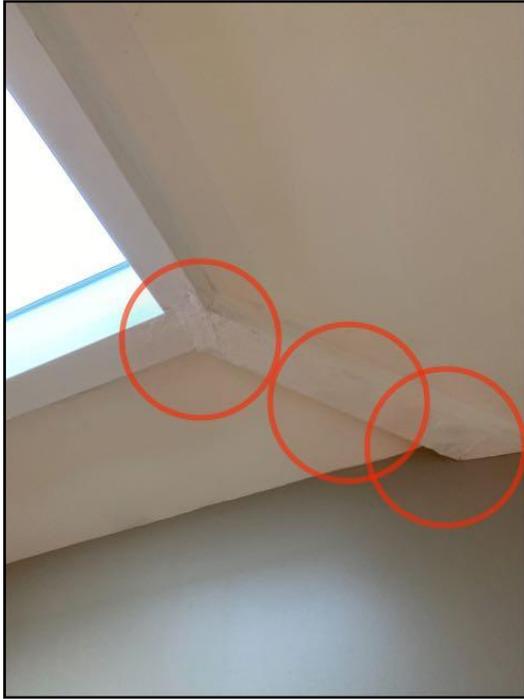
**70. Condition:** • Patched/Painted Areas

Patches and painted areas in ceilings are usually from previous leaks that may no longer be leaking or only leak in certain circumstances. Suggest consulting with the seller as to why these repairs have been done.

106. Patched/Painted Areas

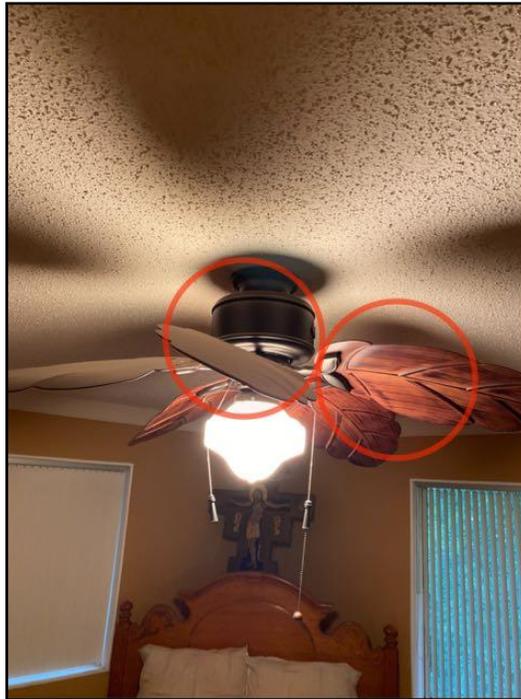
**72. Condition:** • Inoperative

113. Inoperative

**Task:** Repair or replace

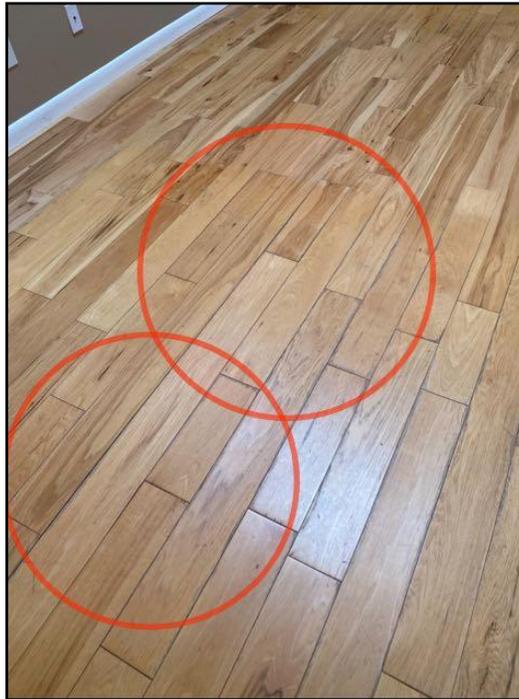
**73. Condition:** • Buckled or Swollen

This could be caused from a water issue. Source of water must be identified and corrected, if necessary, before repair or replacement of flooring.

114. *Buckled or Swollen*

**Task:** Repair or replace

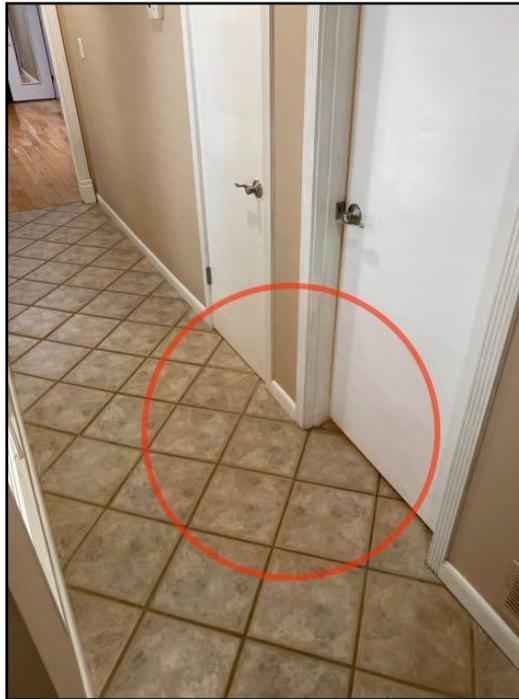
117.

**75. Condition:** • Sag/dip

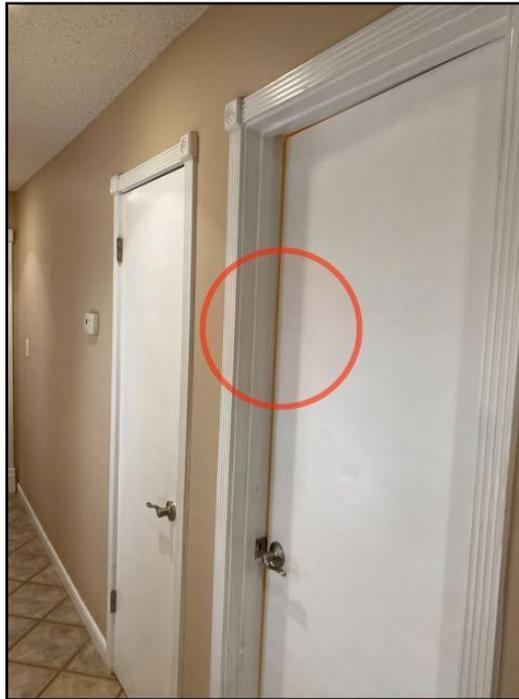
**79. Condition:** • Door Binds  
**Location:** Left side hall bathroom  
**Task:** Adjust  
**Time:** Discretionary  
**Cost:** Minor

124. Door Binds

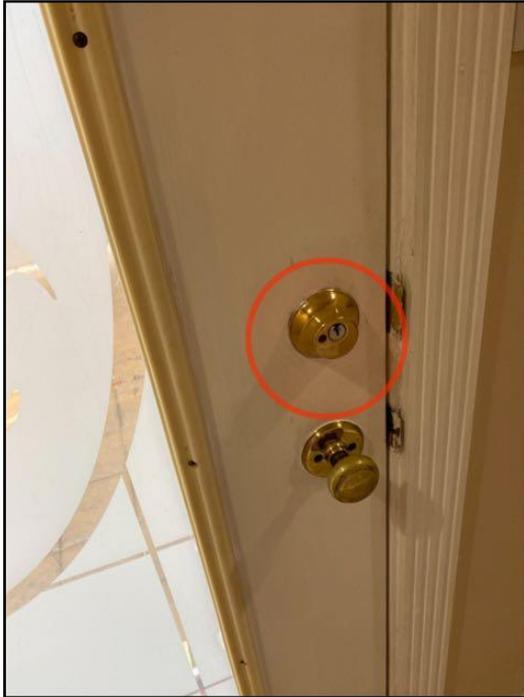
**80. Condition:** • Key Required for Deadbolt

125. Key Required for Deadbolt

Recommend replacing keyed deadbolt with hardware that uses interior thumb latch.

**Task:** Replace

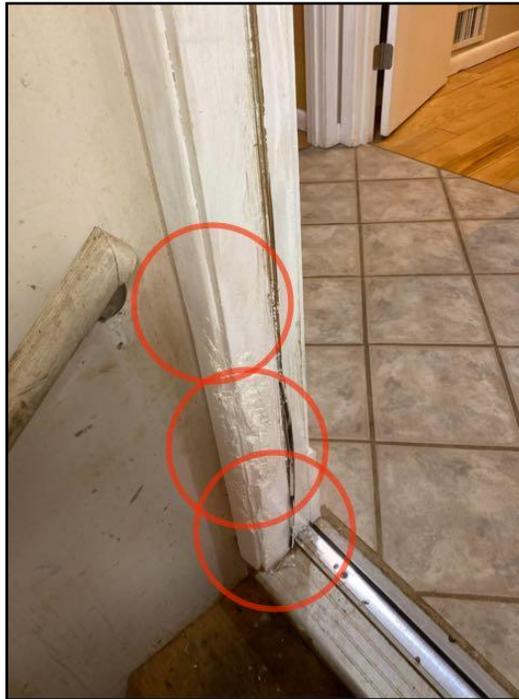
**82. Condition:** • Damage

128. *Damage*

**Task:** Repair or replace

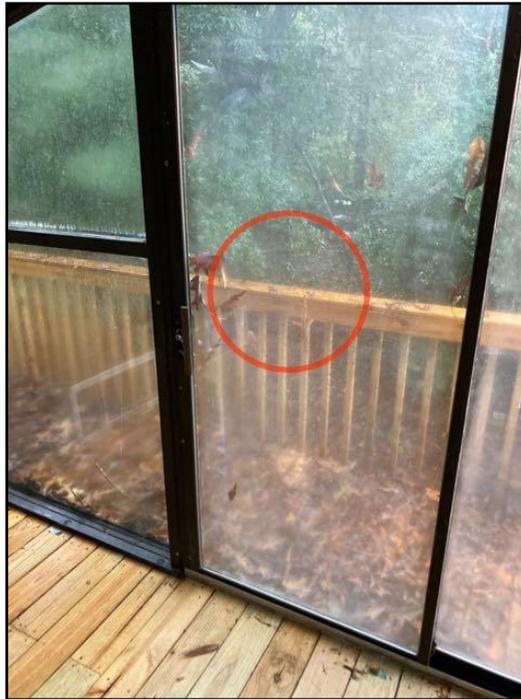
129.

**83. Condition:** • Poor operation

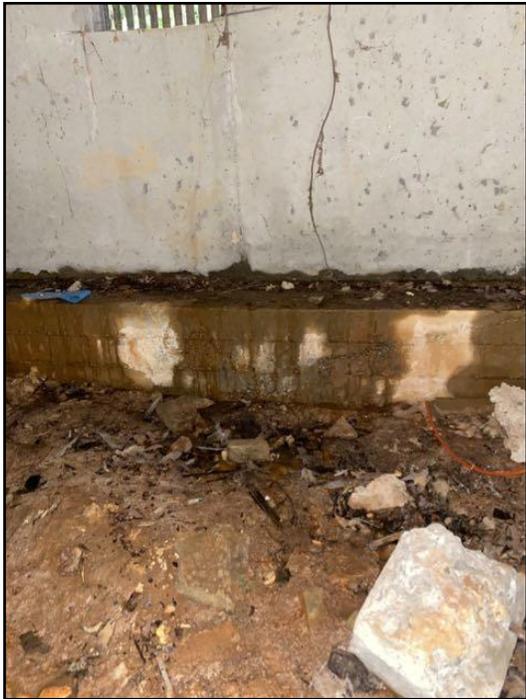
89. Condition: • [Dampness on floor or walls](#)

132. Dampness on floor or walls

Task: Consult with a foundation or waterproofing company

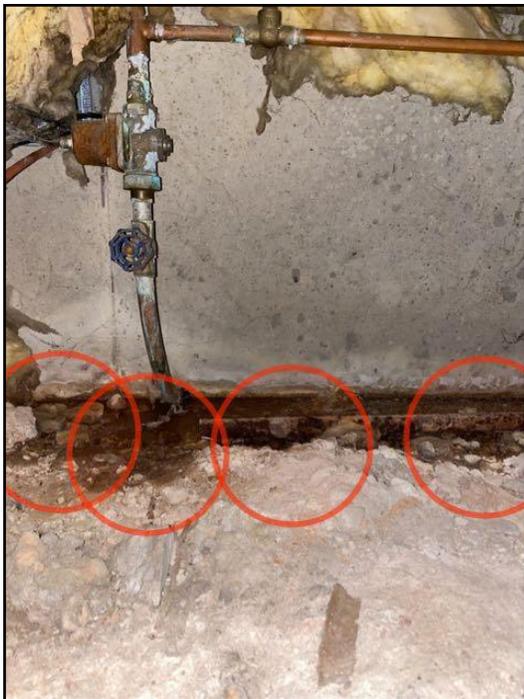
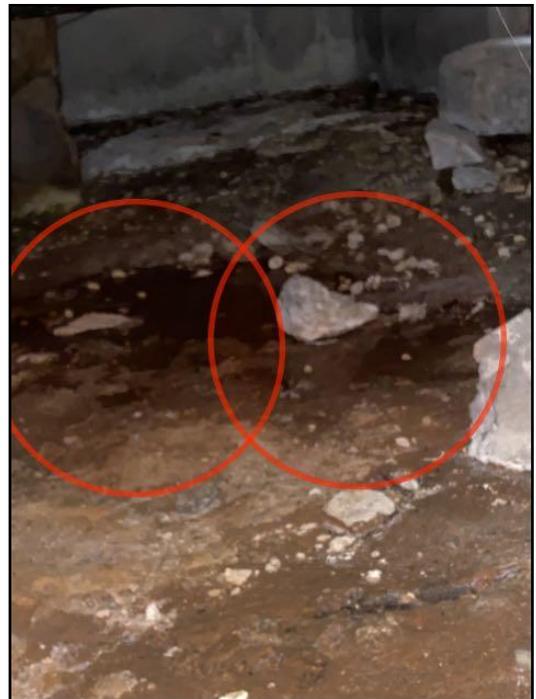
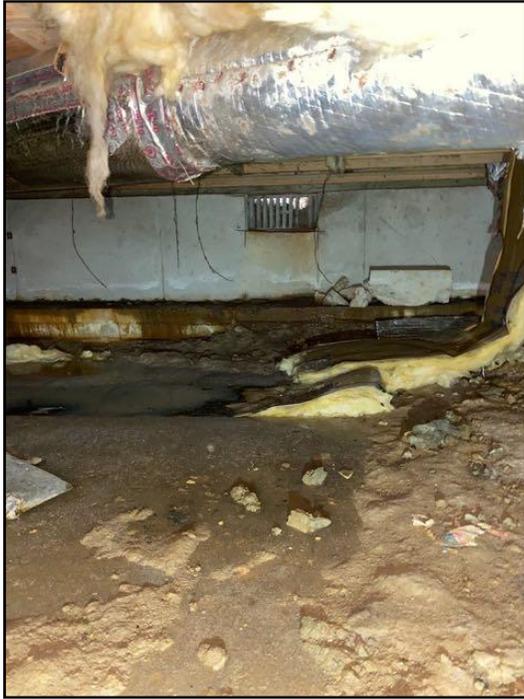
90. Condition: • [Water on floor](#)  
 Location: Throughout crawlspace

134. Water on floor

135. Water on floor

136. Water on floor

137. Water on floor

**Task:** Consult with a foundation or waterproofing company

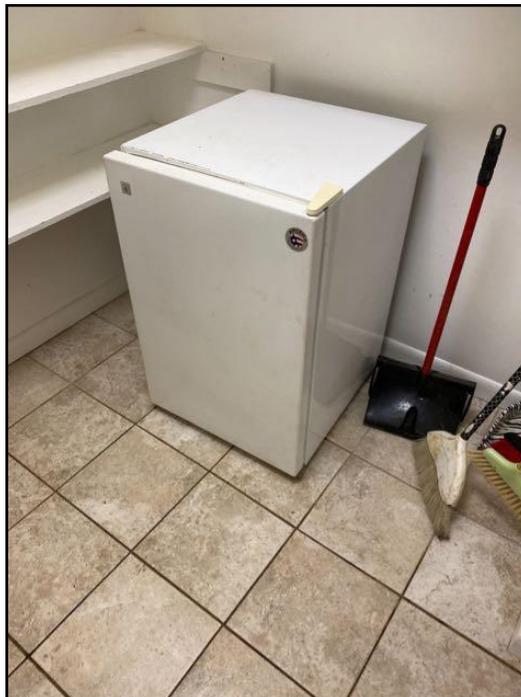
138.

91. Condition: • Mini fridge frosted over

Location: Pantry

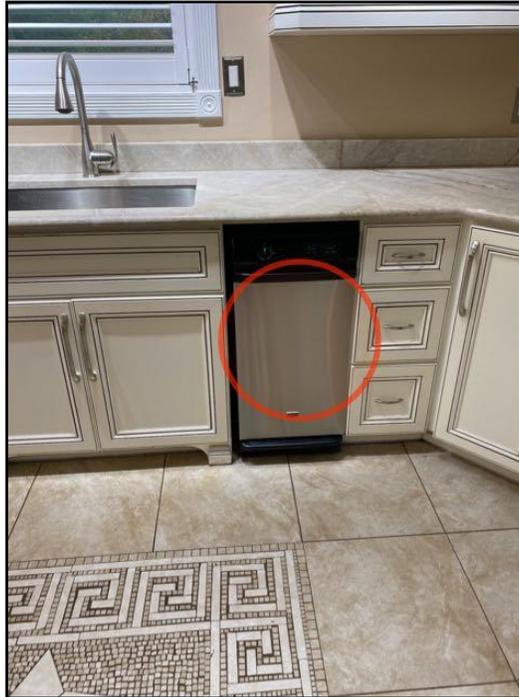
**92. Condition:** • Inoperative

139. Inoperative

**Task:** Repair or replace
